**Subject: Kaipapa Bay – Knowles – U130376 – Request for Additional Information –
Review of Wastewater Report
Our ref: 2337A**

▪ **Wastewater Report**

**Structural Assessment,
Yellow Building - Kaipapa Bay**

▪ **Engineering Report**

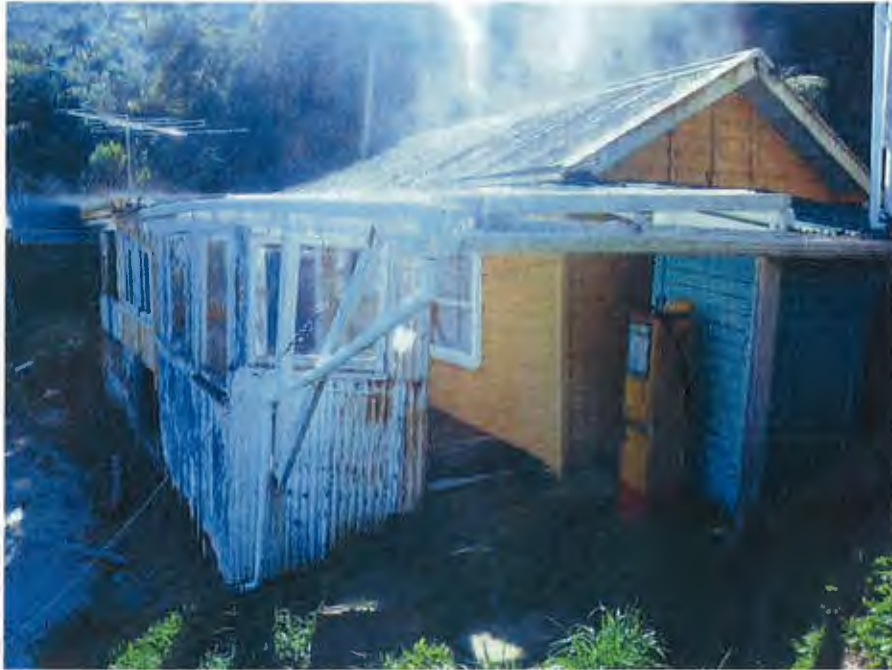
The yellow building (herein called building) is in a poor state of repair as it has been sparingly maintained. The structure however is generally in good condition and only requires the removal of the southern deck and replacing of two central piles (these areas currently being the only 'unsafe' portion of the building).

Southern decking and associated wall and roof to be removed

- Remove the southern deck and associated walls and roofing.
- Replace the two undermined piles behind the seawall with piles extending below the bottom of the seawall.

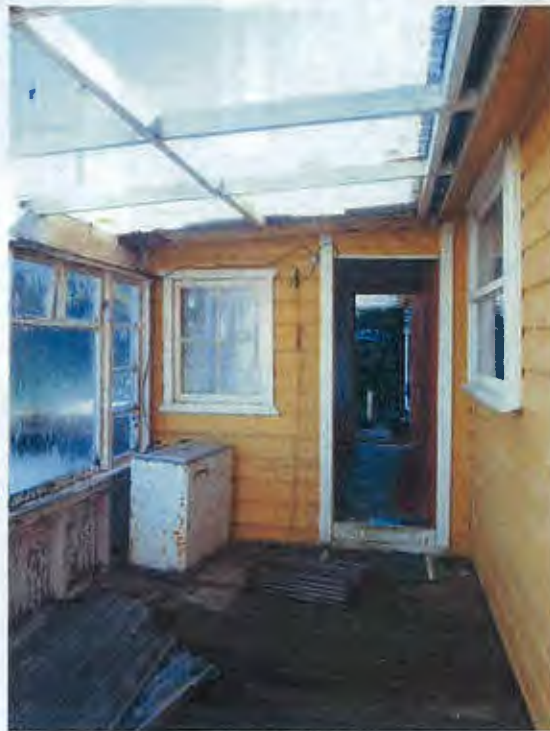
Southern decking area

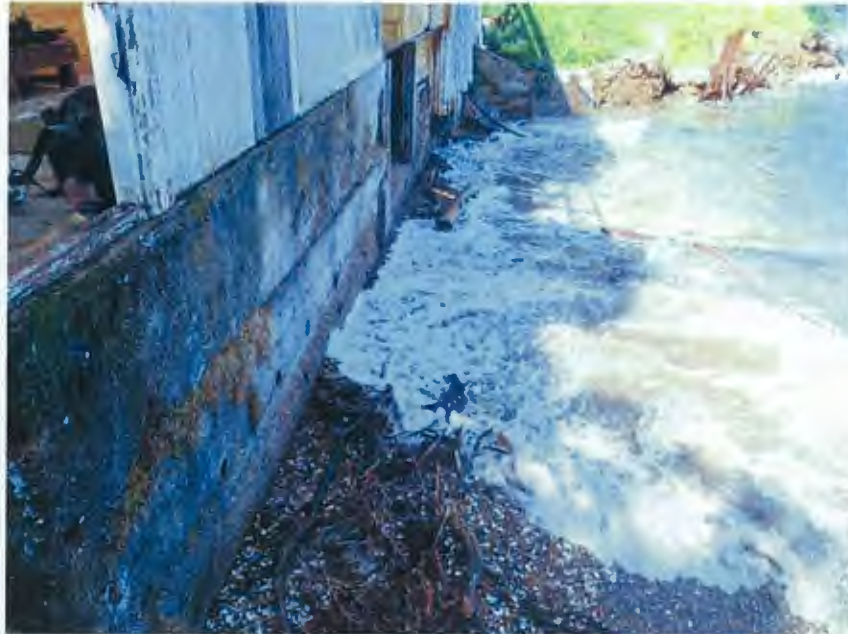
The seawall does not appear to have any reinforcing. The concrete is of poor quality and the aggregate is beach material. The areas of the wall subject to wave action are showing signs of deterioration and the southern end has collapsed.

Seawall and wave action at high tide

- The sea wall be replaced.
- The foundations and subfloor requires replacing. We recommend the building is lifted, supported, a concrete slab installed tied to the top of the sea wall and the building lowered and fixed to the new slab.

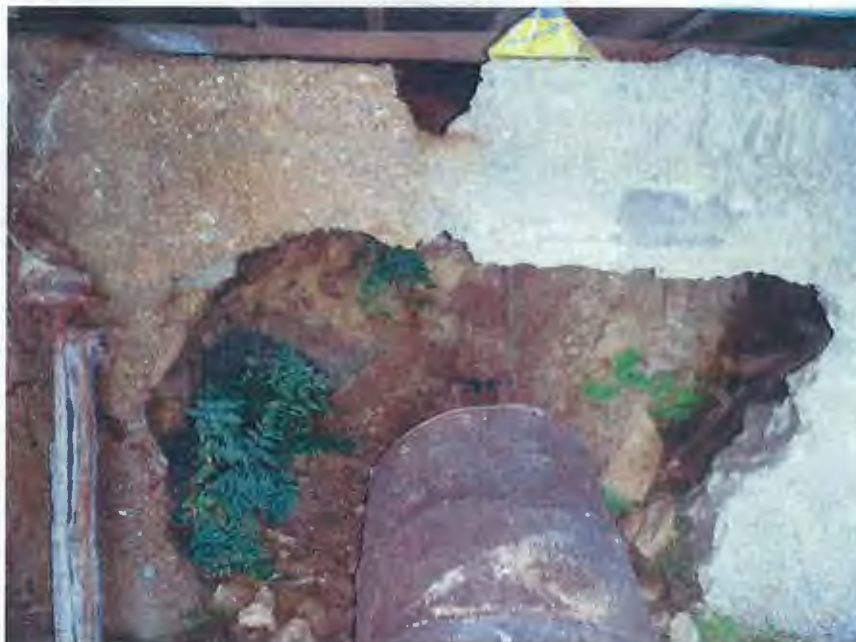
The sea wall is open in the middle creating a storage area below the seaward section of the building. The back wall of this area has collapsed which has resulted in the earth supporting two piles being undermined.

Internal part of seawall

Repair of the rear wall to the storage area and replacement of the two piles would repair the collapsed area. This is no more than repair and maintenance that can be expected of any building of this age and as such does not present any danger to the building or its occupants. It is essentially part of repairing the piles.

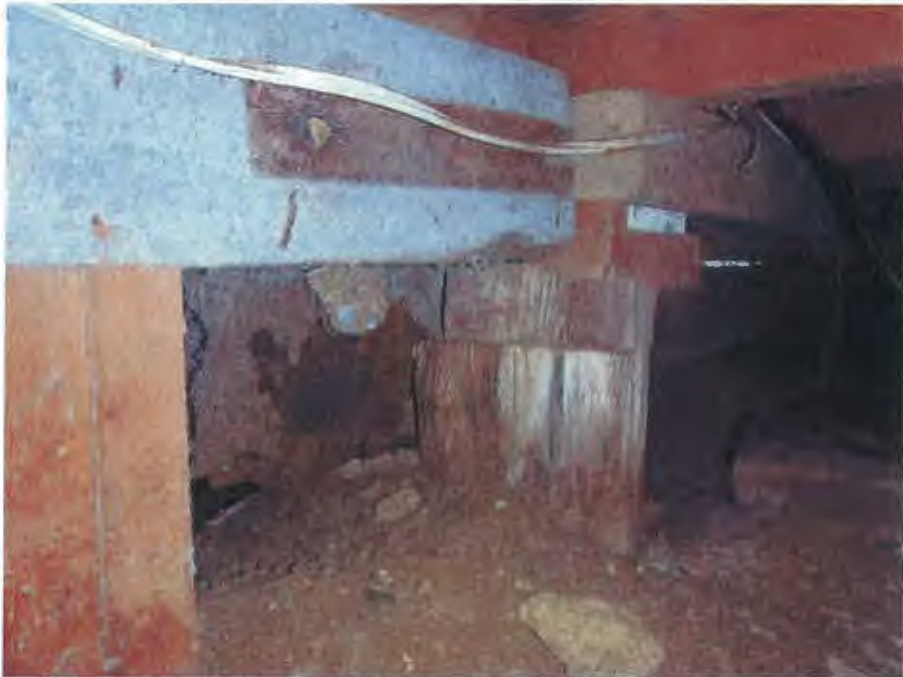
The untreated timber piles have rotted at ground level and are expected to be rotten below ground level. The rot has caused localised sinking of the floor. Packing above the piles has been installed at some point to level the floor. This has not caused any structural damage to the house or caused any immediate unsafe conditions for the building or its occupants and can be easily repaired by replacement of the two piles.

Typical foundation detail

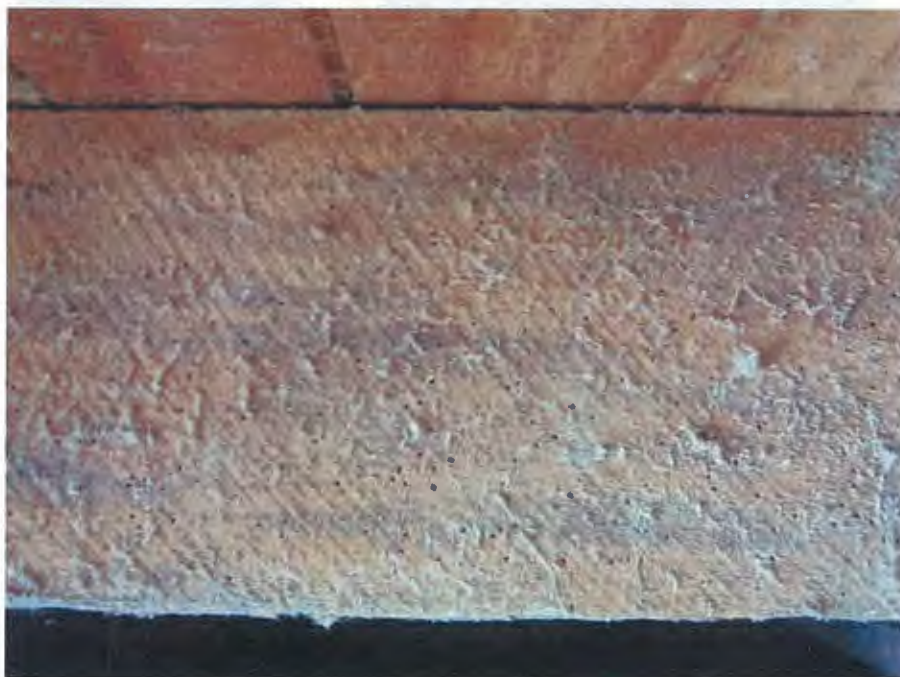
The bearers and floor joists have been attacked by borer and have been slightly weakened by this. This has not caused any immediately unsafe structural conditions that threaten safety of the building or its occupants and that can not be easily repaired when need for this occurs. At present these timbers still have adequate strength .

Borer in floor joist

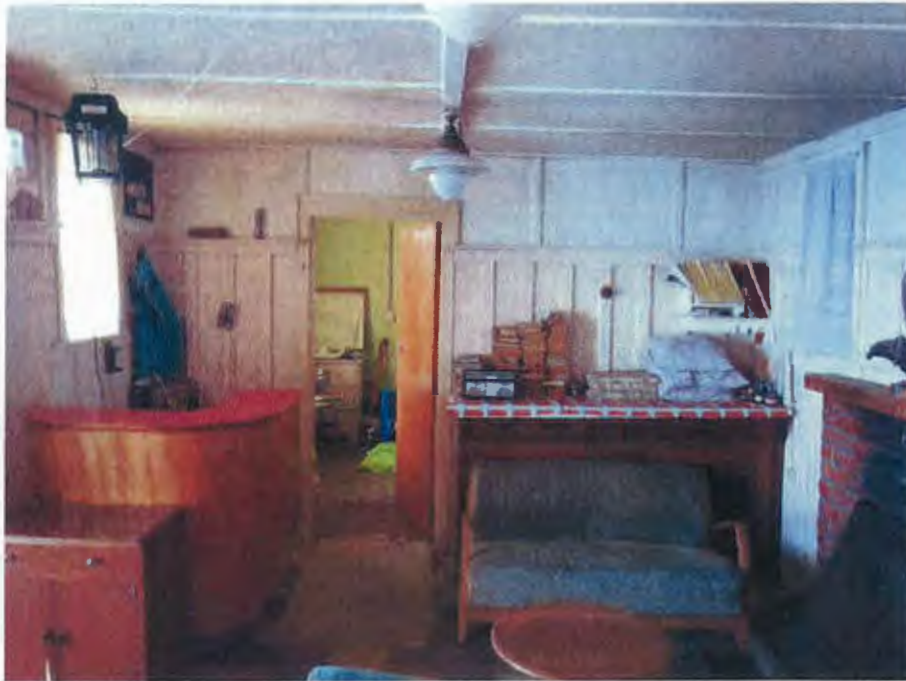
Most of the walls are deformed due to the pile subsidence however the deformation is only vertical as common to houses of this era requiring localised re-piling. It is expected the majority of the framing is in good condition. Replacement of the two rotten piles and remedial works on the foundation will correct the vertical deformation.

Internal layout - note subsidence in dividing wall

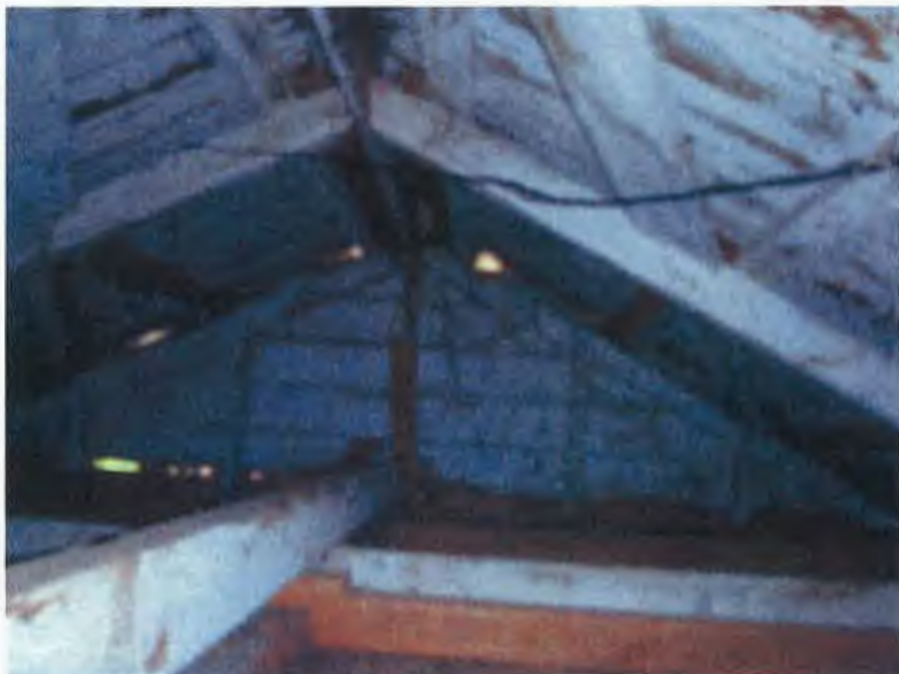
The roof is in relatively good condition, most members have been painted and there is no sign if significant deflection or failure.

Roof layout
