Helen Bray

**Geotechnical Stability Investigation
Two Building Sites, Coles Bay
Port Underwood**

May 2002

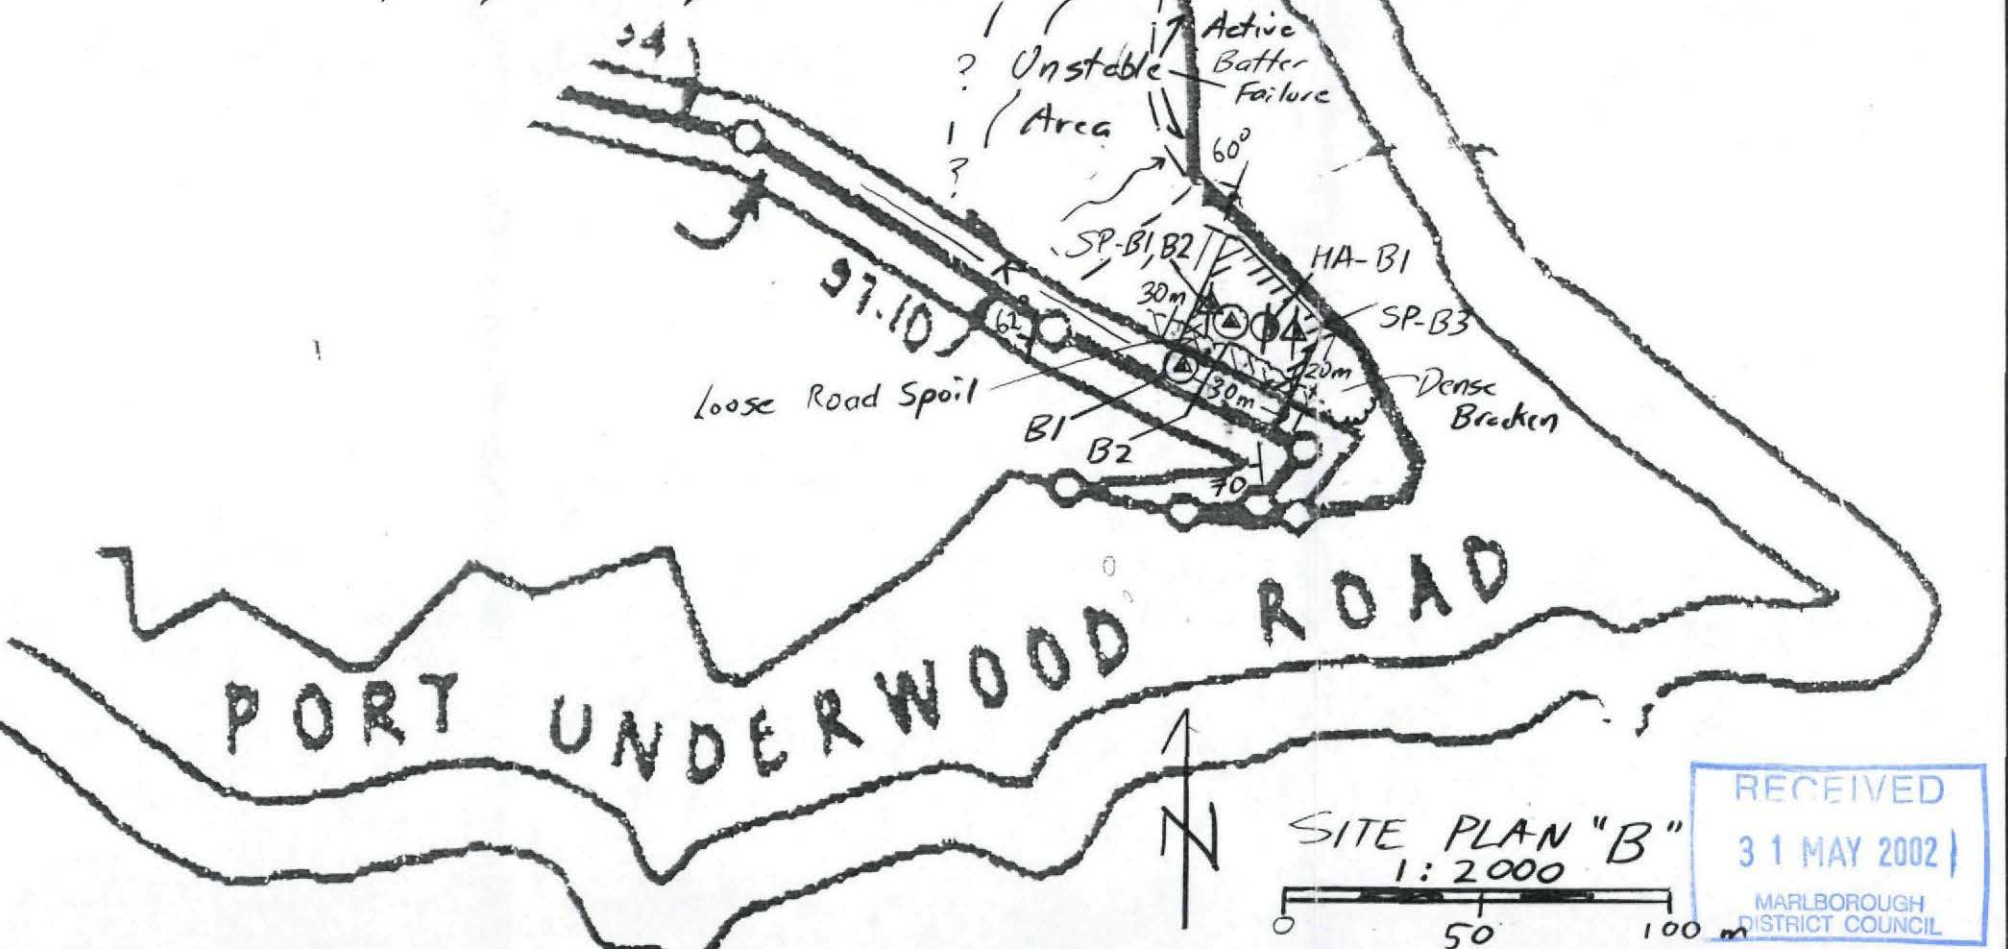
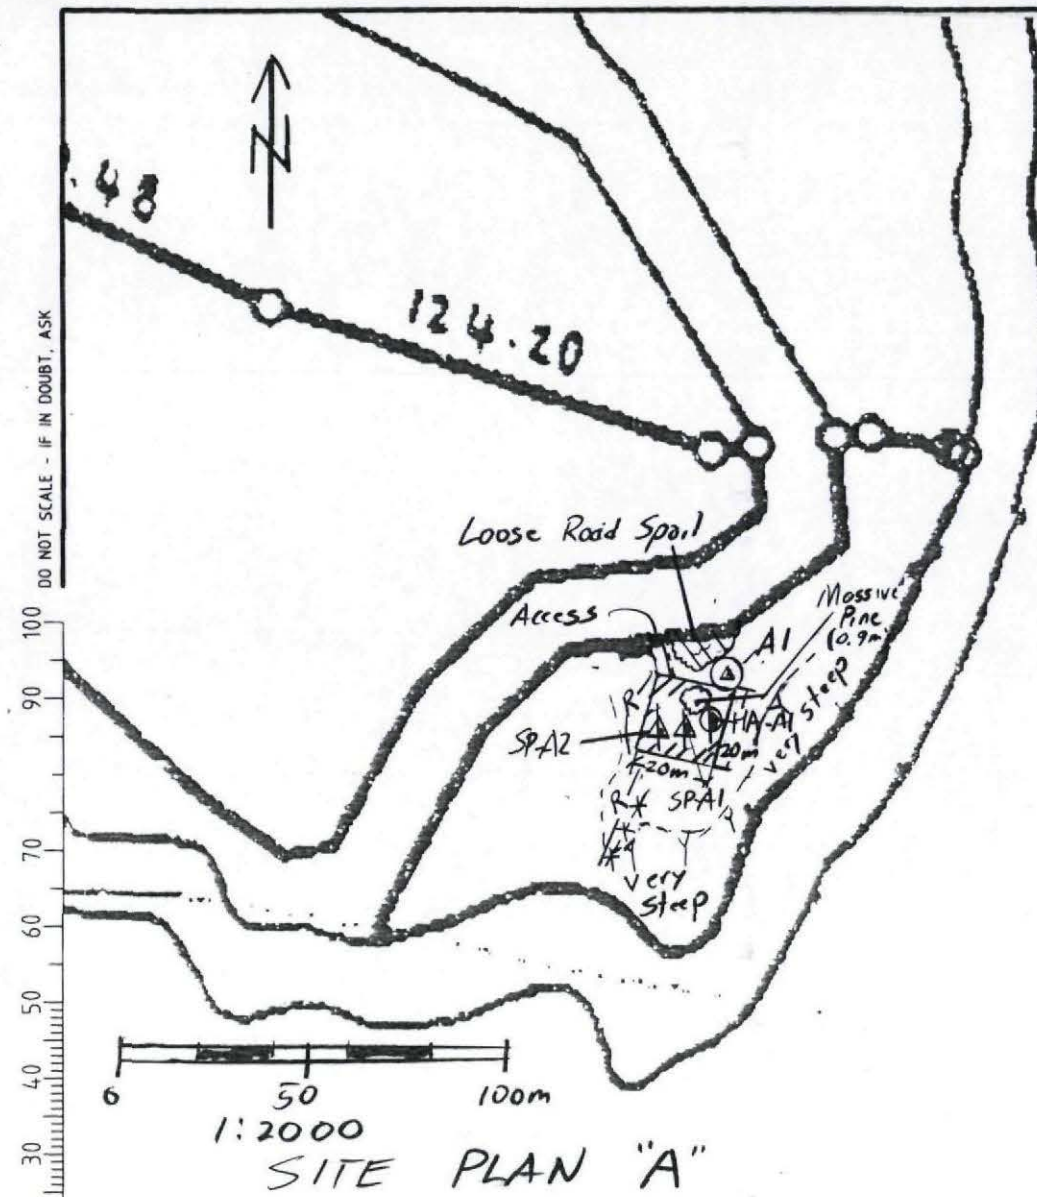
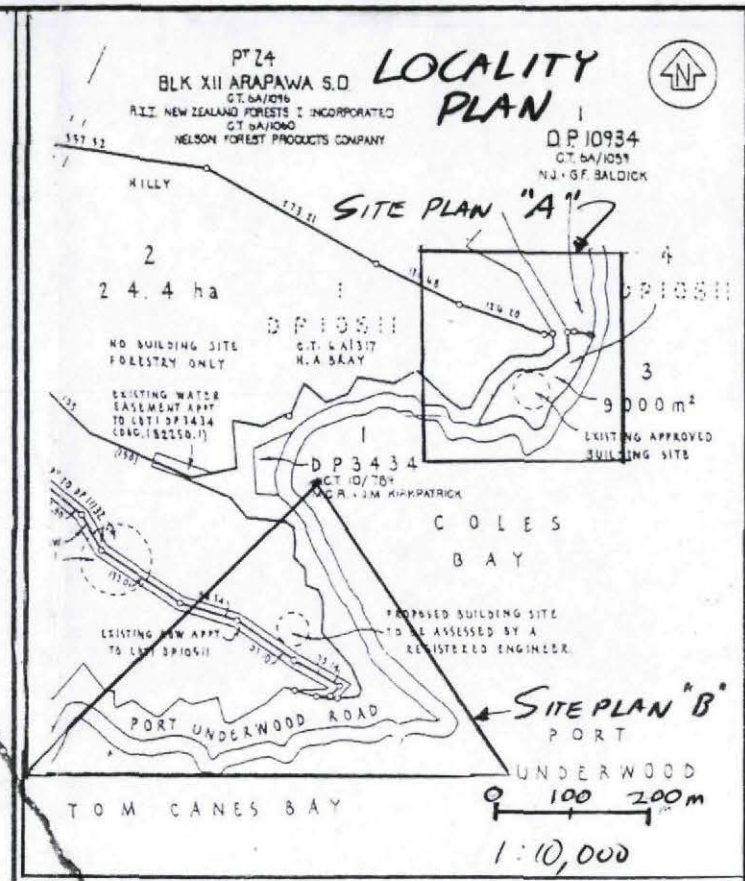
Refer attached Site Plan, Sheet 1

- 3.1 Areas indicated as *Suitable for Erection of a Residential Dwelling* has been identified for Sites "A" and "B" as shown on the *Site Plan*, Sheet 1.
- 3.2 Access to the potential building sites appears geotechnically feasible for both sites. Set out and design of access by a qualified engineer will be required.

Areas indicated as *Suitable for Erection of a Residential Dwelling* have been identified as shown on the *Site Plan*, Sheet 01 for both Sites "A" and "B". Localised areas of loose road spoil exist along the upper perimeter of both sites. Removal or remediation will be required to prevent these area of creeping spoils from impacting on site developments within the designated building sites.

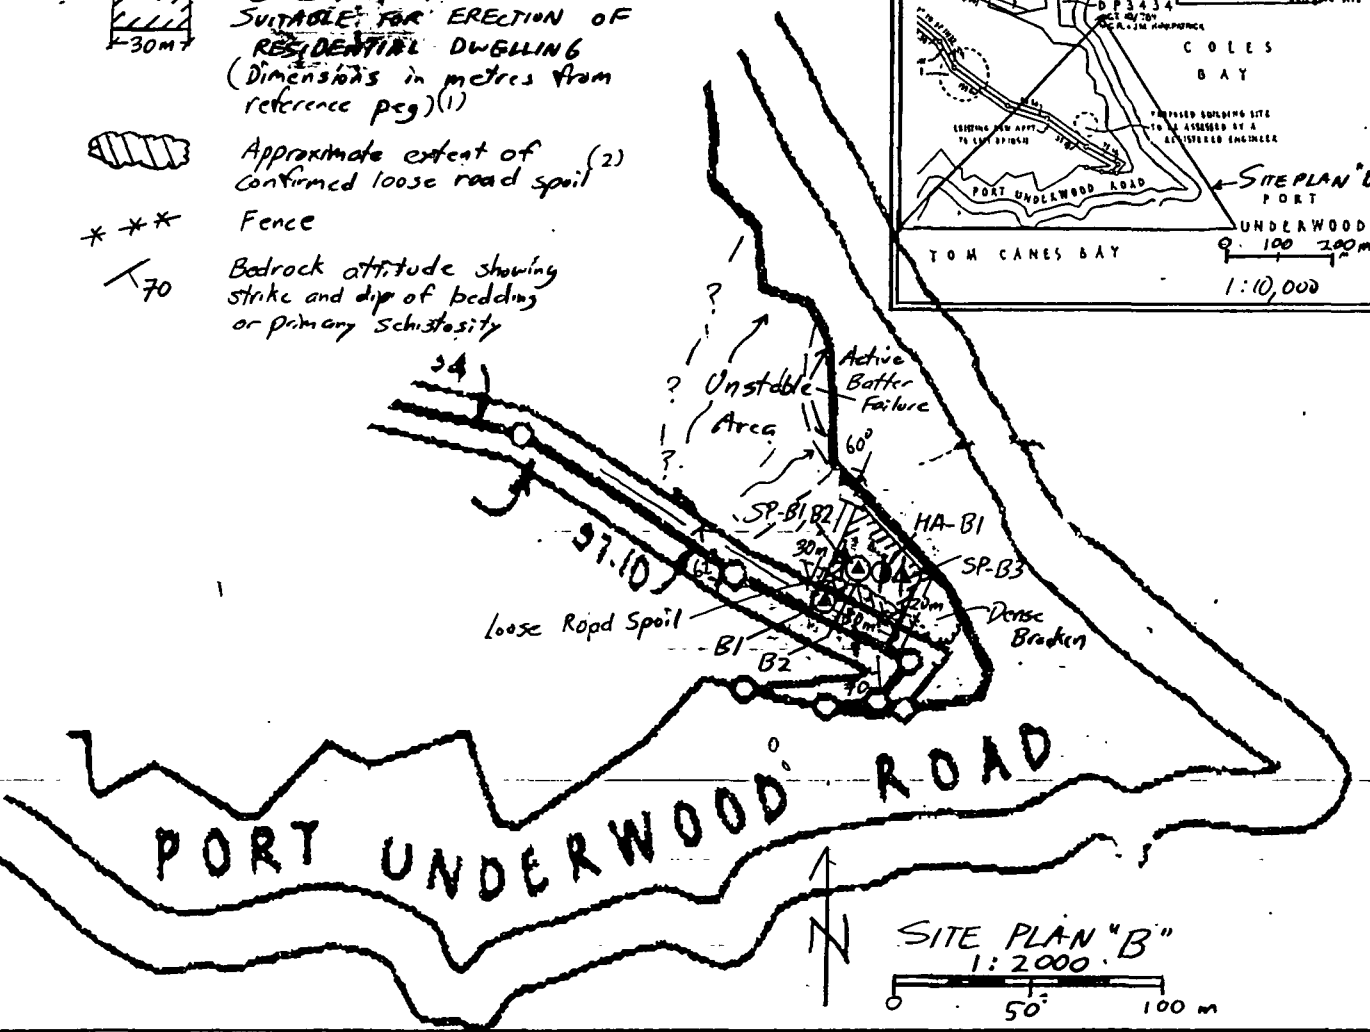
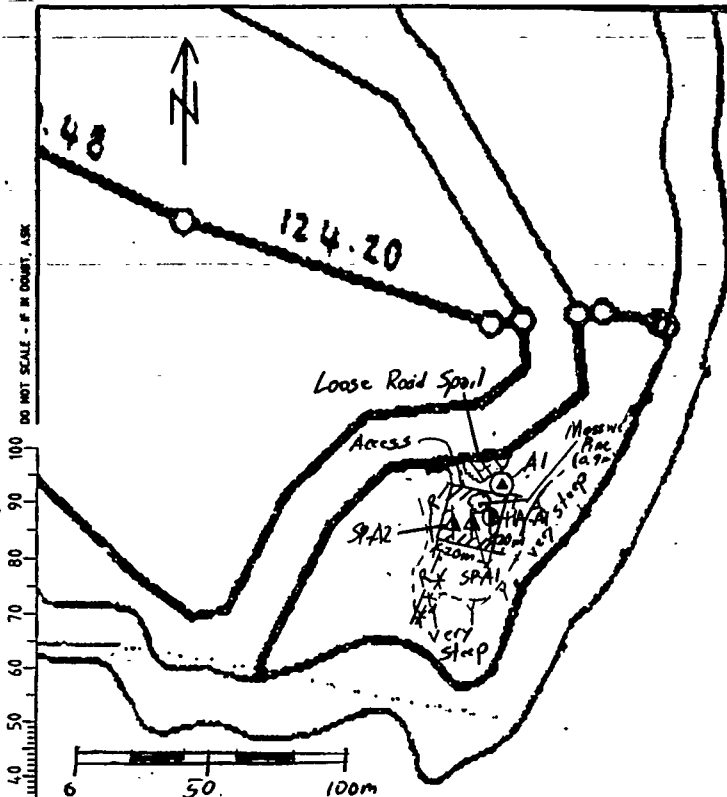
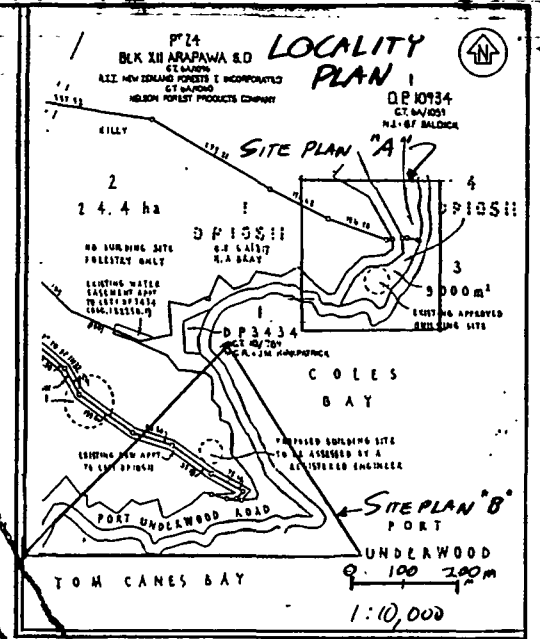
CONCEPTUAL	
Date	Rev.
17 May 2002	
Job No.	Sheet No.
61050	01

An area exhibiting widespread, apparently shallow instability exists to the northwest of the identified building site. A batter failure several metres in height extends adjacent to the road towards the base of this area as indicated on *Site Plan "B"*, Sheet 01. The orientation of bedrock dips into the hillside, roughly perpendicular to the trend of the ridge. Outcrops of bedrock observed to the north, west and south of the designated building site reflect a consistent orientation (refer Sheet 01). No indications of instability were observed within or below the identified building site which is effectively protected from runoff by the existing access track above it.
