ENGINEERING REPORT

House Site Stability

Mr Melvin Goodall

**Moutapu Bay Road
Pelorus Sound**

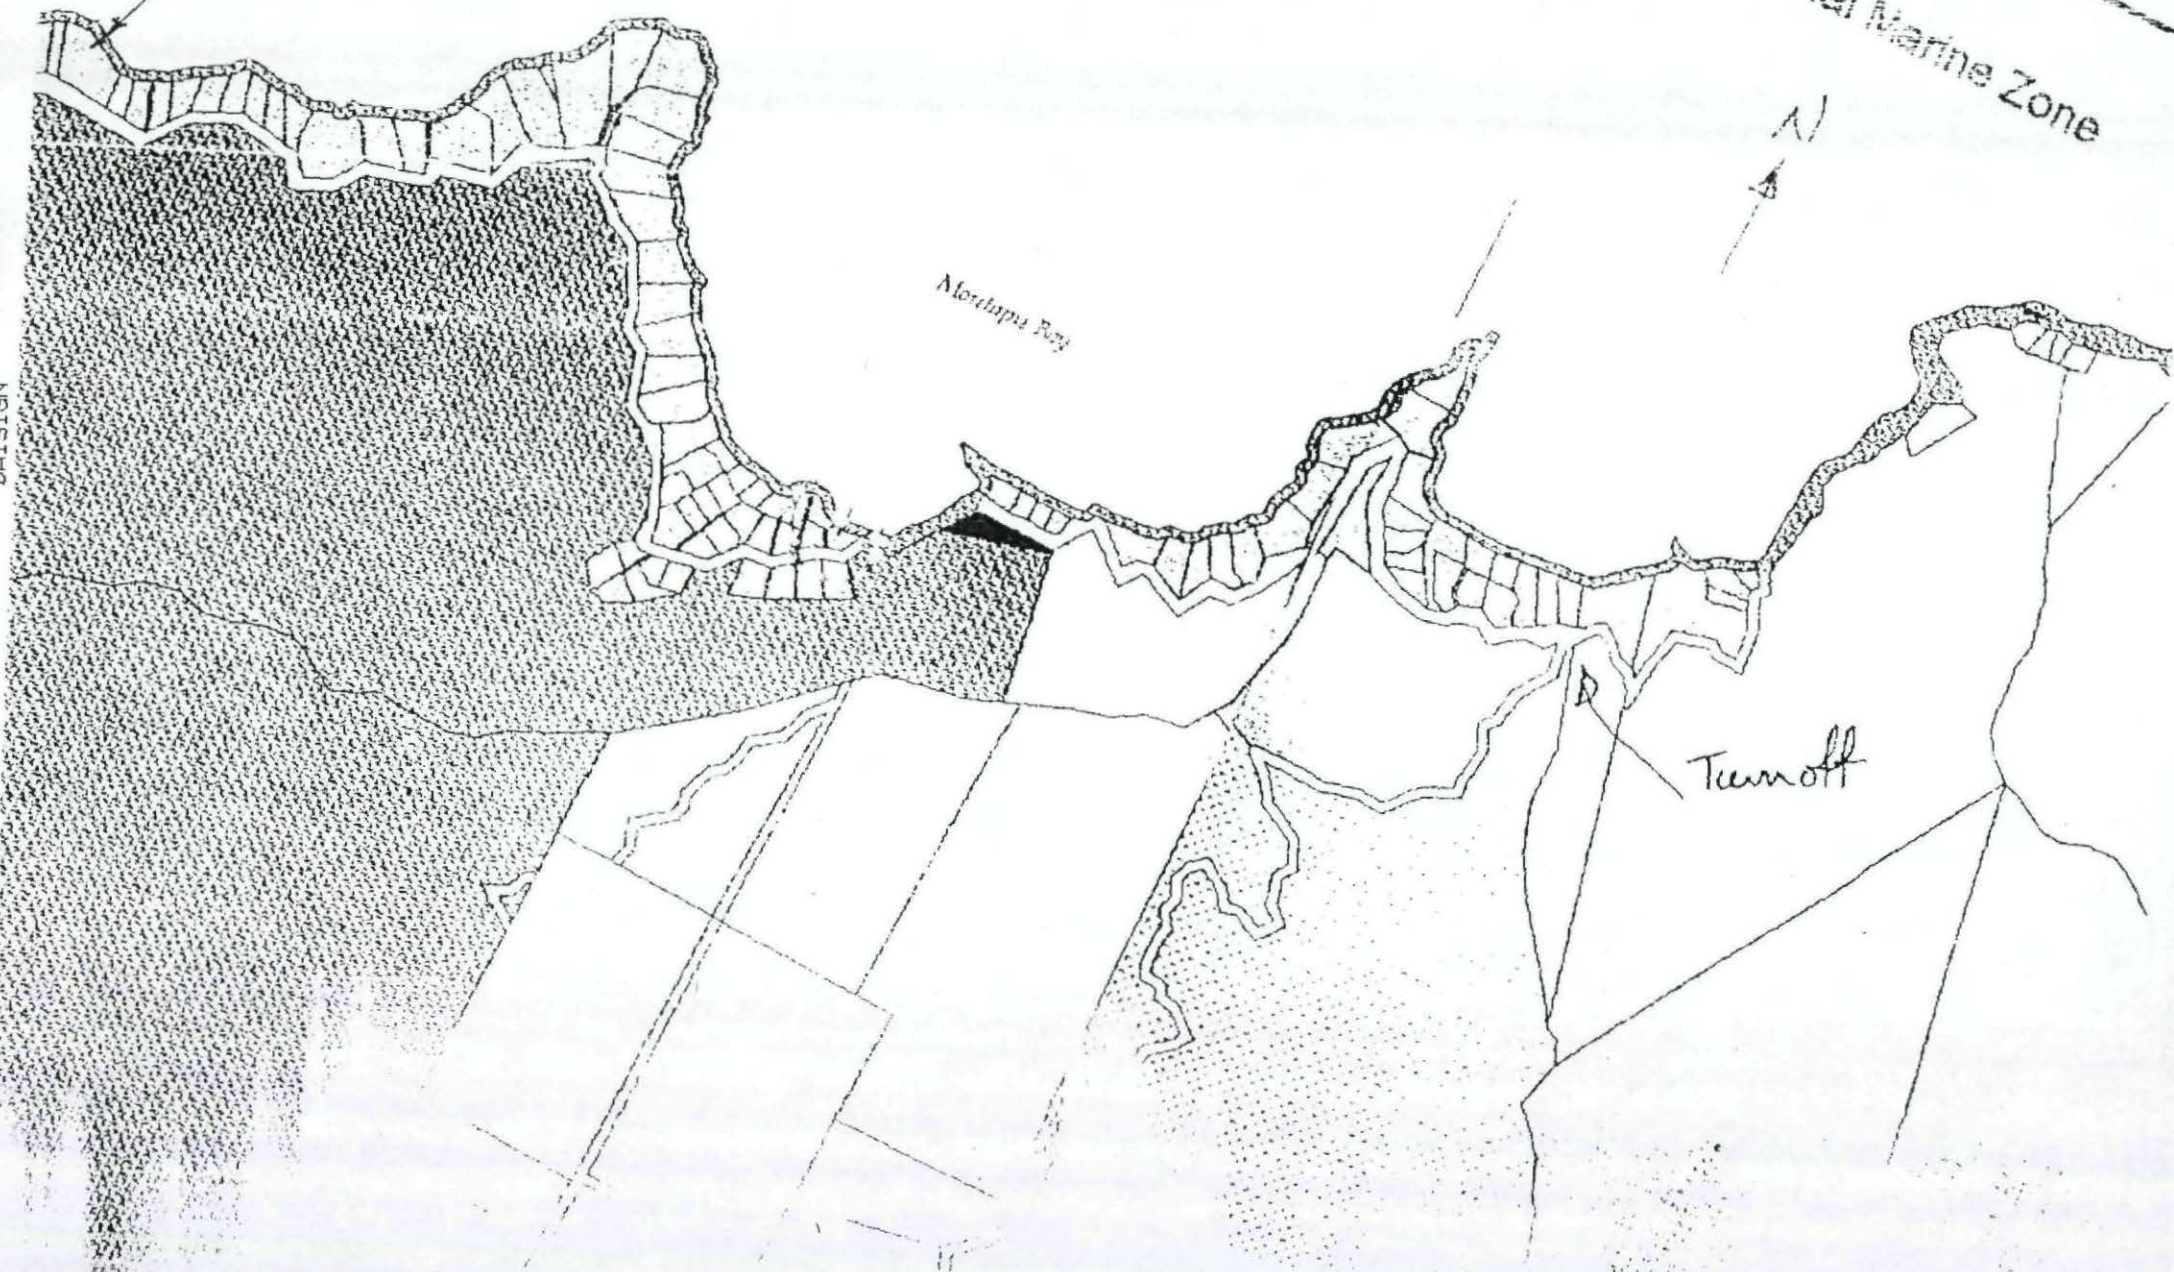
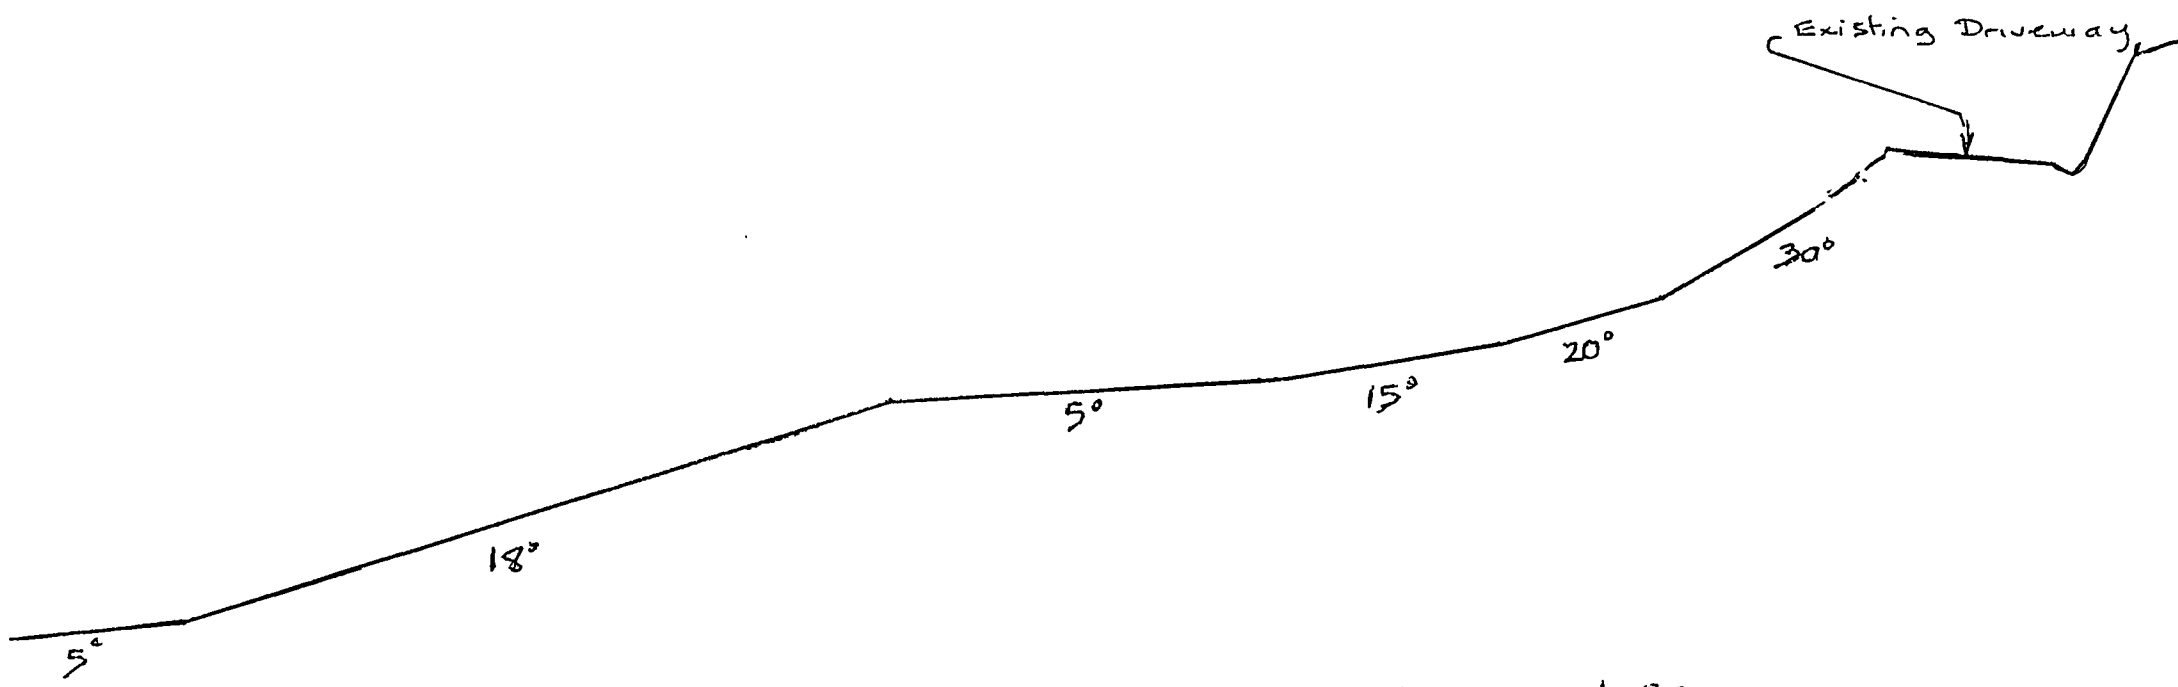
TYPICAL SITE CROSS - SECTION - 1:200

- 3.4 Ground surface slopes were measured taking an approximate line through the centre of the proposed section below the driveway. From a steep drop off on the driveway batter of 30° adjusting to 20° then 15° there is ample house site area on the moderate mid to lower slopes of 5° steepening to 18°. A representative cross section is shown on Appendix C.

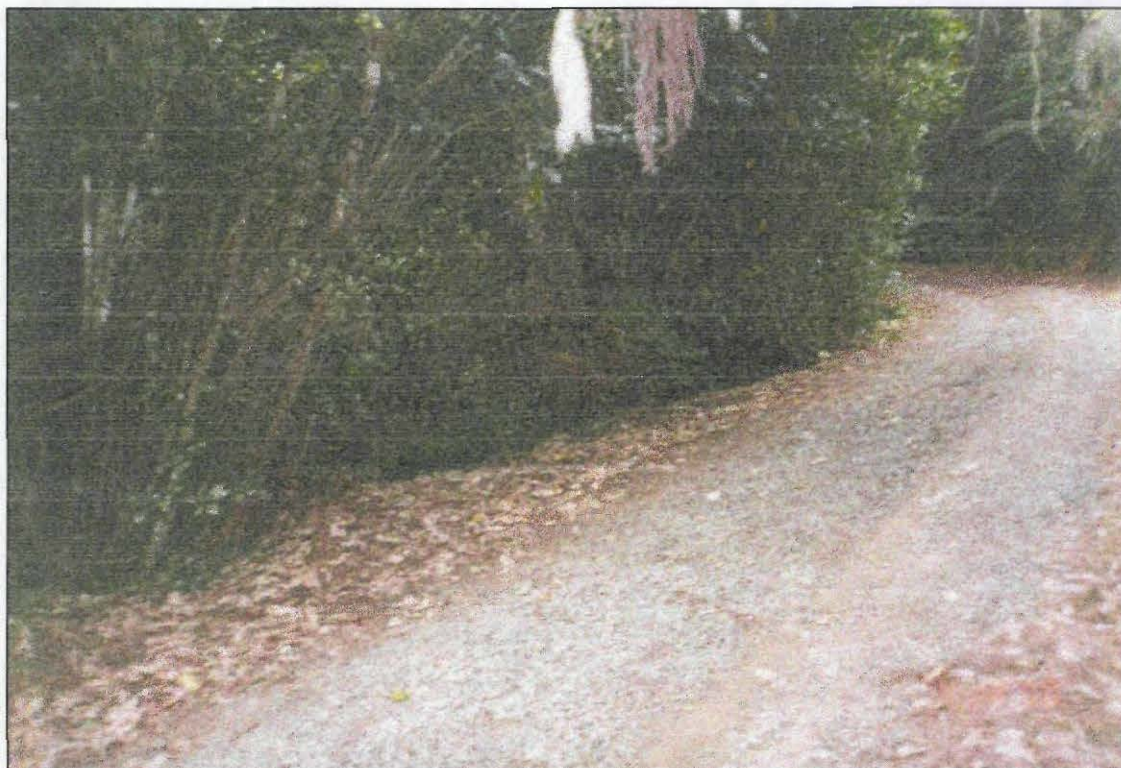
EXISTING DRIVEWAY AT PROPOSED TURN-OFF TO HOUSE

- 4.1 A well formed driveway from the road gives access to the property at a grade of about 1 in 10 and this will also serve the new house site.
- 4.2 A turnoff at the proposed boundary can be formed to provide a bend with minimum internal radius of curvature of about 7m radius and gradient to the house site of about 1 in 10 where adequate parking and turnaround space can be designed. A photo of the existing drive at the proposed turnoff is attached (Appendix D).
- 4.3 The turnoff will have a wider formation width of about 5m which can narrow down to 3.3m sloping into the bank with a water table channel against the bank. This channel is to be continued above the parking/turnaround area to discharge to the stream on the Eastern boundary. A typical formation detail for the new driveway connection to the house site is shown on Appendix D.

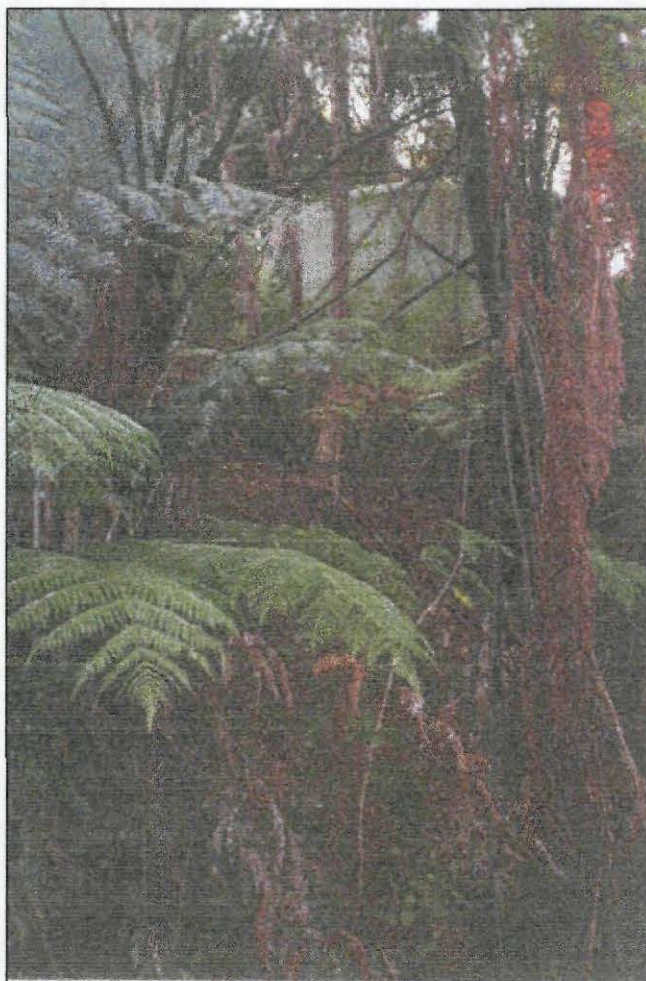
- 3.5 There is a cut bank above the driveway about 3m high which has remained stable and is covered in ferns, bracken and manuka.

CUT BANK ABOVE EXISTING
DRIVEWAY - WATER TANK

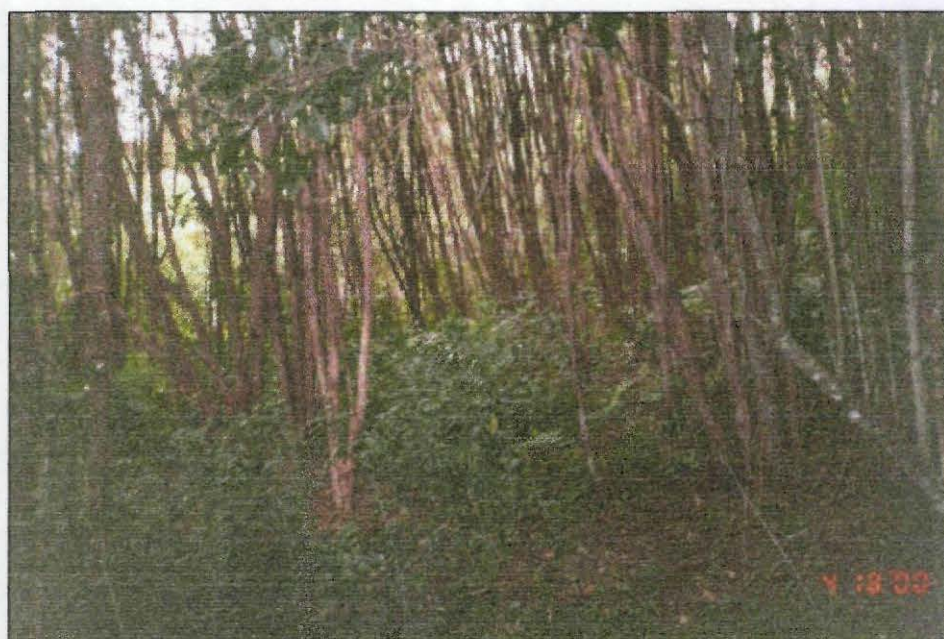
- 3.6 A house site envelope separated 10m from the stream on the East boundary is shown on the attached site plan Appendix B.
The site is on stable ground and in our opinion the addition of a house within this area of about 22m wide and 35m long will not affect ground stability.
- 3.7 The driveway above the site serves as a bench above the site and the formed legal road above the road boundary serves as another wide bench and added safety margin from any slips that may occur in the hills above the road.
- 3.8 Below the site the land flattens out to a slight 4° - 5° slope about 20m wide to the foreshore.
- 3.9 The soil bearing capacity at a depth of 300 – 400mm is over 100 KPa. Standard house foundations complying with NZS 3604 are acceptable. Pole frame platform foundations are an alternative involving less earthworks but will need engineering input for structural design.

HOUSE SITE - TYPICAL SIDE VIEW
