Edgar Alterations

Wastewater Assessment

31 January 2017

Edgar Alterations
Wastewater Assessment
397 Ben Morven Road
Fairhall

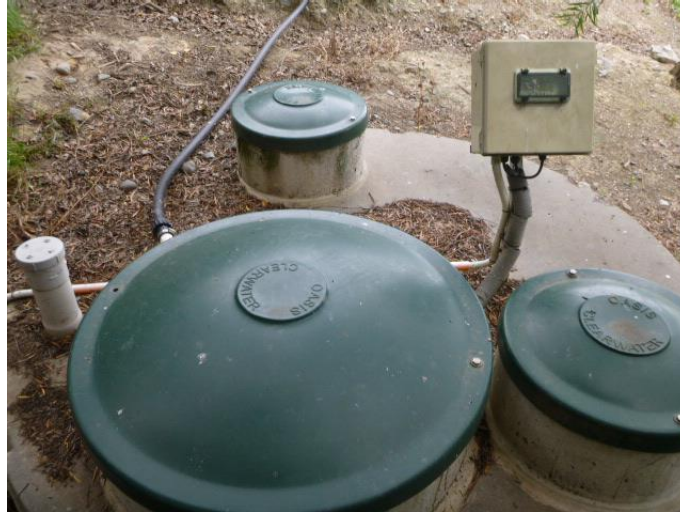
It is considered that the existing Oasis Clearwater TEXASS unit is able to achieve these standards as long as it is maintained in accordance with the manufacturer's guidelines. A photograph of the existing unit is shown in Figure 1 overleaf.

Figure 1: Existing Wastewater System

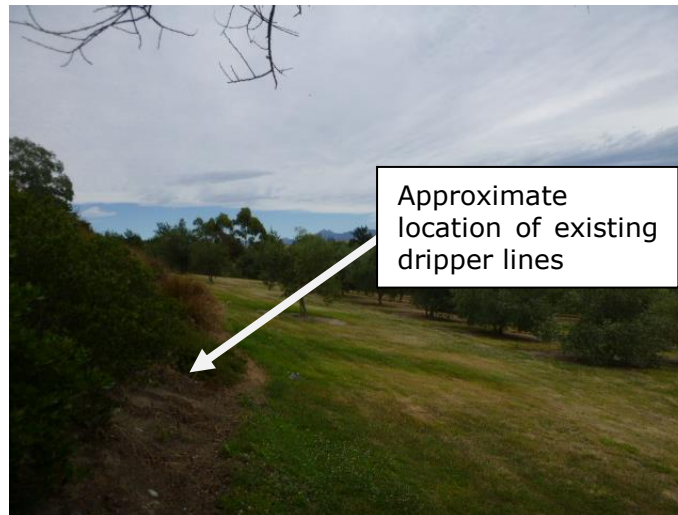
The current and proposed irrigation system should consist of 1.6 litre/hr emitters spaced at 1m centres. The additional dripper line is to be positioned next to the existing dripper lines once the remedial repairs (discussed later in the report) are carried out. A photograph of the existing dripper line location is shown below.

Figure 2: Existing application area

The dripper lines are to be positioned within the topsoil layer and laid at a maximum of 150mm below the existing ground surface or 200mm if within a light trafficable area. They should not be positioned in areas which encounter frequent heavy traffic such as tractors.

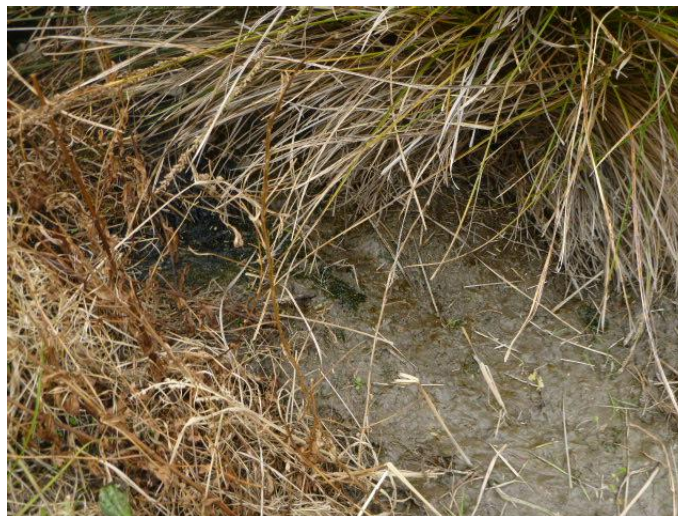
During the assessment, there were a number of damp areas which showed signs of sludge growth. This may indicate a concerning leak in the dripper line and is, therefore, a repair is required to ensure a concentrated discharge of effluent does not occur. Refer to the photograph in Figure 3 below.

Figure 3: Significant dripper line leak

Prior to the irrigation lines being upgraded, all leaks should be sealed and the system flushed and checked to ensure that effluent is distributed evenly over the dripper lines.

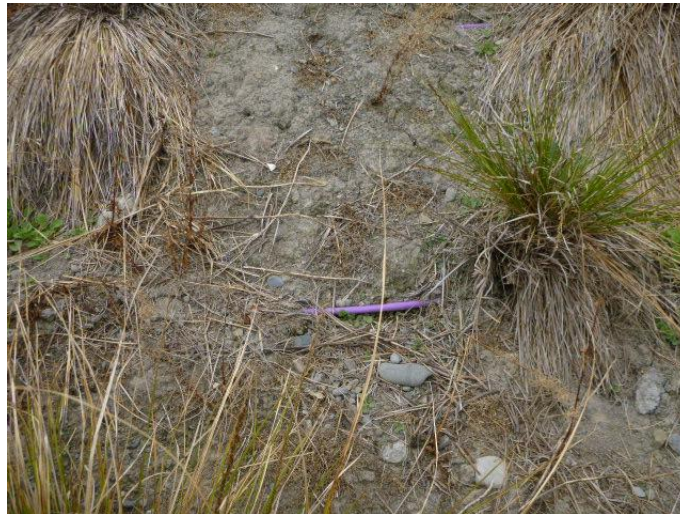
During the assessment, there were a number of dripper lines that were exposed and at risk of being damaged by UV rays. The dripper lines should be protected or be placed beneath the ground surface. It is recommended that the dripper lines are carefully assessed by a contractor and as a minimum, be appropriately pinned to the ground and covered with a 150mm layer of mulch or other inert material so that no part of the irrigation line is exposed. A photograph highlighting one of the many exposed irrigation lines is shown overleaf.

Figure 4: Exposed dripper line

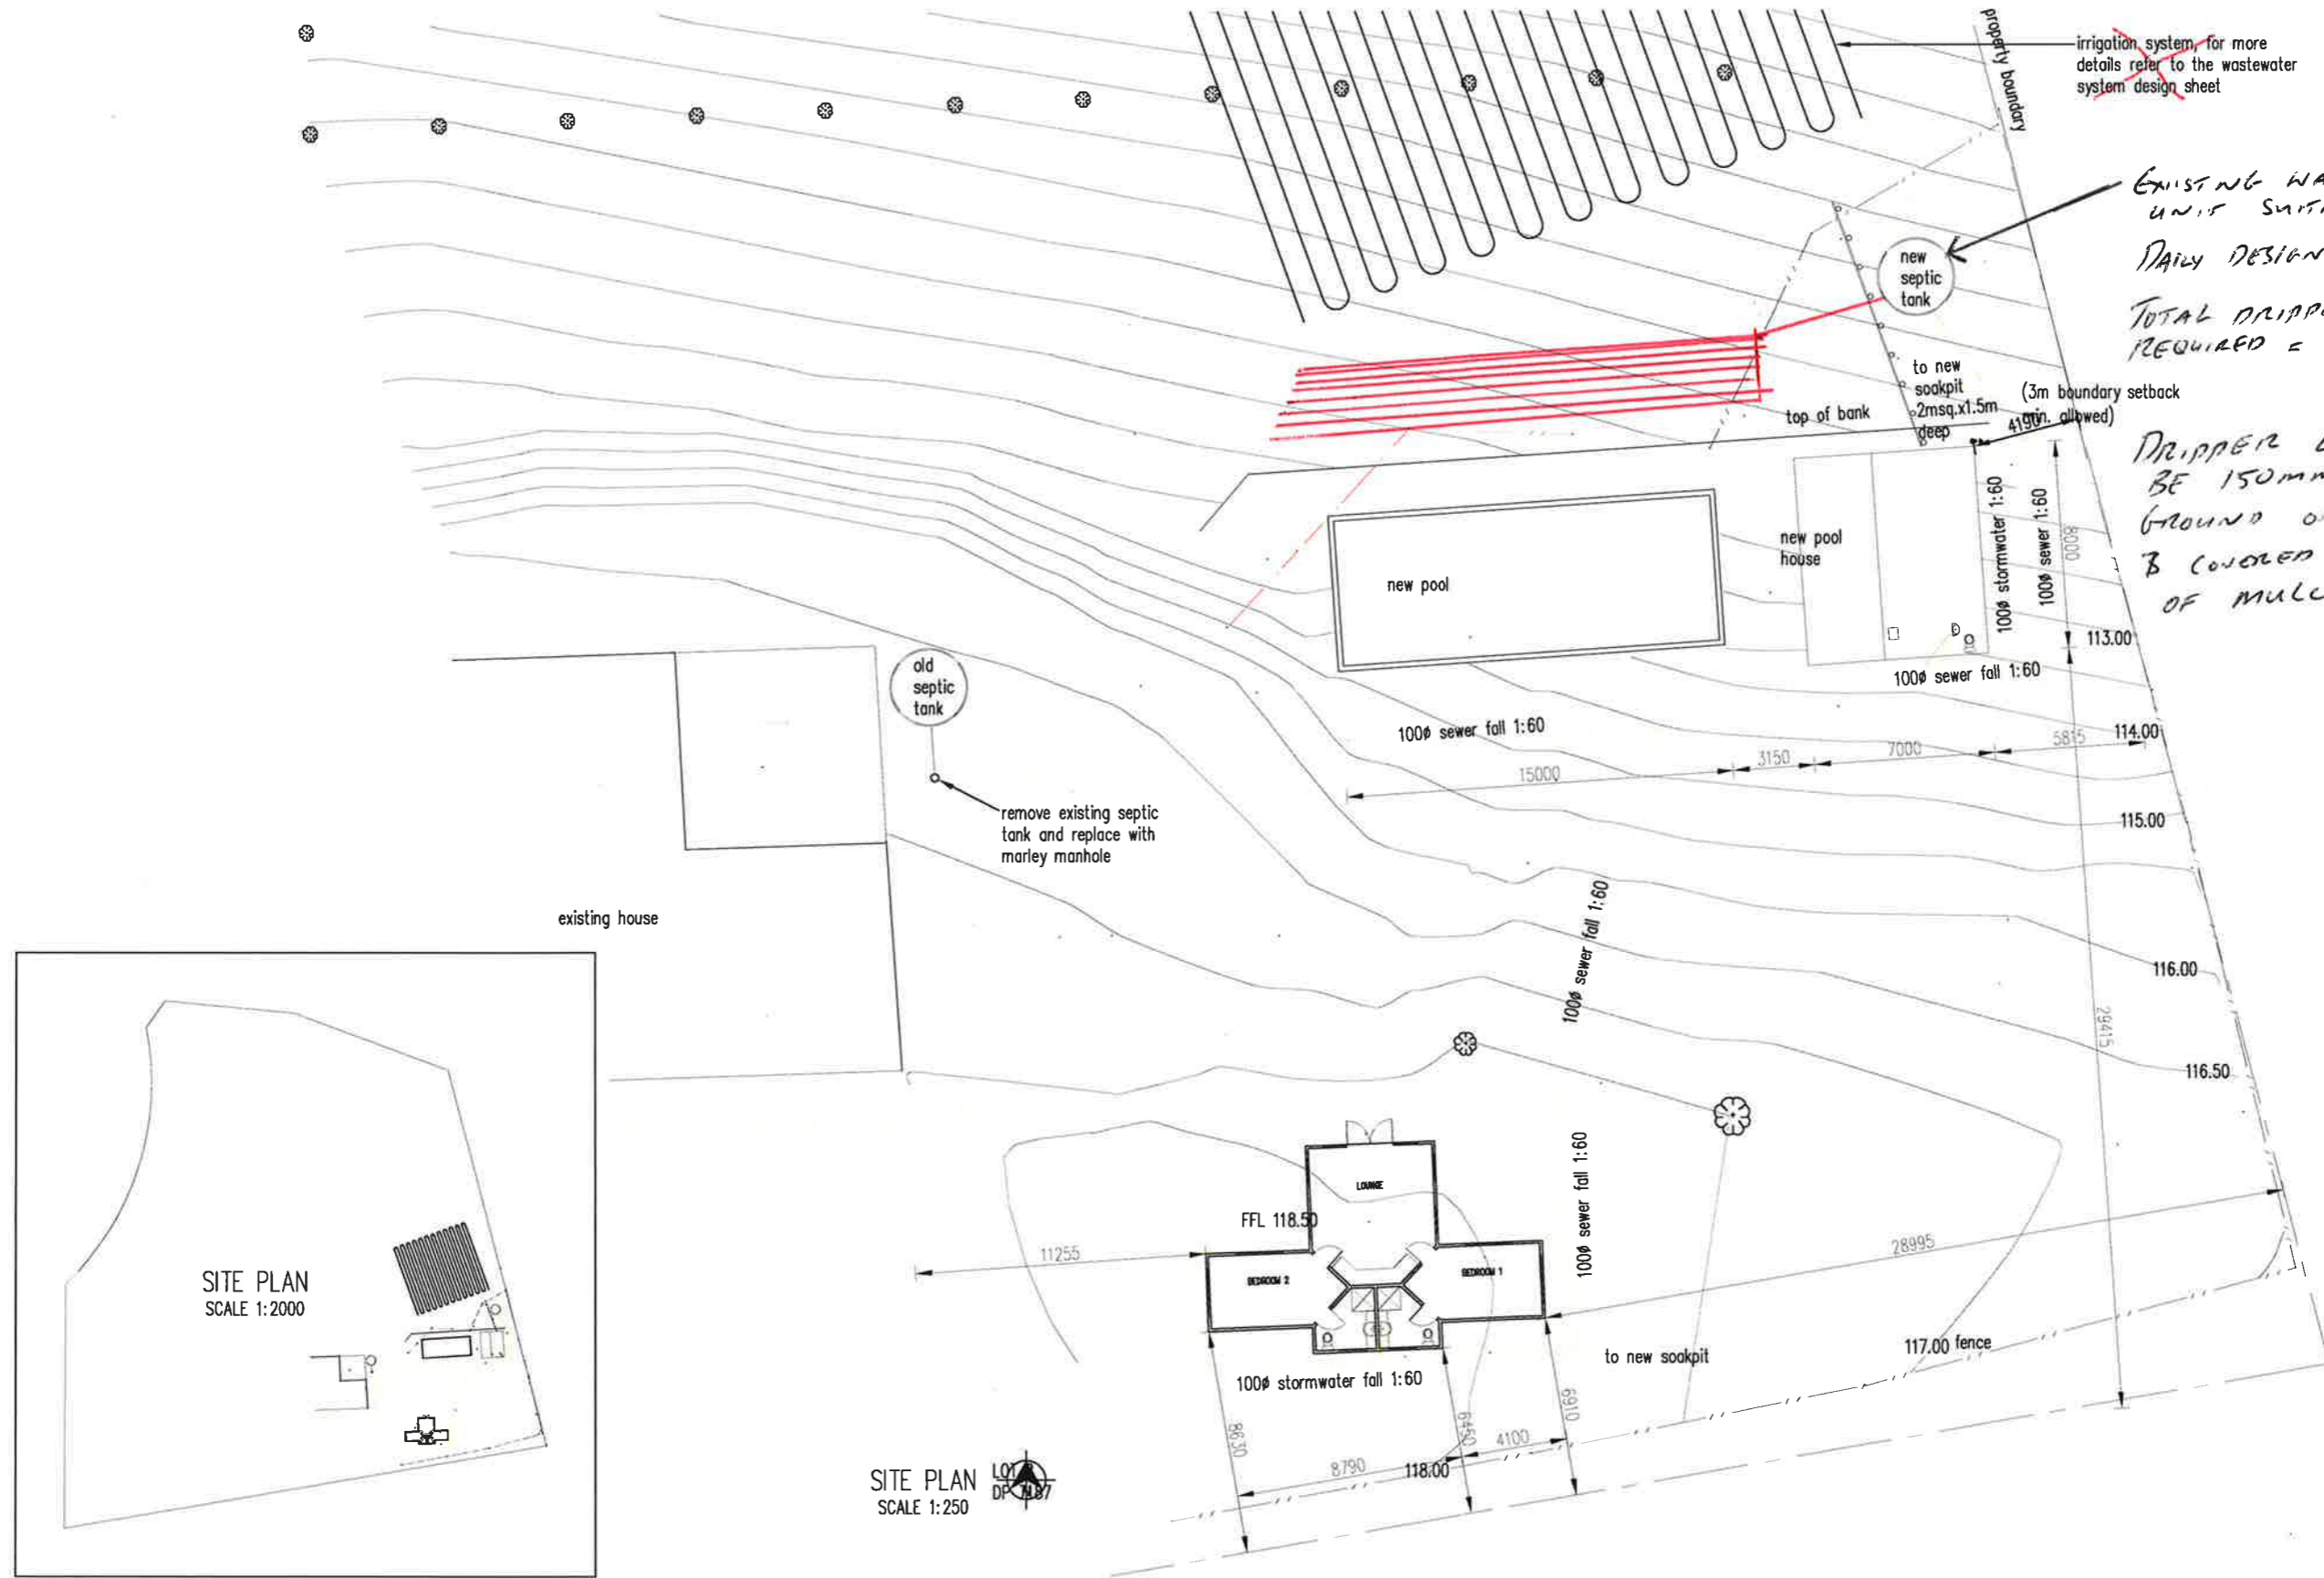
PROJECT
NEW POOL & POOL HOUSE
397 BEN MORVEN ROAD
 DRAWING
SITE PLAN - Amended
MARKED UP JAN 2017

- Marked-up existing design drawing
