**REPORT ON AN EXISTING
WASTEWATER SYSTEM FOR
SERENDIP RETREAT LTD**

**Our Ref: 26783
Date: May 2019**

REPORT ON AN EXISTING WASTEWATER SYSTEM FOR SERENDIP RETREAT LTD

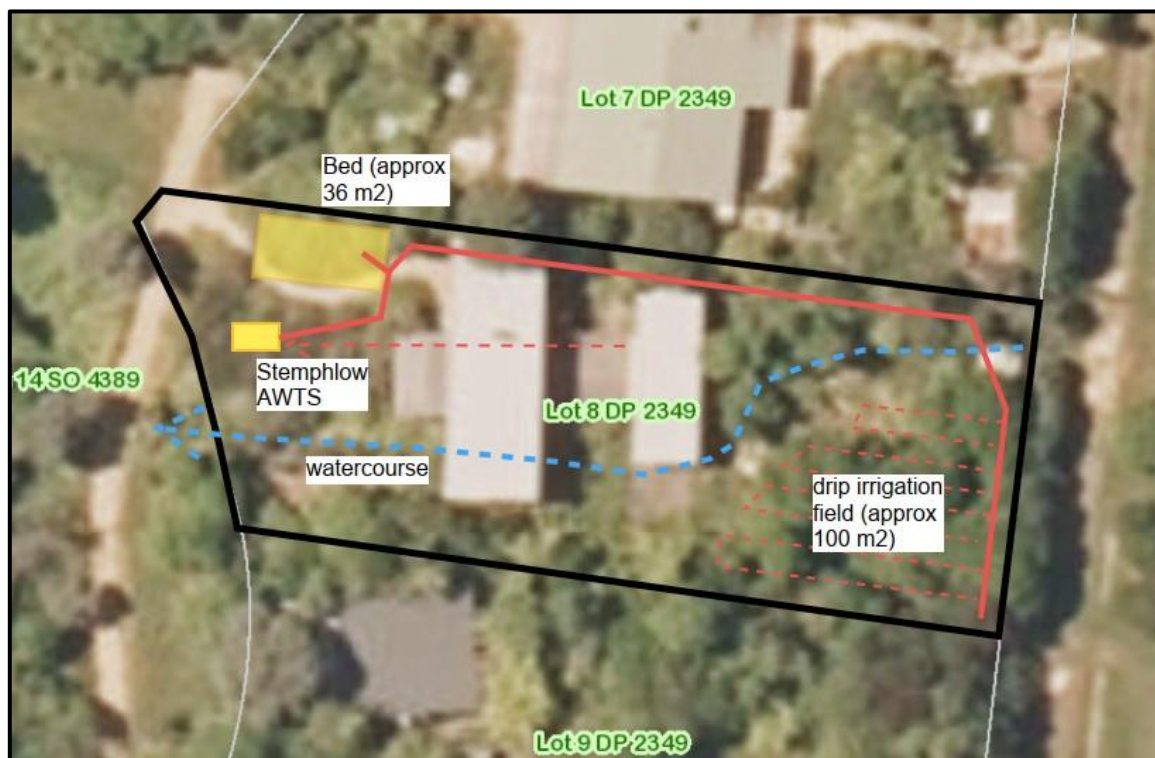
Site Plan

The wastewater system in place consists of a Stemphlow aerated secondary treatment plant discharging to a 9 m x 4 m bed (assumed based on design) in addition to approximately 100 m² of drip irrigation. The drip irrigation field is permanently fed, but the bed can be included by manually turning a valve.

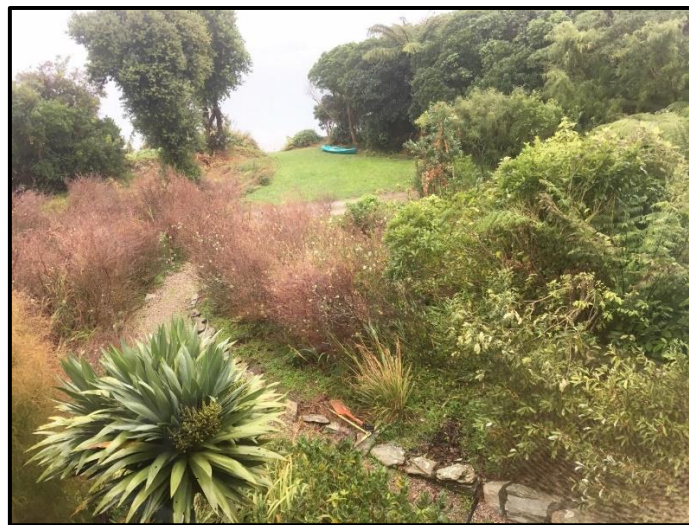
The bed is located in a well vegetated garden and partly under a path. An attempt to excavate a pit to inspect the pipes was abandoned due to the difficulty and time it would have taken, but in our experience where they are holiday baches, as is this one, there has never been an issue due to;

- the low annual loading
- the fact that they get long periods of non-use to rejuvenate the aerobic bacteria, and
- the effluent is pumped (dose loaded) to evenly distribute the load.

Bed (partly under and to right of path)

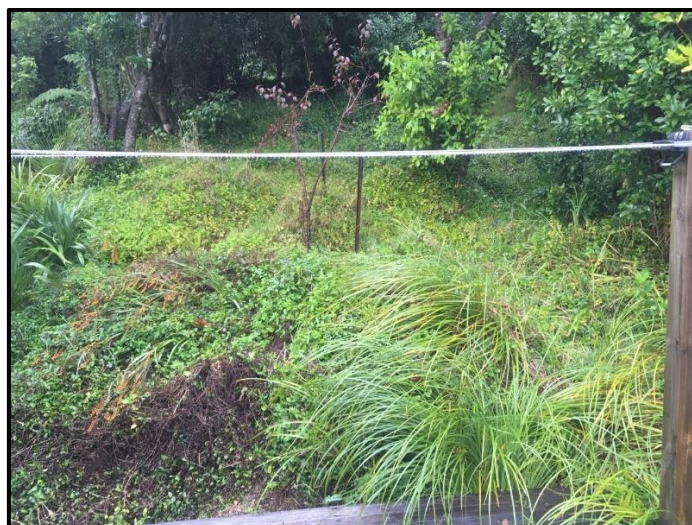
The drip irrigation area is well vegetated. However, the lines are running up and down the slope rather than across the slope as is standard practise. There are also no flush or air valves.

Drip Irrigation Area

The drip irrigation area is in addition to code requirements but is not laid out correctly.

This work should include annual checks by a certified service person (currently overdue), the installation of an automatic 3-way sequencing valve to switch from the bed (2 ports) to the drip area (1 port) and the relaying of the drip lines across the contours, 1 m apart, including air and flush valves.
