**WASTEWATER MANAGEMENT REPORT  
FOR  
BE JOHNSON**

**Our Ref: 27543  
Date: October 2023**

24 October 2023

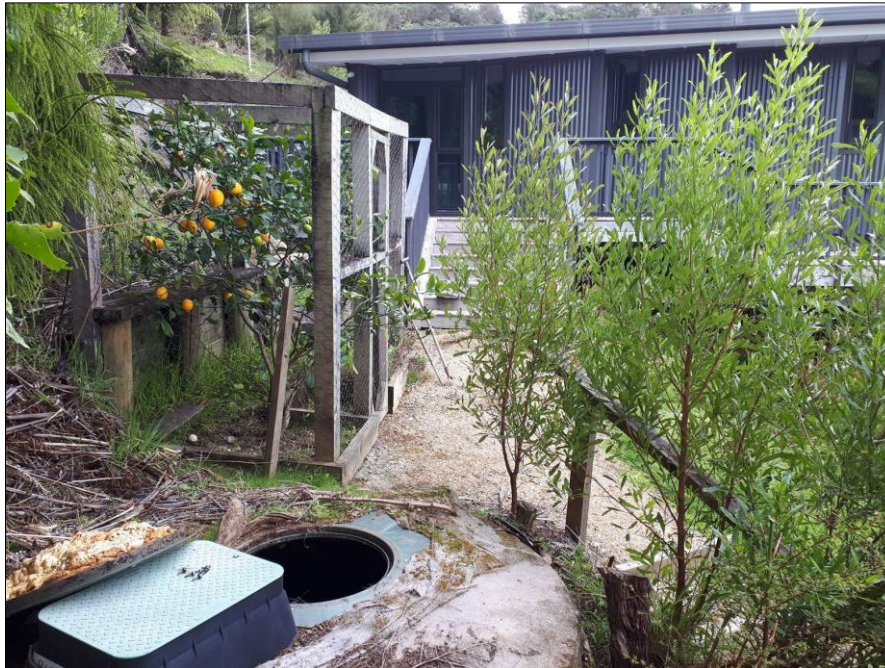
The tank is only accessible for servicing on foot. On inspection we noted there was a delay in water flow entering the tank from the house which can be fixed by readjustment on the inflow pipework to ensure fall towards the tank.

**Biolytix tank location**

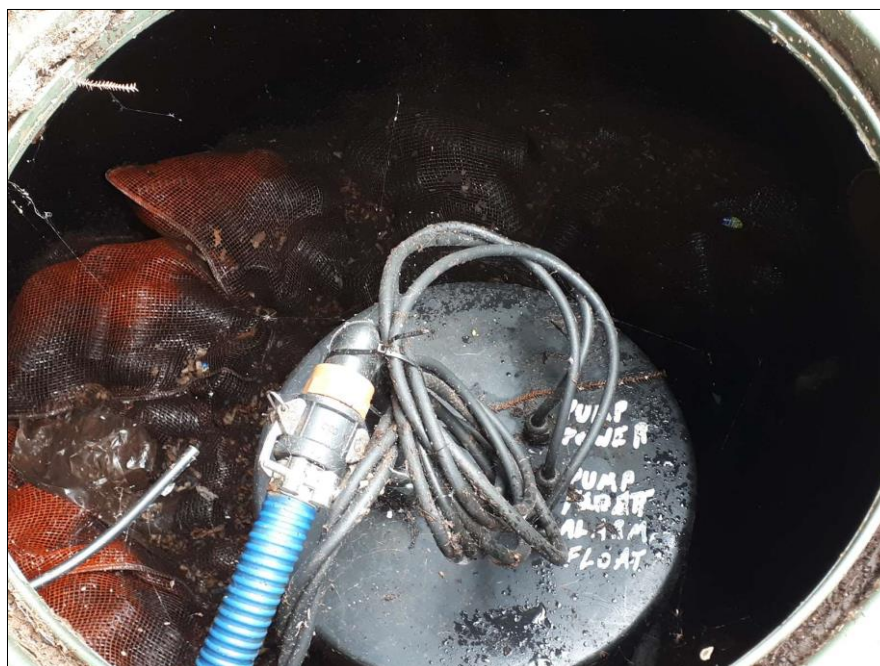
**Treatment media inside Biolytix tank**

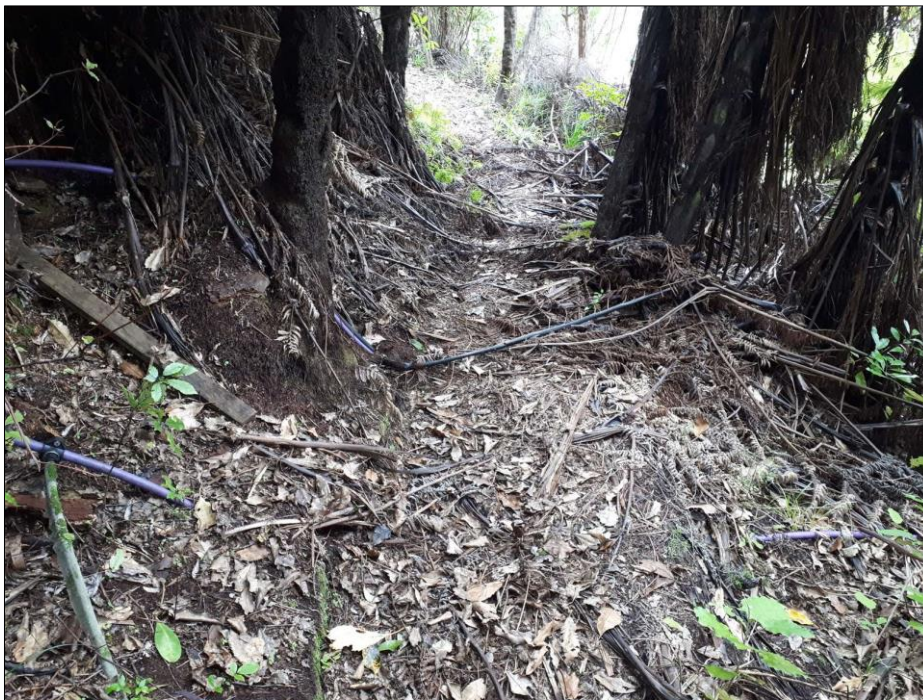
There were no environmental issues noted within the LAA. The lines are mostly covered with organic material and difficult to follow. It is a good practice to mark the extend of the effluent field to make people on the property aware of its location and for inspection and maintenance purposes.

**Existing driplines**

The as-built plan shows an automatic flush valve and air valve. Manual flush valves provide better flushing and modern practise is a flush valve for every 100 m of dripline, well-marked for maintenance use. We recommend the Owner discuss a flushing upgrade with the service contractor and have this done at the next service.

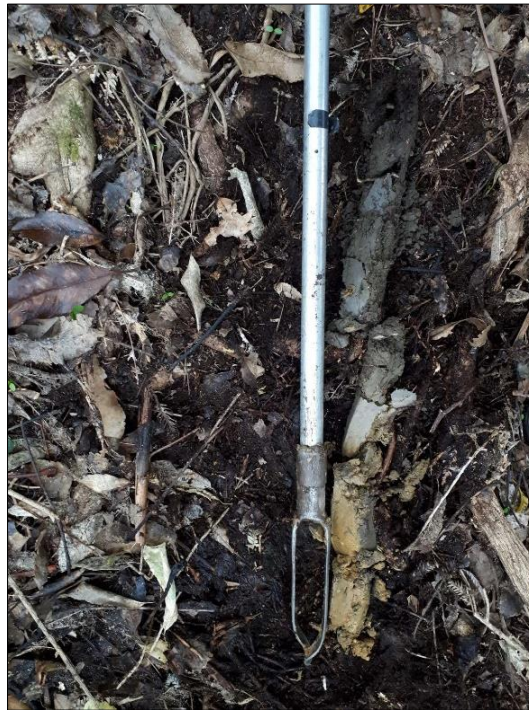
**Soil Profile**

The upper 600 mm of the soil profile in the land application area consists of native bush organic cover layer over dark grey-brown, slightly moist, firm silty loam with roots and is underlain by yellow-brown, slightly moist, stiff silty clay loam.

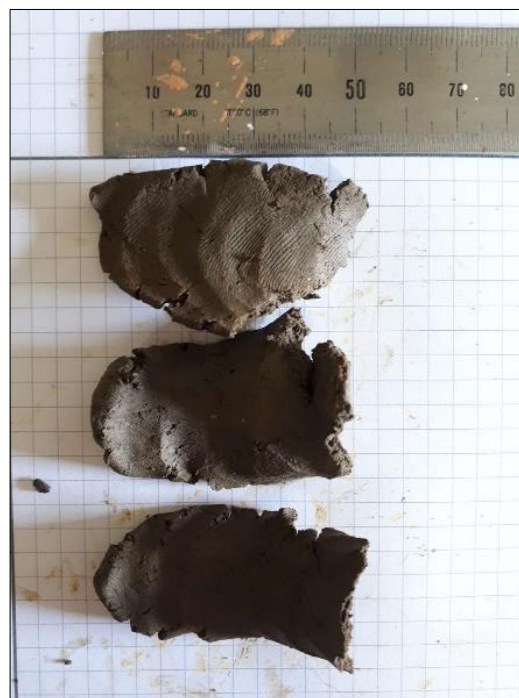
A test sample was taken during our site visit and found the soil was a silty clay LOAM. Ribbon lengths of 40 - 50 mm were achieved as shown below which confirms that a Category 4 soil is appropriate for this site.

**Ribbon Test Results**

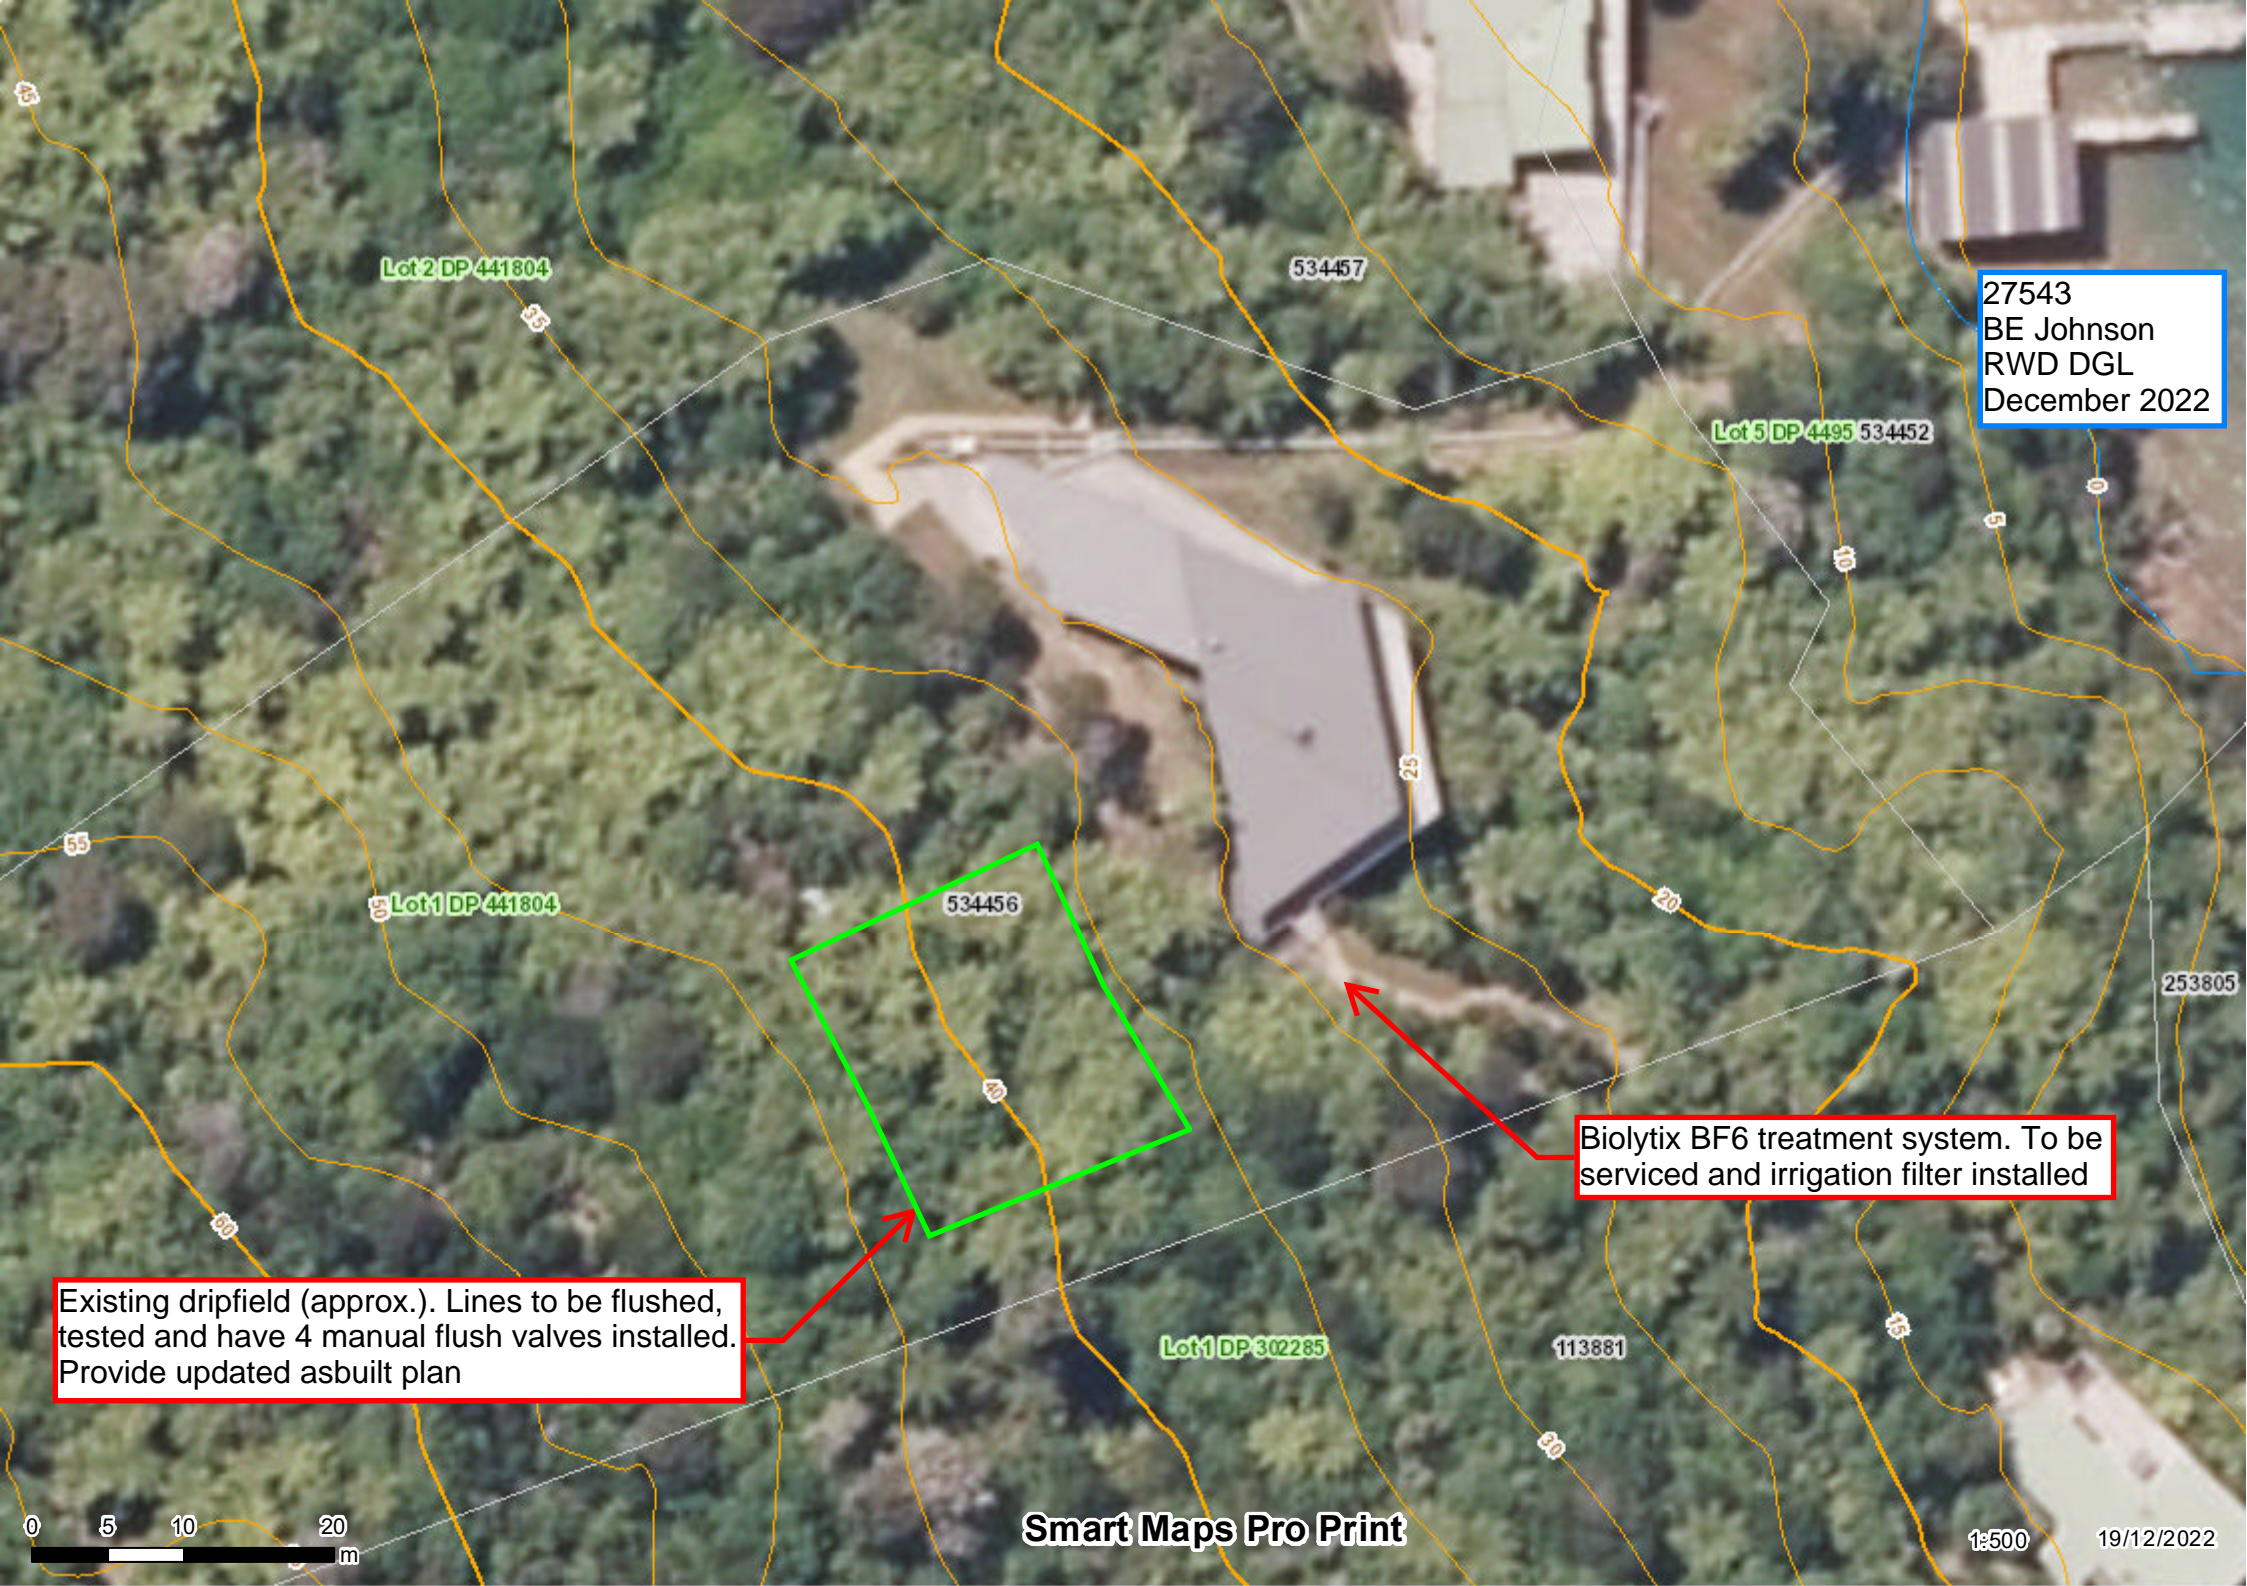
Existing dripfield (approx.). Lines to be flushed, tested and have 4 manual flush valves installed. Provide updated asbuilt plan

Biolytix BF6 treatment system. To be serviced and irrigation filter installed
