Ecological report for the
proposed renewal of marine
farm site 8289 located near
Round Hill, Croisilles Harbour

Research, survey and monitoring report number 655

22 October 2010

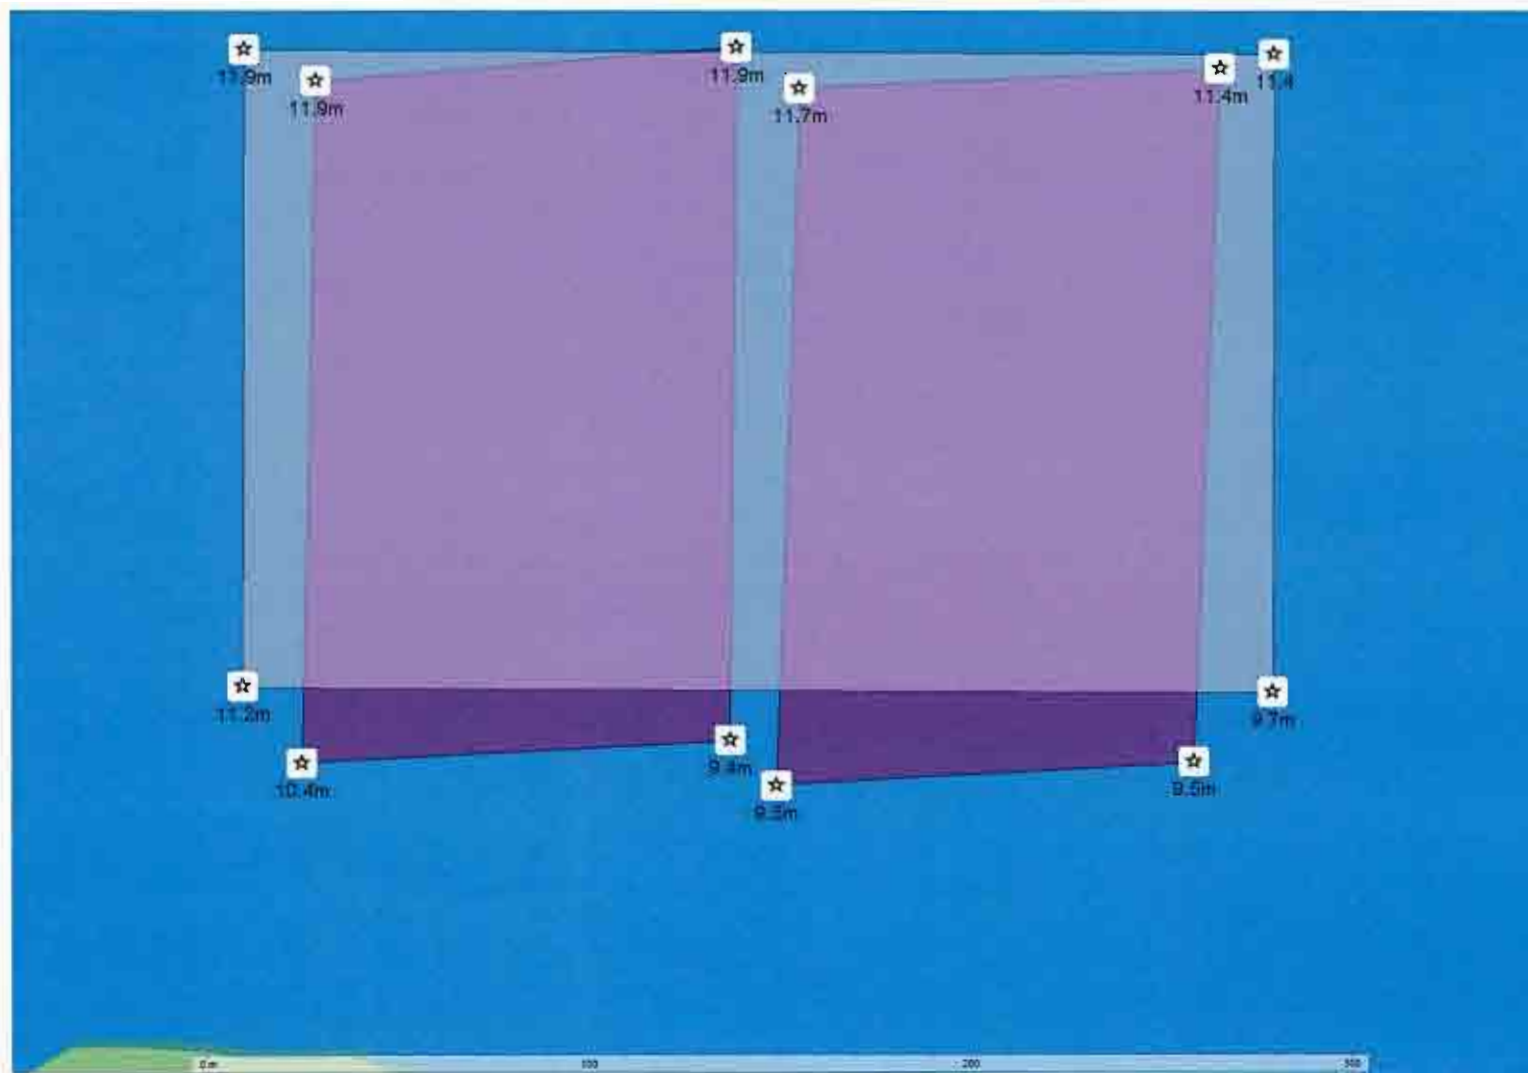
Figure 1. Depths of the marine farm (grey block) and surface structures (pink) for site 8289.

The consent area (grey) and areas occupied by surface structure (pink) have been plotted onto Figures 1 and 2. Inshore depths for the validated consent area ranged from 9.7 m to 11.2 m, while offshore depths were 11.4 m to 11.9 m (Figure 1). The depth for surface structures ranged from 9.4 m inshore to 11.9 m at the offshore extent of backbones. The consent area and areas occupied by surface structures (pink) have been plotted in Figure 1. Depths and locations of all drop camera stations have been listed in Table 2 and plotted in Figure 2.

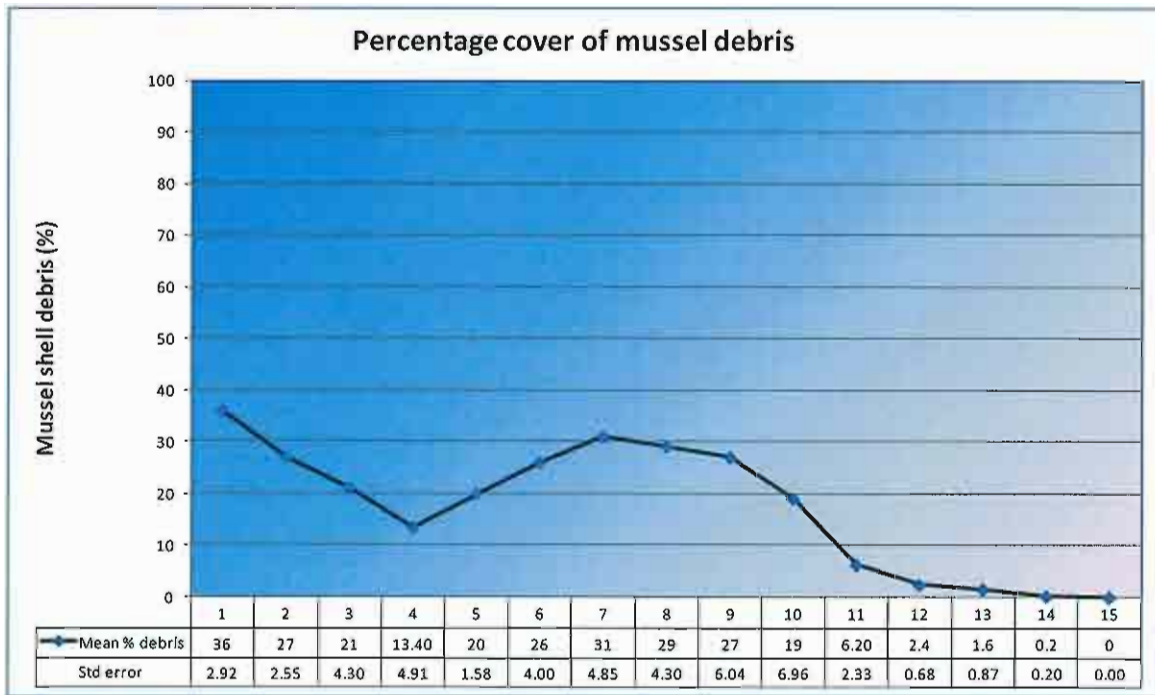
Figure 3. Mean percentage cover of mussel shell debris versus increasing distance from the backbone. Mean values were collected from contiguous quadrats installed along transects extending perpendicular to the inshore backbone. Standard error values are listed (1 s.e).

Mussel shell debris immediately below the inshore backbone at its eastern end was relatively low with a mean cover directly under the backbone of 36% cover, ranging from 30 to 45% cover for individual quadrats (Appendix 2). By 12 m distance from the dropper, mean mussel shell debris declined below 5% cover (Figure 3). No mussel shell debris was observed by 15 m distance from the backbone (Figure 3).

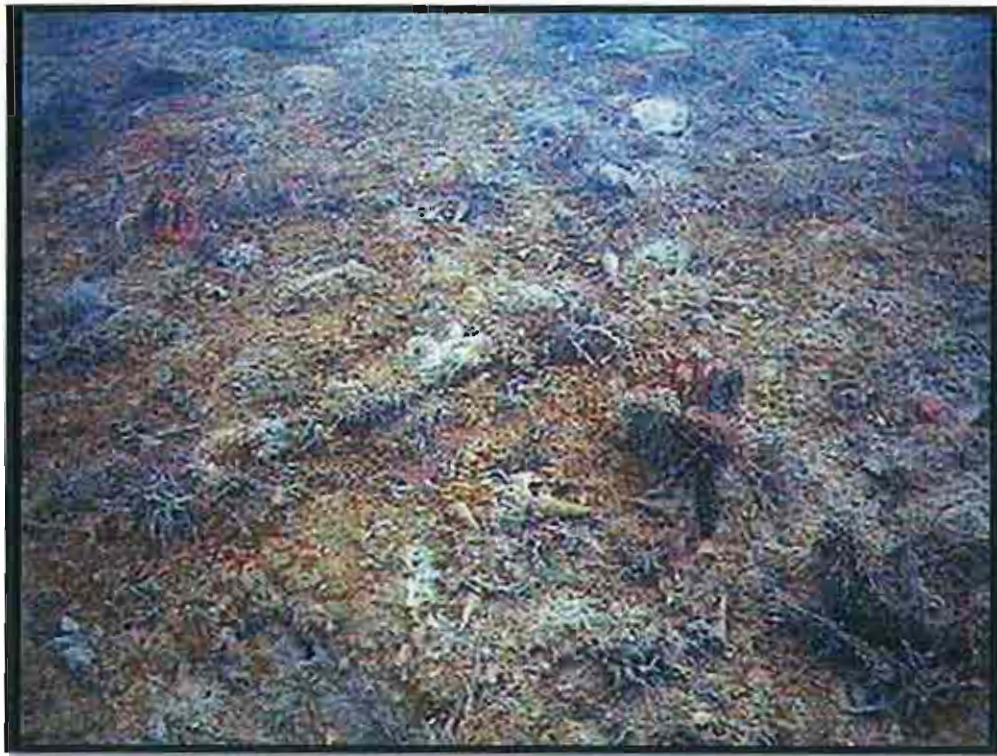
Photo site 7

The benthos under the validated consent area was characterised by silt and clay and mussel shell substratum (e.g. photos 19, 20, 21). Areas located inshore of the validated consent were also characterised by silt and clay with some mussel shell debris (e.g. photos 7, 8, and 17).
