**Momorangi Bay
and French Pass Camps
Land Disposal of Effluent**

Geotechnical Report

Date: August 2002
Report No: SPT : 2002 / 28
Reference: 5G398A.00 and 5G416A.00
Status: Final

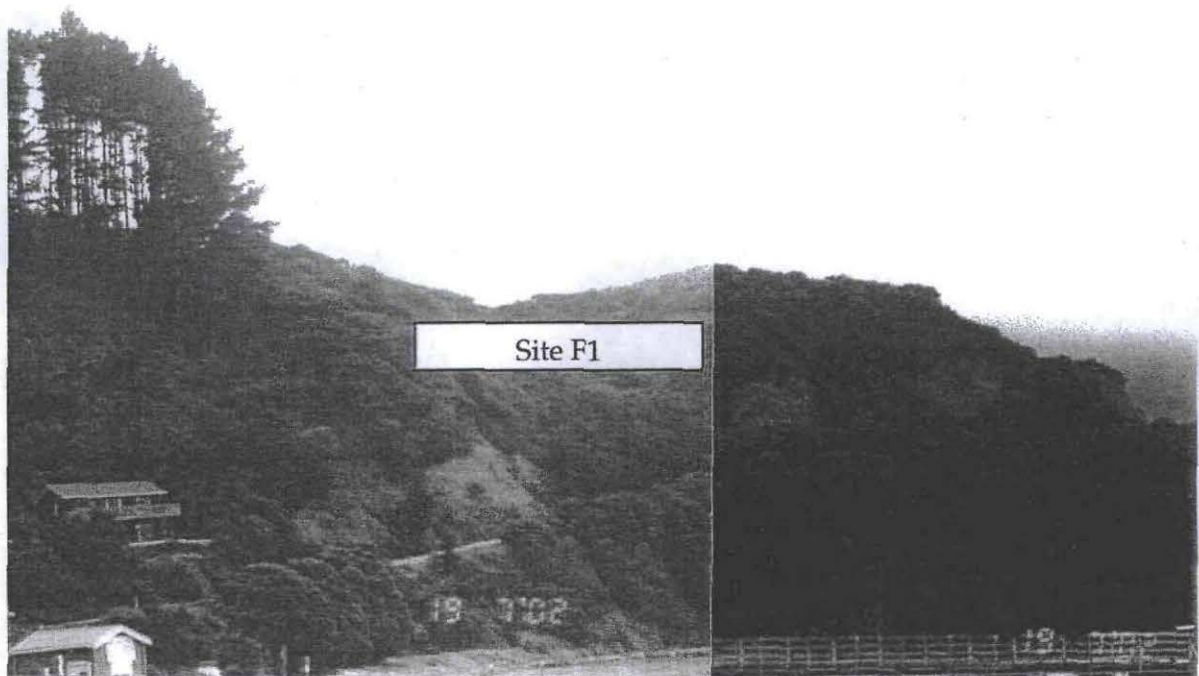
Plate 3 - French Pass : Possible Effluent Disposal Site F1

Site F1 proposed for effluent irrigation is in the vicinity of this depression and on the adjacent spurs. The slope of the depression is variable, and on average is about 20° to 35°. Bedrock spurs with a thin (200 mm or so) cover of residual soil or colluvium are located on either side of the depression. The slopes of these hillsides are steep at 35° to 40°. The upper part of the hillside has gentler slopes of about 15° to 25°. The hillside has a steep 40° slope with a stand of pine trees and a holiday house, south of Site F1. There are signs of slope instability in this area, evident as hummocky ground, a leaning power pole and some small trees that lean downslope.

A small pit was excavated in the upper slope, south of the depression. A thin layer of residual soil of about 150 mm to 200 mm in thickness was encountered in the pit and is likely to be underlain by bedrock. This residual soil is a light brown, clayey silt with humus and organic matter. The overburden soil thickness is likely to vary across the slope and is about 0.5 m in the middle of depression. The slopes were generally dry at the time of the site visit.

There is an existing effluent soakage field on the southern side of the proposed irrigation area, and there were signs of slope instability in this area. It is not known whether the effluent soakage field contributed to the instability.

Site F1 shows signs of slope instability, despite the absence of a catchment above and the limited potential for overland flow or high groundwater conditions. It is possible that the depressions may have been formed at times of higher sea level or earthquakes in past geological times. However, the signs of recent movements at Site F1 suggest that the slopes are marginally stable. This is a reflection of the steep slopes at the site. Increased groundwater pressures are likely to exacerbate the slope instability. Therefore, irrigation of effluent beyond the likely evapo-transpiration rates is not prudent. Given that the evapo-transpiration is likely to be variable, Site F1 is not suitable for irrigation of effluent.

- (c) There are signs of existing slope instability in the vicinity of Site F1 and it would be prudent to avoid this area.
- (d) The application rates be limited to 2 mm per day during initial trials, and the hillsides should be inspected to ensure that there is no instability and to confirm that it is prudent to continue or increase the rate of application of effluent.

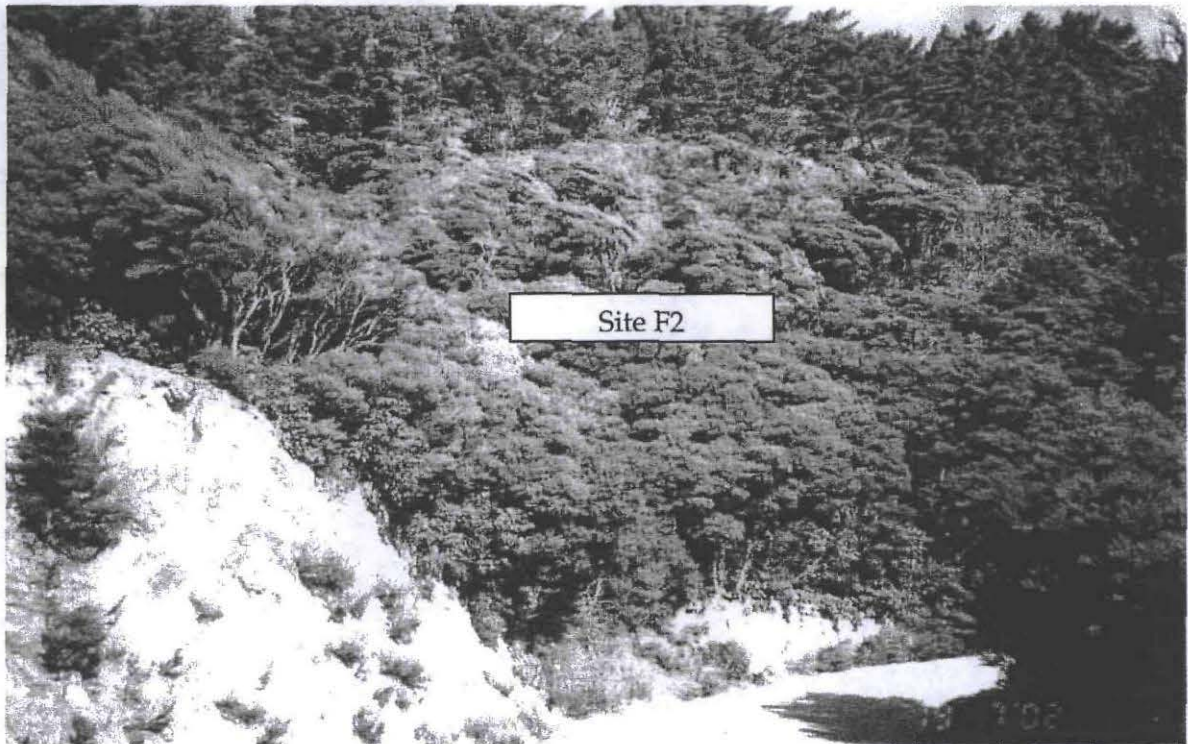
Plate 3 - French Pass : Possible Effluent Disposal Site F2

Site F2 is located on the northwestern side of the ridge facing Durville Island, west of the DoC camp, see Figure 2. This site is also located in a depression in the bedrock, which may have been an old failure. However, there are currently no visible signs of instability. The depression has a slope of about 15° to 25°. This slope has larger trees than at site F1.

Although no pits were excavated on this slope, the soils are likely to be similar to Site F1, with a relatively thin cover of overburden of about 0.5 m, based on exposures at the bottom of the slope.

Site F2 has similar catchment characteristics, but has slightly gentler slopes, and there are no obvious signs of slope instability. Also this slope has larger trees of moderate size and may have a higher groundwater loss from evapo-transpiration. The slope does receive direct rainfall during the year. Therefore, it is likely to be able to sustain some effluent irrigation, particularly in drier periods and at the peak periods of summer when evaporation is higher.

However, even at Site F2, it would be prudent to limit the effluent irrigation rates as much as possible. It would be prudent to inspect the slopes after the effluent irrigation has been established to ensure that slope instability, erosion or concentration is not occurring.

- (a) Area F2 could be used for effluent irrigation at the site.
- (b) Consideration should be given to the evapo-transpiration capacity of the sites in deciding on the rate of application. Based on the assessments of evapo-transpiration, the rates of application should be kept low, such as at 2 mm per day during peak season only and lower application rates during off season.
