Engineer's Report Lot 1 DP 18348 Bulwer For McCauley Family

21 November 2003 Reference 318a/40/CC Revision 1 **Document Control**

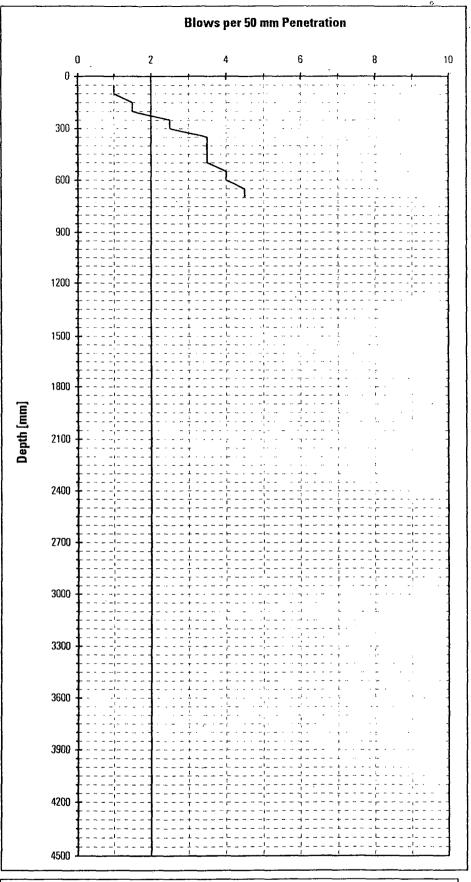
McCauley Family	SCA	SCALA PROBE		
location McCauley Residence, Bulwer	No :	SP 2		
Tester	Date	Job Number	Sev	
AJF	26 Sep 2003	318A/40/cc	1

Test 2 – Near the SE corner of the proposed dwelling. Calculated Allowable bearing capacity is greater than 100kPa (300kPa ultimate) throughout. Refusal was encountered at a depth of 600 mm.

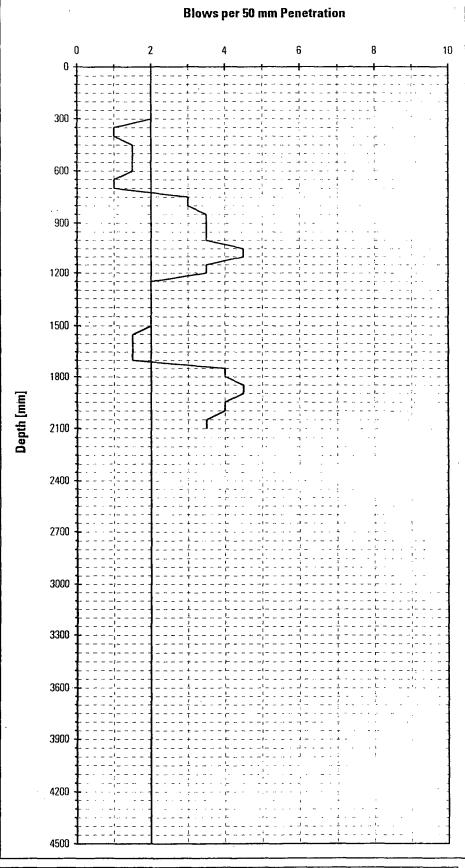
McCauley Family	SCA	SCALA PROBE		
McCauley Residence, B	ulwer	SP 4		
Tester	Date	Job Number	Яev	
AJF	26 Sep 2003	318A/40/cc	1

Test 4 – Near the NW comer of the proposed dwelling. This area was also filled by slip debris following the 1989 slip. Calculated Allowable bearing capacity is less than 100kPa (300kPa ultimate) in one softer layer. Refusal was encountered at a depth of 2100 mm.

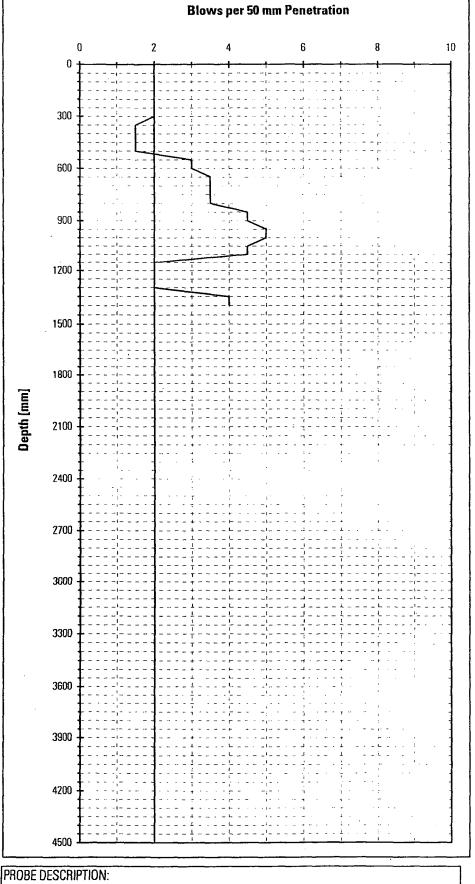
McCauley Family		S	SCALA PROBE		
Location	McCauley Residence, Bulwer	No	SP 5	A4	
Tester		Date	Job Number	Rev	
ļ	AJF	26 Sep 2	003 318A/40/cc	1

Test 5 – Near the centre of the proposed dwelling. Calculated Allowable bearing capacity is greater than 100kPa (300kPa ultimate) throughout. Two softer layers were encountered at 300 mm and 800 mm depth though still in excess of 100kPa. Refusal was encountered at a depth of 1300 mm.
