ENGINEERING REPORT

**M DAVIS & Z GILSON
PORT UNDERWOOD**

Our Ref: 25544
Date: April 2014

**ENGINEERING REPORT
FOR
M DAVIS & Z GILSON**

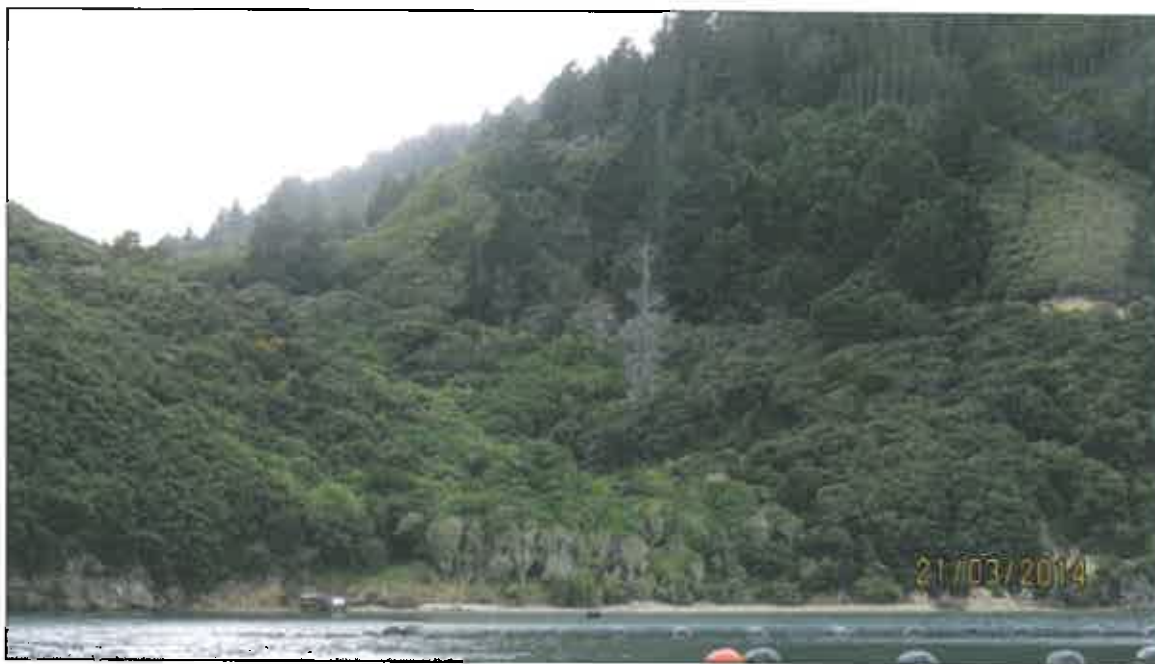
View looking east towards the site

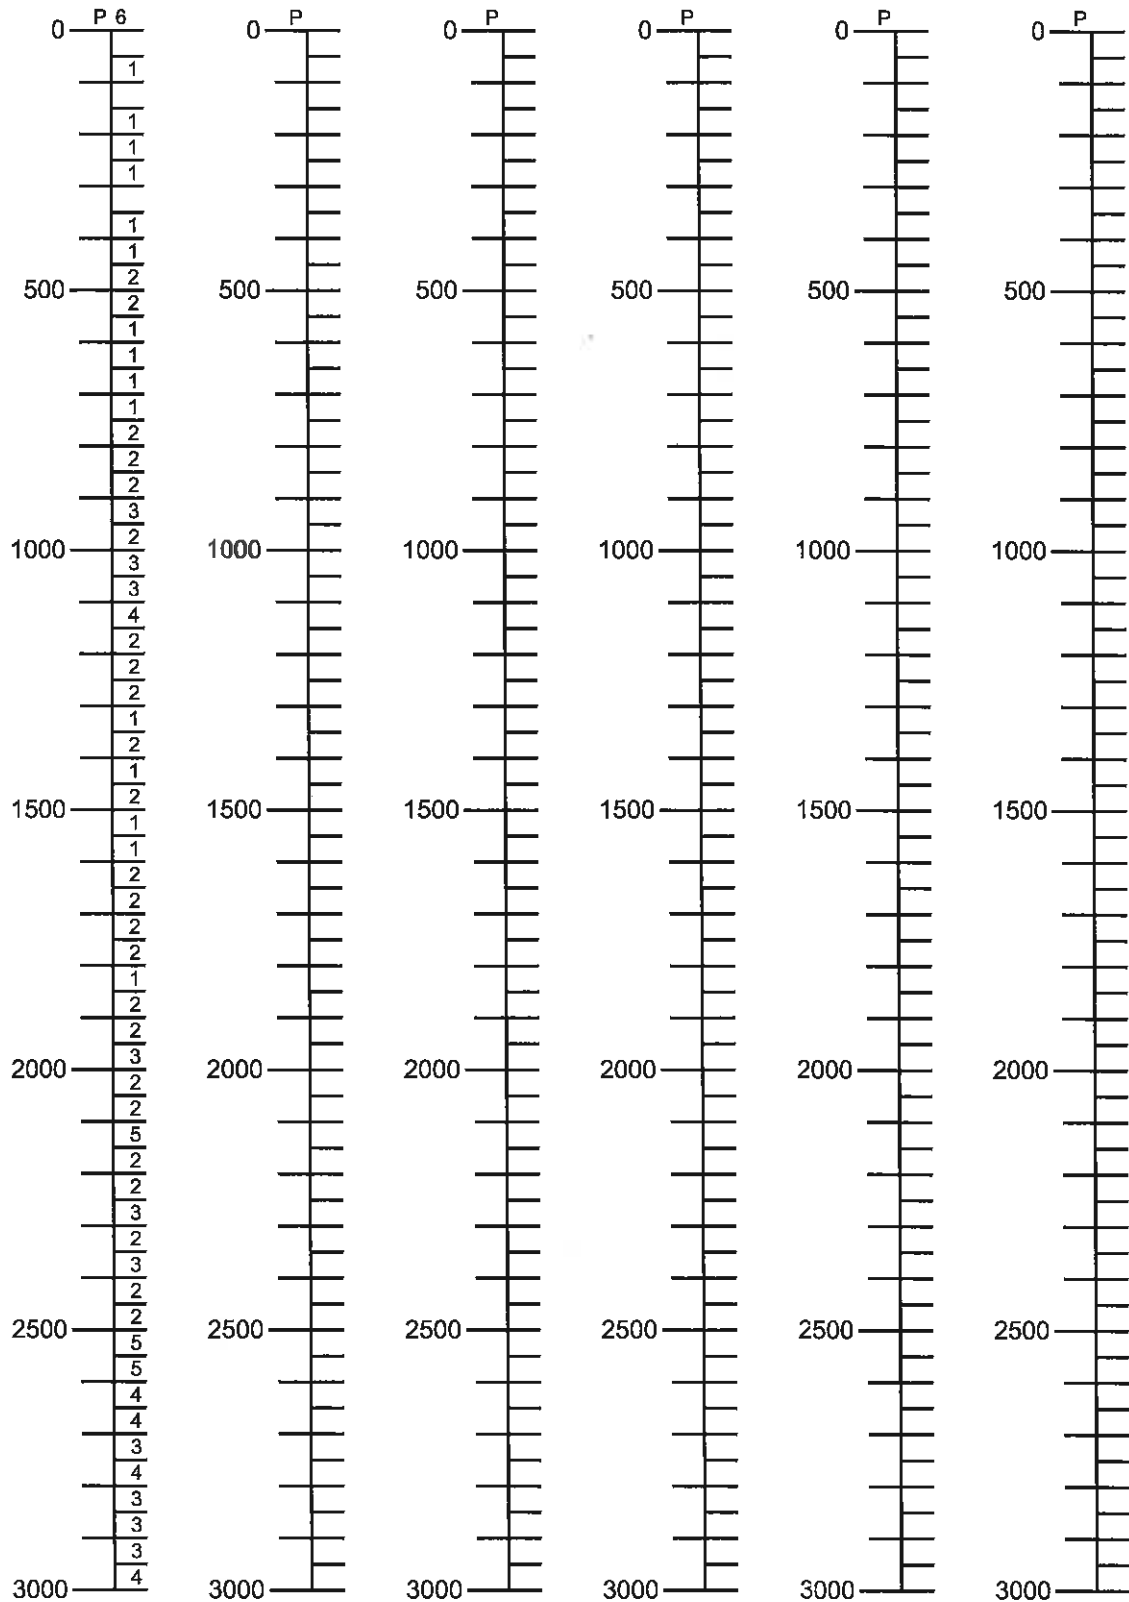
scala penetrometer results

- P1, at the back of the flat area, showed soft and variable material to about 1.5 m and firm to hard to 3 m.
- P2, in the sidecast from the flat area, confirmed very soft to about 2 m and weak to firm to 3.4 m.
- P3 confirms soft and variable material to about 1.5 m and firm to 3 m.
- P4 was soft to 700 mm and firm to 3 m.
- P5 was firm from 200 mm to 3 m and
- P6 was soft and variable material to about 800 mm and firm to 3 m.

Bedrock was not found at the test depths (3 m).

A suitable building envelope has been identified and is shown on the drawings. The site and the soft soils will suit pole type foundations designed by a Chartered Professional Engineer and founded at 1.0 - 1.5 m below ground level (at least 2 blows/50 mm from the scale results). The founding depths should be confirmed by a Chartered Professional Engineer.
