Opinion as to Land Stability – Proposed Building Site, Lot 6 DP 19539 Pt Sec 5 Pt Sec Blk VI Pt Sec 4 Blk X French Pass Survey District, Reef Point, Admiralty Bay, Marlborough.

Geotechnical Assessment for House Site, Access Road, Effluent and Stormwater Disposal Areas at Reef Point, Admiralty Bay

March 2003

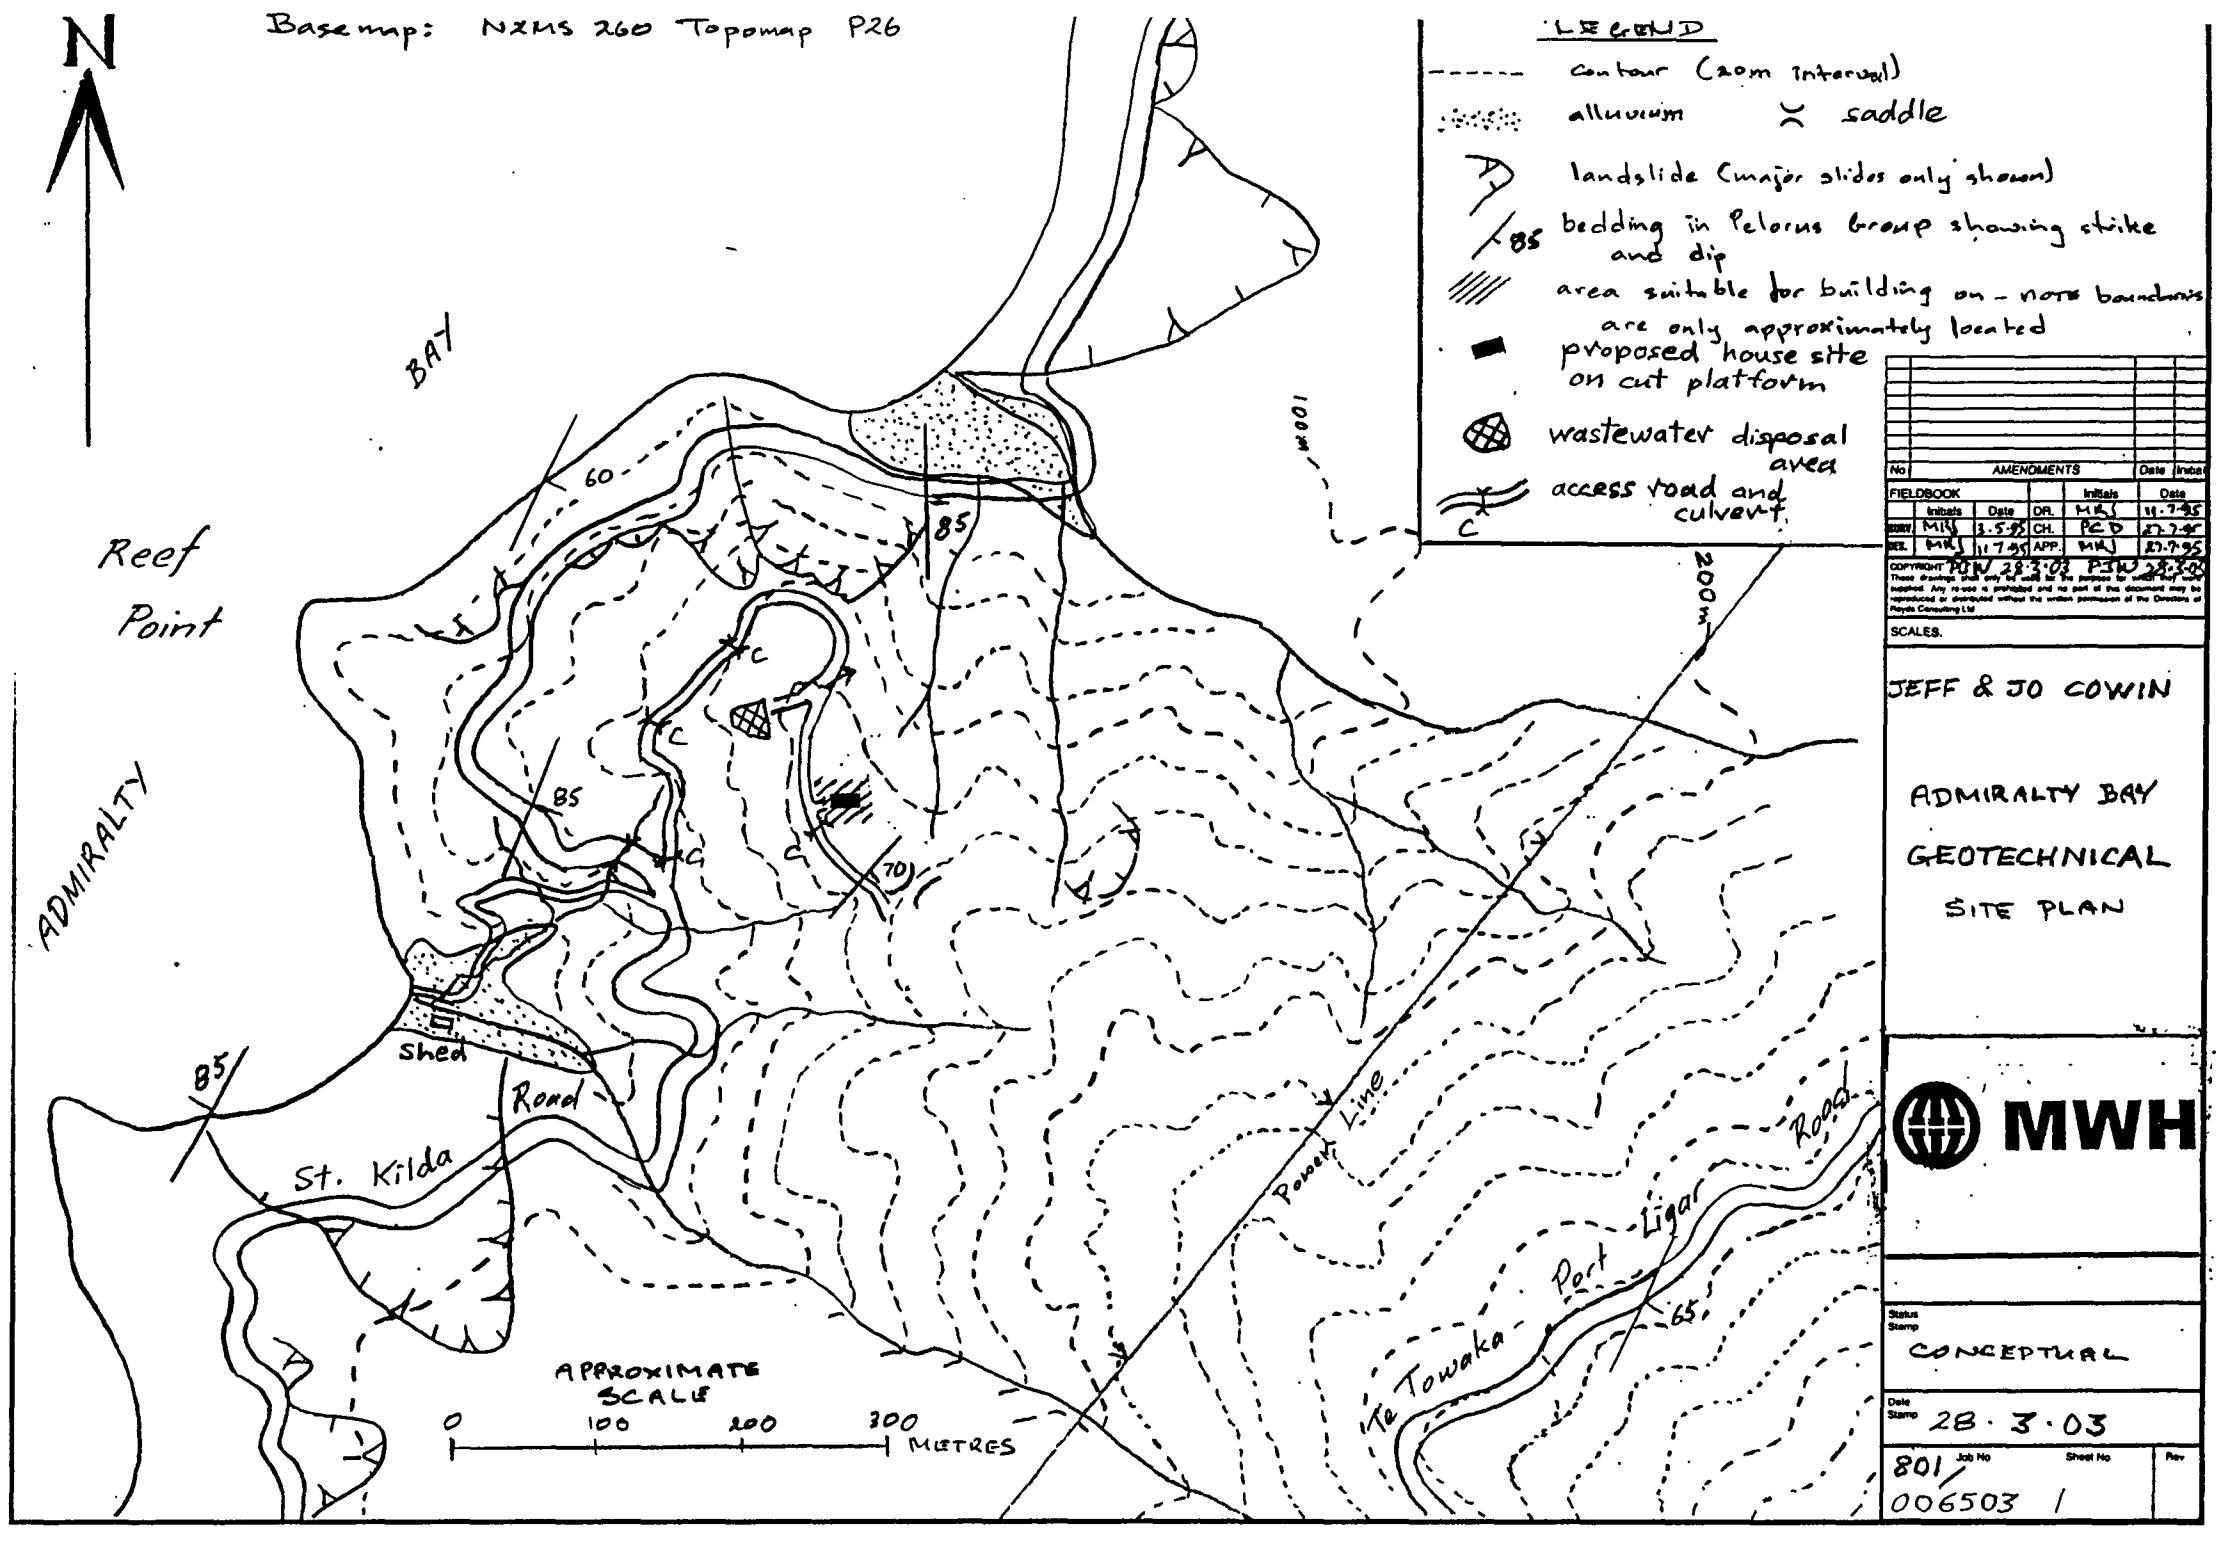
We have assessed the slope stability of the site. No weak layers, soft areas, slumps, slide planes or seepages were observed. We consider the area to has a very low risk of slope instability and that the proposed disposal of wastewater at application rates of up to 5mm/day would not have a detrimental impact on slope stability.

We recommend a cutoff drain should be excavated down to the top of the clay subsoil at the upslope end of the disposal area to divert any run-off water away from the site. Also we recommend a setback of 4m horizontal distance for the soakage basins or trenches away from the outer edge of the bench.
