**ENGINEERING REPORT
FOR
S & R BANKS
KAPOWAI BAY, D'URVILLE ISLAND**

**Ref: 26204
Date: March 2017**

**ENGINEERING REPORT
FOR
S & R BANKS**

LOCATION DETAILS: Te Akau Point, Kapowai Bay, D'Urville Island
LEGAL DESCRIPTION: Lot 5 DP 321686
DATE OF SITE VISIT: 21 June 1993, 11 March 2002, 3 February 2017
ZONING: Rural One (MSRMP) and Coastal Environment Zone (MEP)

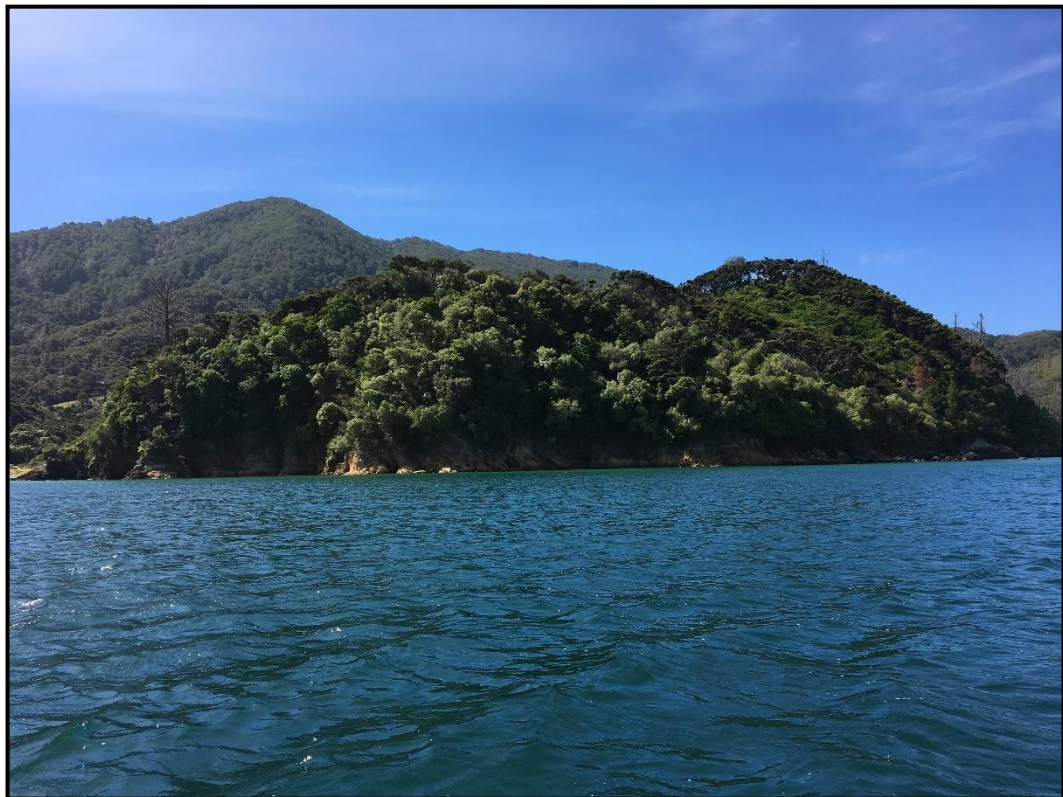
The ridge tops have been cleared of vegetation but the side slopes have a good native cover consisting mainly of kanuka. The ridge line itself is gently sloping (less than 5°). The side slopes are steep, over 40°, to the foreshore.

View of Te Akau Point from the South

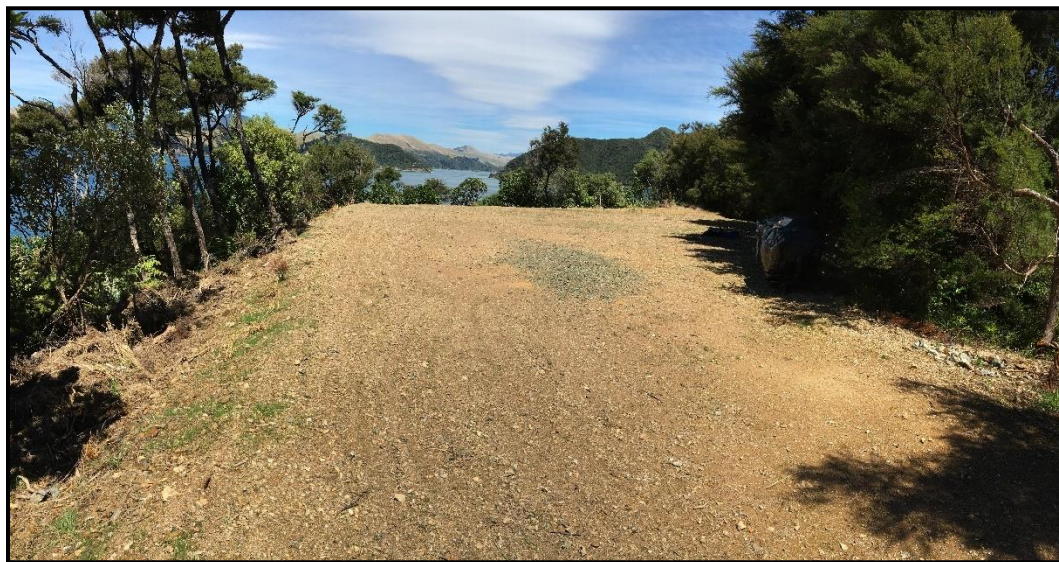
The currently proposed building site is located at the southern end and straddles the bench and side cast material. The steep slope to the sea to the south appears to be subject to slope movement but the eastern and western slopes are much more stable. The whole of the ridge line however has a solid weathered rock base and is stable.

Proposed house site

The tests confirm soft, unconsolidated material (side cast) along the perimeter of the excavated area (less than 2 blows/50 mm) up to 800 mm lying over firm soils to 1.5 - 2.0 m and weathered rock at greater depths.

It is recommended however that a 'no build' zone extends back 5 m from the edge of the very steep slope dropping from the southern end of the bench to mitigate against the risk of further movement on that face.

Foundations constructed in accordance with NZS 3604 'Timber Framed Buildings' would be suitable for this building site, ensuring that they are well founded in the competent soils and rock below the side cast material.

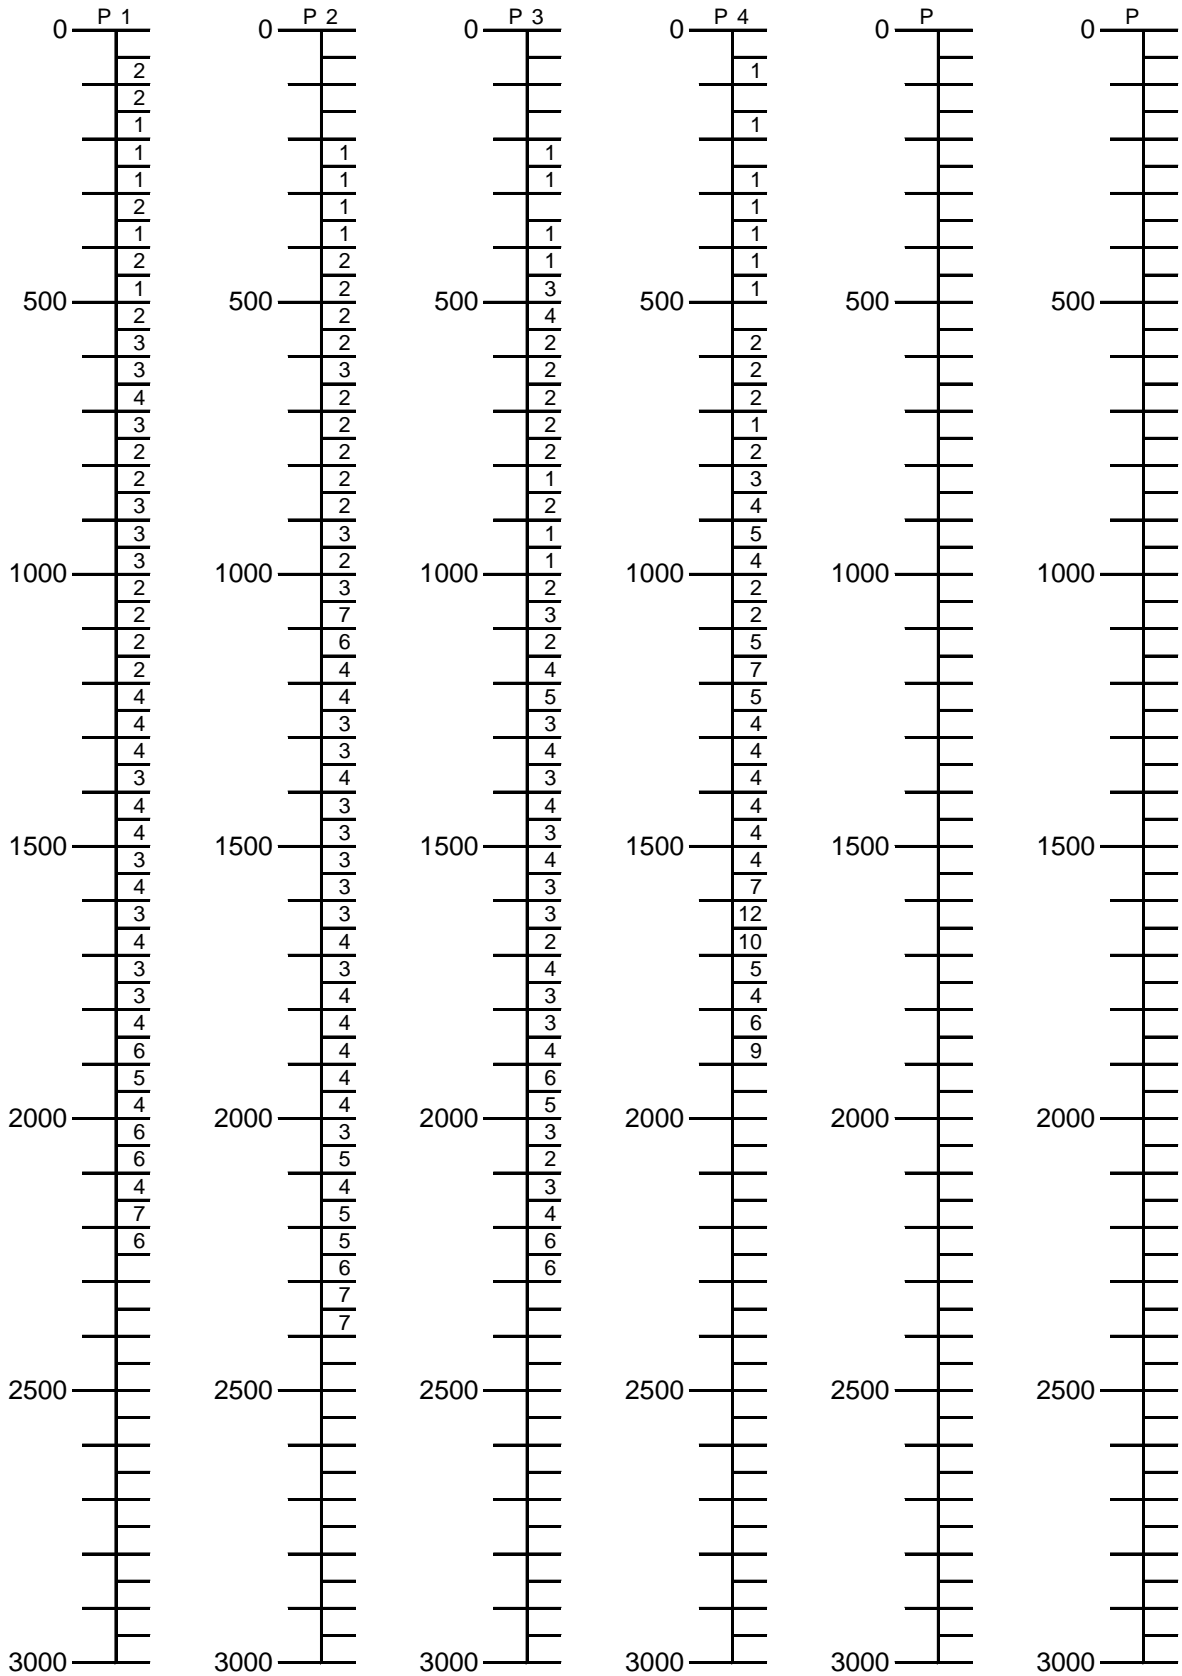
scala penetrometer results

PENETRATION IN BLOWS PER 50mm

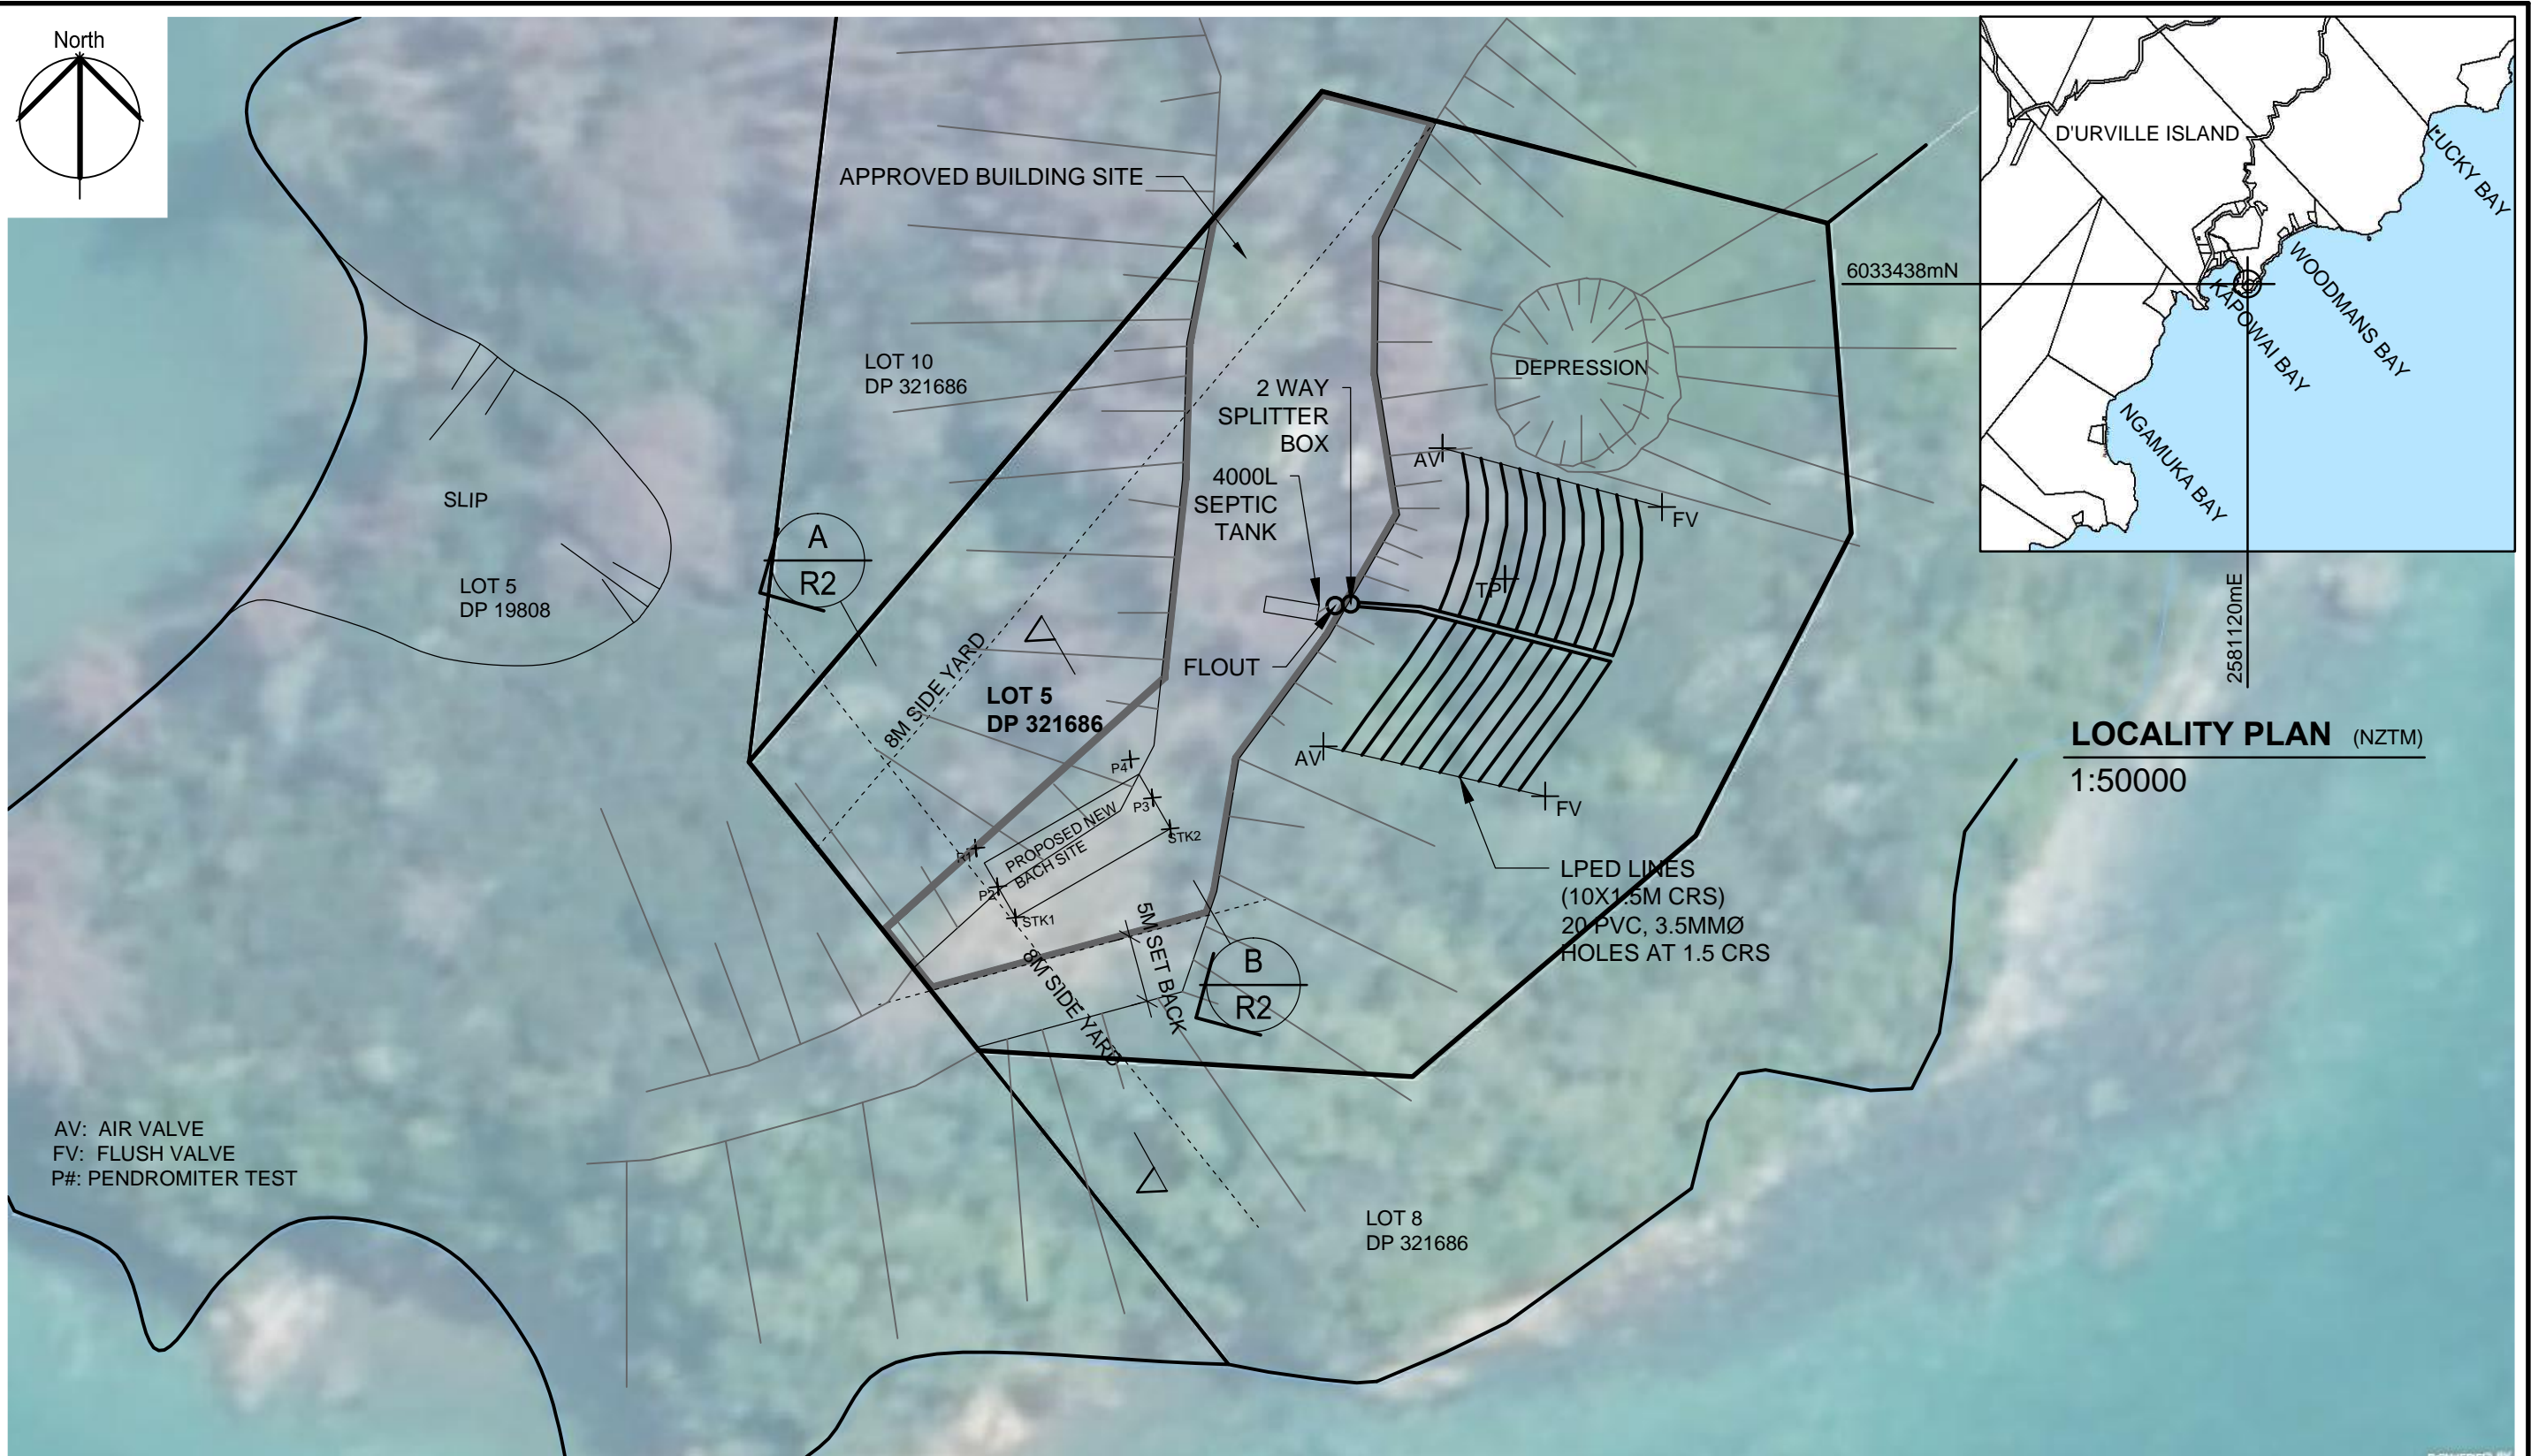
location & site plan

A large stable area has been identified as suitable of a dwelling and this is shown on the drawings attached to this report.

A suitable disposal area has been identified just east of the building site where shown on the plans.

- a) the building site is confined to the area shown on the drawings attached to this report,
- b) water from the roof and storage overflow be collected and piped directly to the foreshore, and
- c) drinking water is tested to ensure it complies with current Council drinking water standards.
