06 April 2018

## Existing Wastewater Assessment at 36 Pukenui Road

Our Reference: 6564

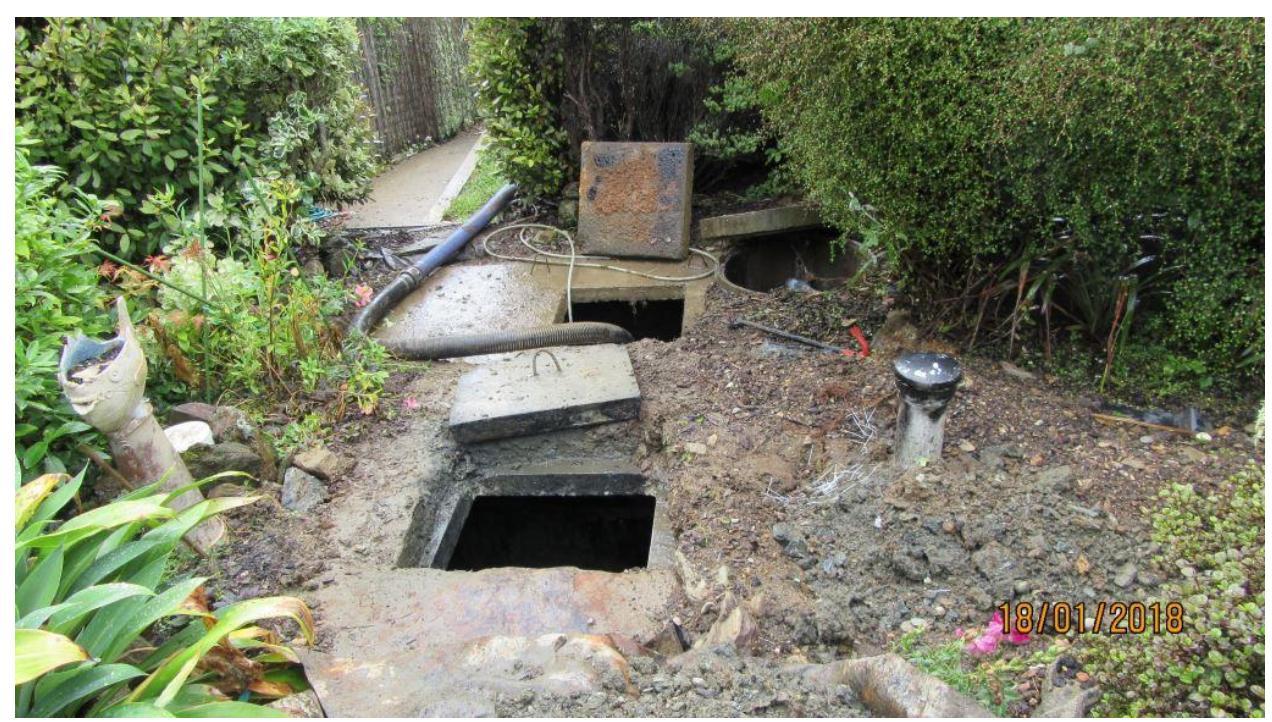
Photograph of the septic tank pump out undertaken on 18 January 2018
