Kaituna Closed Landfill Annual Monitoring Report 2011-2012

✦ Prepared for
Marlborough District Council

✦ October 2012

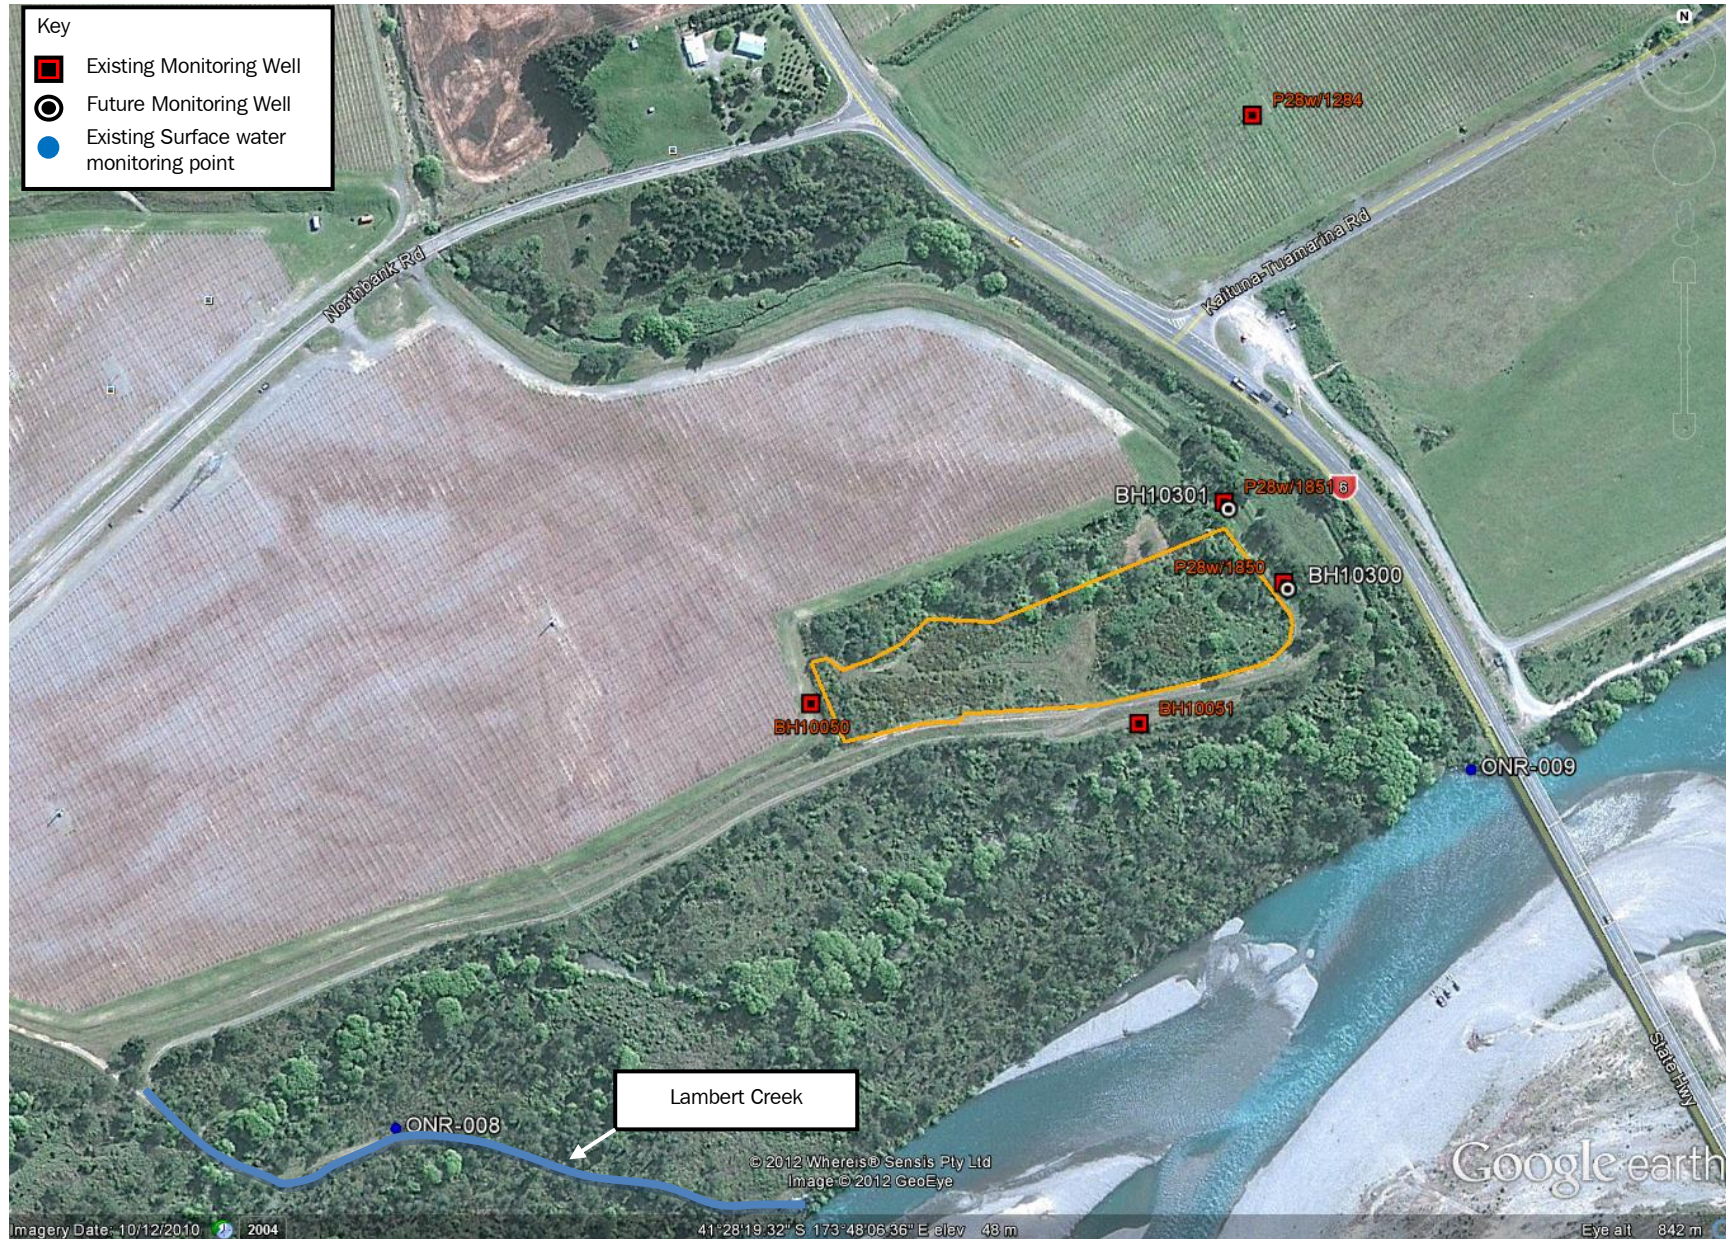
Figure 2: Location of Monitoring Points, Kaituna Closed Landfill

Current environmental monitoring requirements are summarised in Table 1. Sampling locations are shown in Figure 2 in Appendix A.

Data from groundwater samples is available from five different locations around the Landfill. Note that static water levels in the boreholes indicate that groundwater flow is generally west to east across the site, sub parallel to the Wairau River:

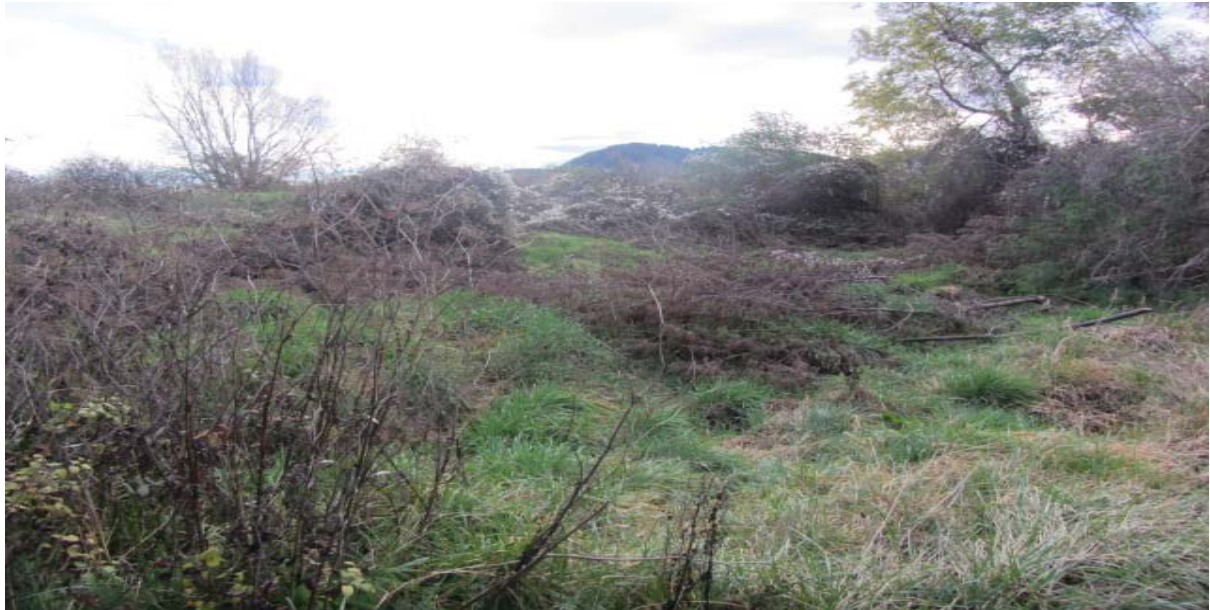
Observation: site is undulating in contour

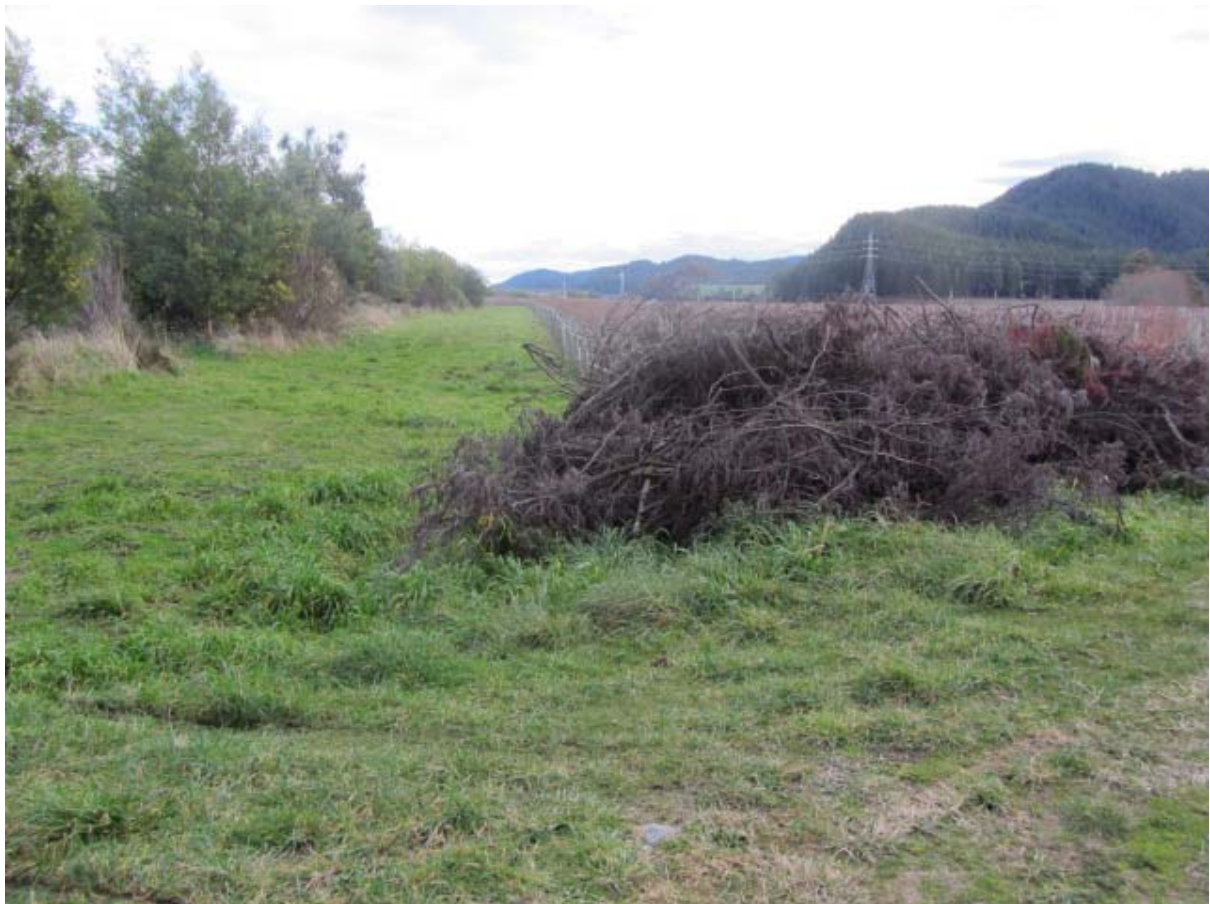
The site inspection indicated that the condition of the Landfill was generally good. No cracks or slumps were observed, nor was any exposed refuse evident at the site. The site is generally covered with vegetation, and pruning to control the spread of trees and gorse has been undertaken.

Observation: tree pruning and gorse control has been undertaken
