# Ecological report for the proposed renewal of marine farm site 8170 located Melville Cove, Port Gore

Research, survey and monitoring report number 653

18 October 2010

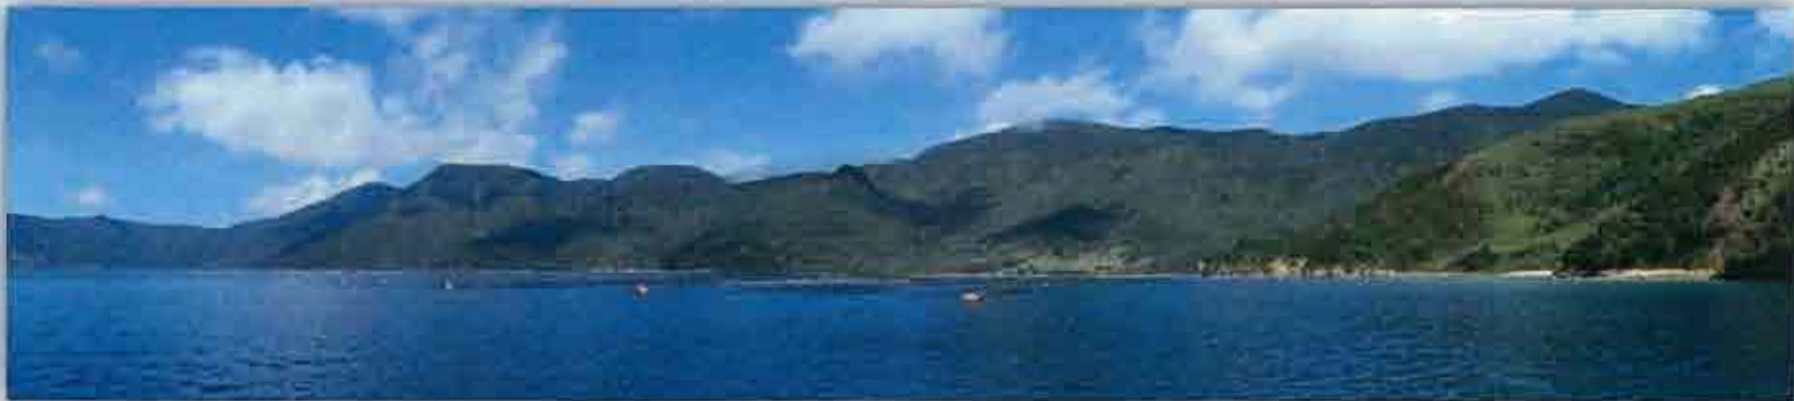
*Plate 2. Marine farm site 8170 looking south-westward along the backbone lines from the northern-most block.*

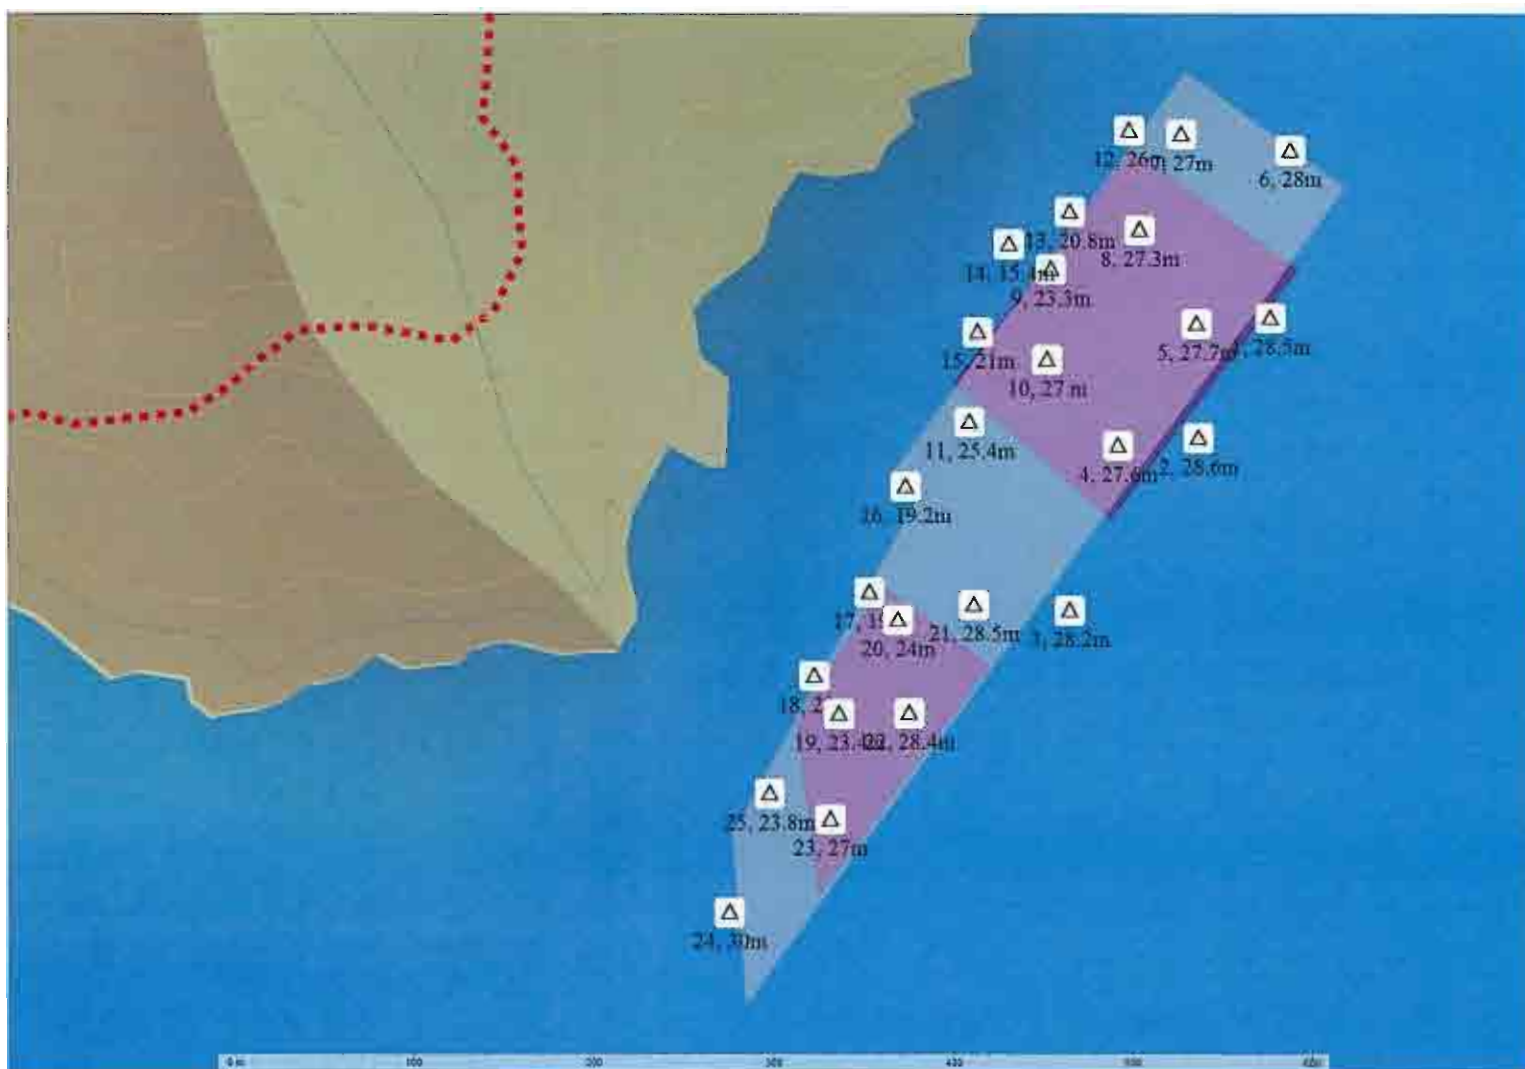
The consent area and areas occupied by surface structures (pink) have been plotted in Figure 1. Depths and locations of all drop camera stations have been listed in Table 2 and plotted in Figure 2.

Figure 2. Location of marine farm consent area (light grey) and surface structures (pink). Triangles are locations of drop camera stations; numbers are the photo number and water depth (m).

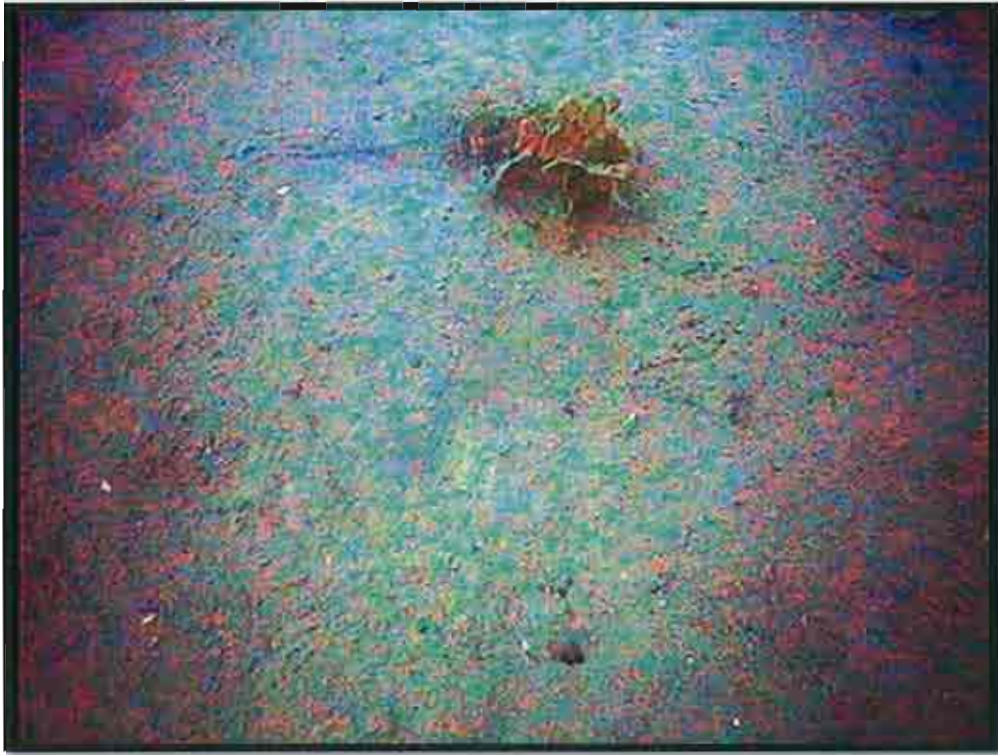
Photo site 5

Mussel shell debris was observed from areas under backbones (e.g. photos 5, 19). No mussel shell was observed under warps, however mussel shell was observed immediately inshore of the consent (e.g. photos 13, 15).

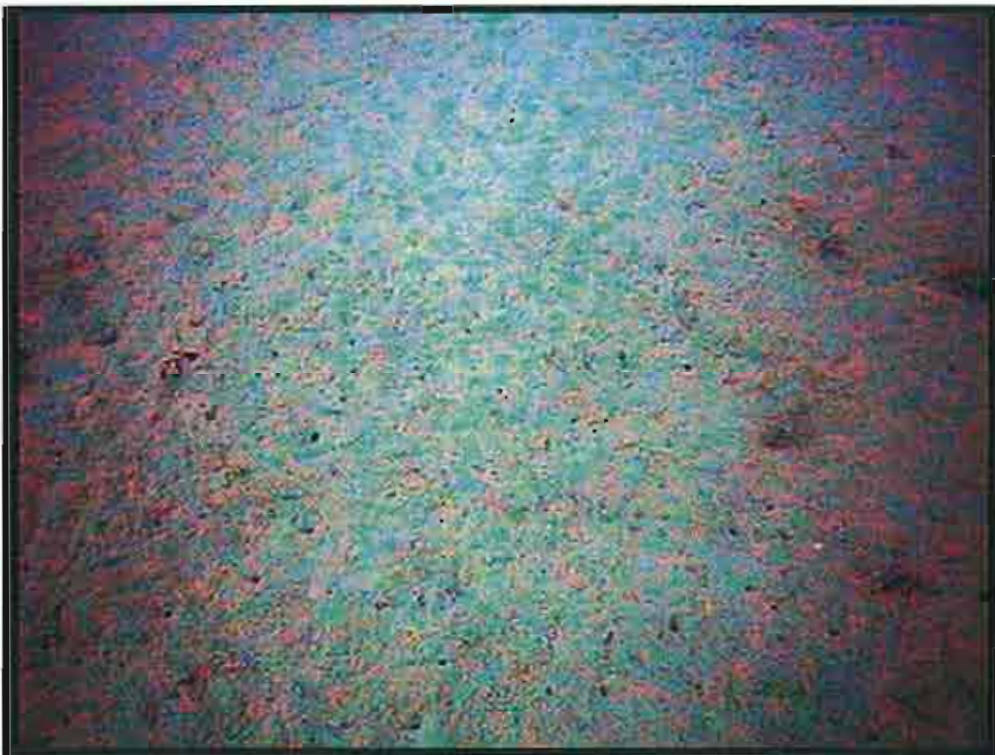
Photo site 6

The benthos under the consent area was dominated by silt and clay substratum (e.g. photos 6, 7, 11, 21). Combinations of natural shell and fine sand were observed from areas immediately inshore of the consent (e.g. photos 12, 13, 14).
