Davidson Environmental Limited

Ecological report for validation of an offsite marine farm (site 8415) located in Port Underwood

Research, survey and monitoring report number 628

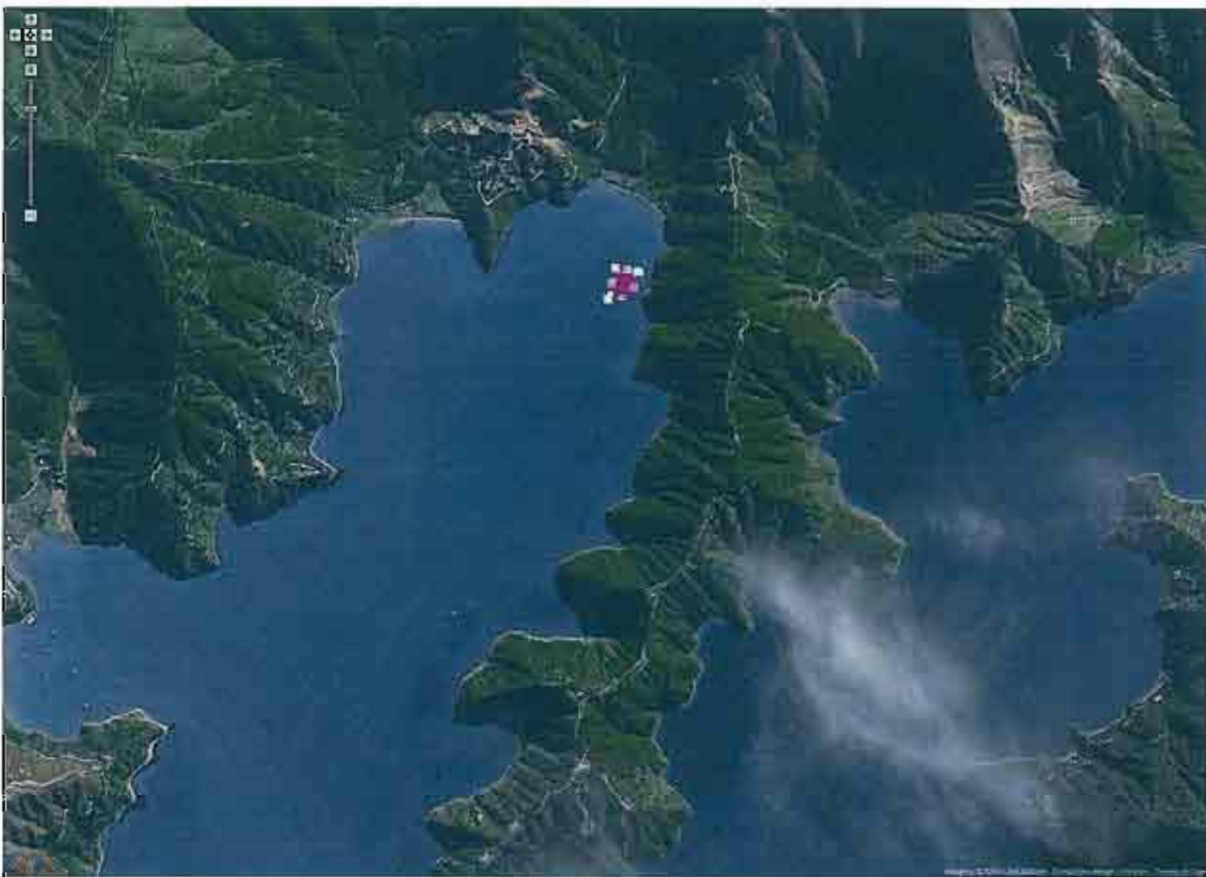
Plate 1. Marine farm site 8415 located in inner Port Underwood. Grey area is the consent area and pink area is the location of surface structures.

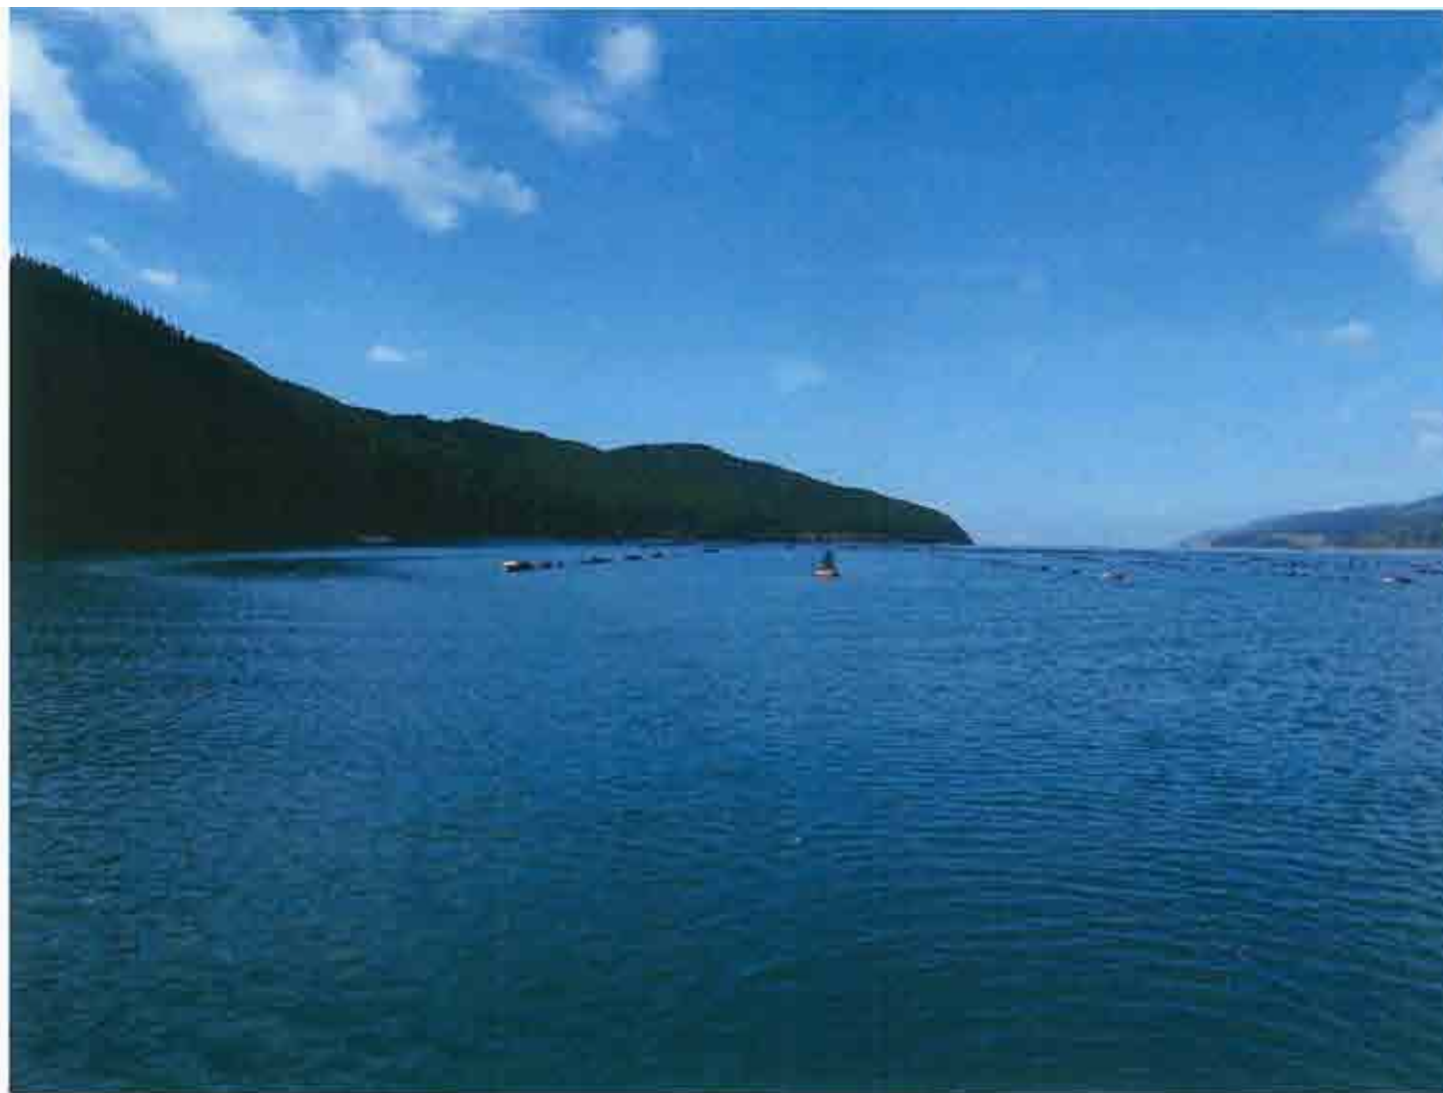
Plate 2. Looking southward along the backbone lines of marine farm site 8415.

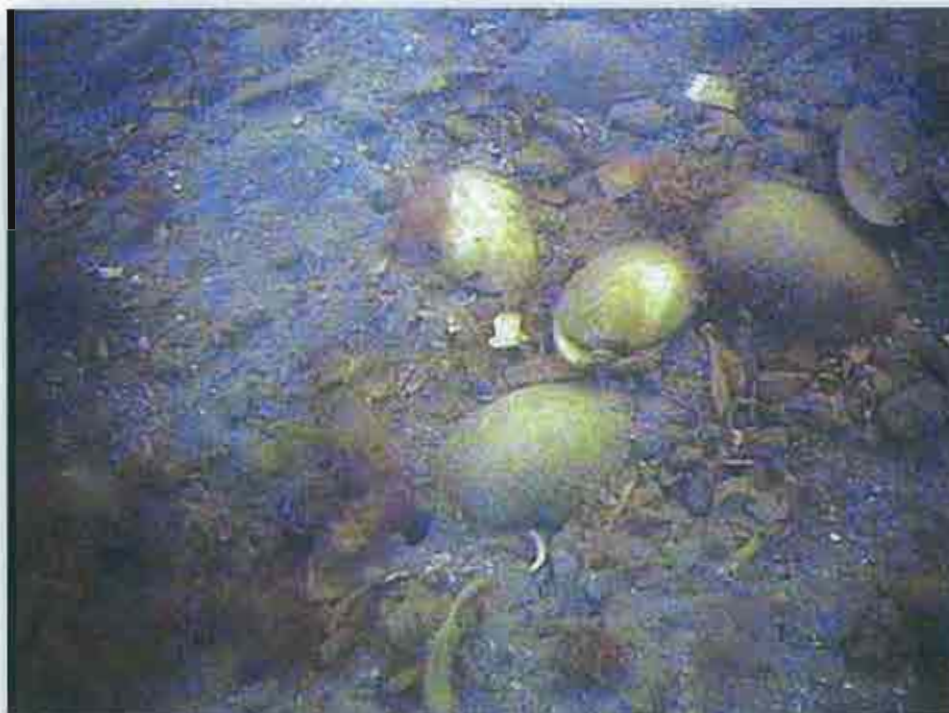
Photo site 3

Areas inshore of the consent supported coarser substrata including fine sand and natural shell (photos 3 and 4).

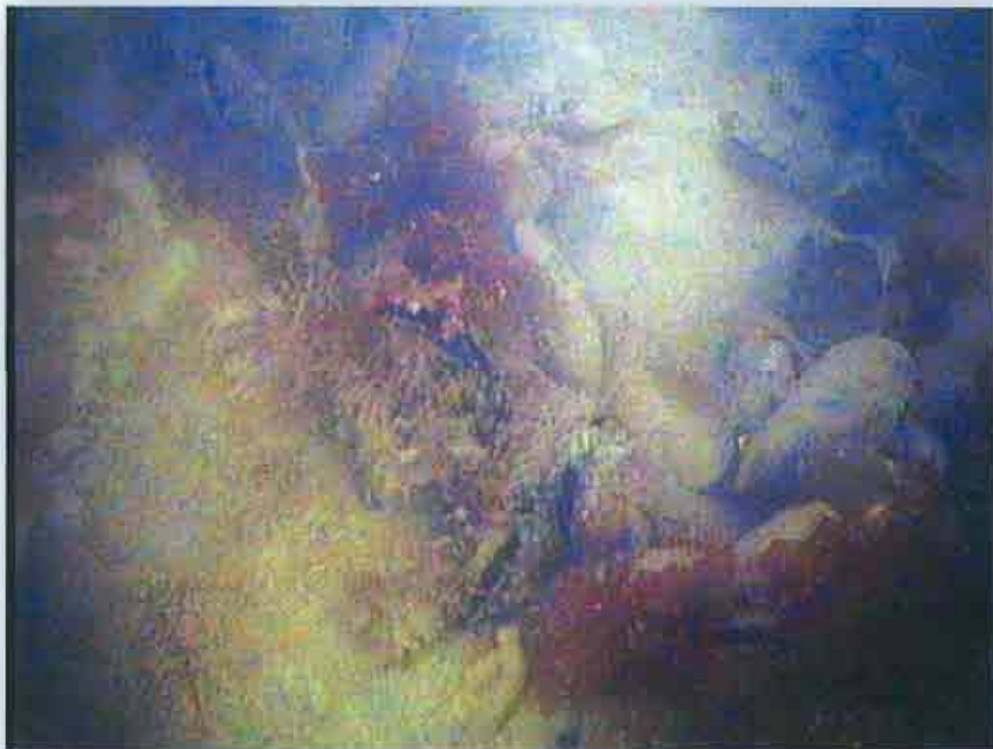
Photo site 6

Areas under and adjacent to backbones offshore of the consent were characterised by silt and clay with variable levels of mussel shell debris (photos 7-10). Areas of the consent not occupied by marine farm structures also supported silt and clay (photos 1, 2, 5, and 6).

Low to moderate levels of mussel shell was observed from drop camera photos close to or under backbones (photos 6-10). No shell was observed from photo sites located away from backbones.

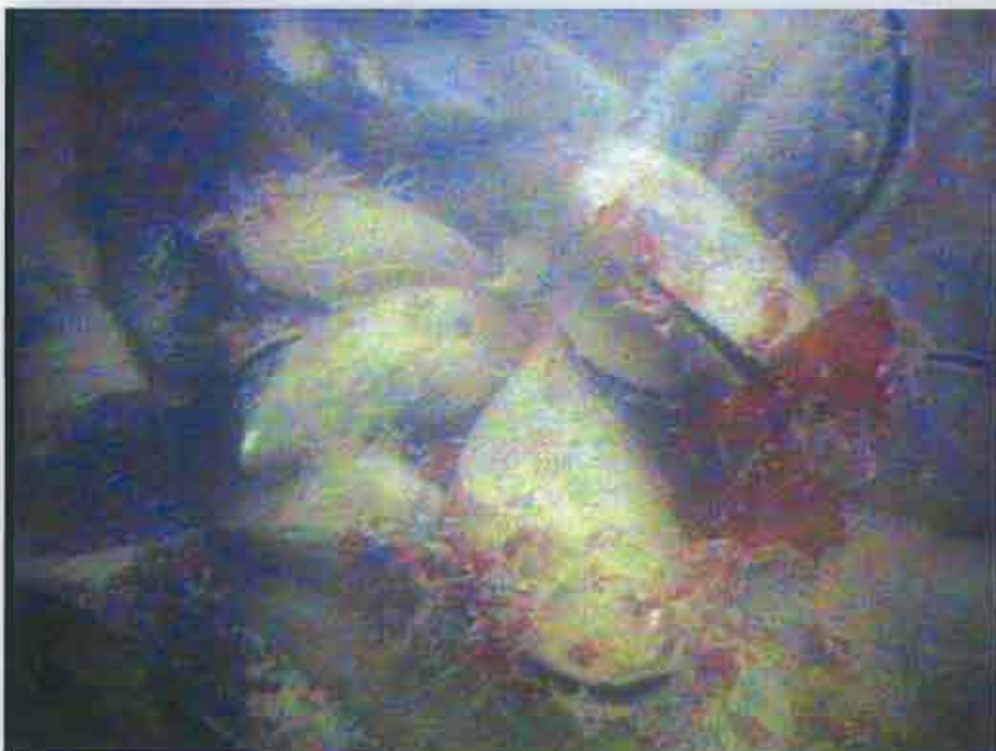
Photo site 10

10, 9m	2606040.0,5990375.4	Offshore consent, under backbones	Silt & clay, mussel shell	High
