Impacts of diquat herbicide and mechanical excavation on spring-fed drains in Marlborough, New Zealand

SCIENCE FOR CONSERVATION 240

Roger G. Young, Nigel B. Keeley, Karen A. Shearer and
Anna L.M. Crowe

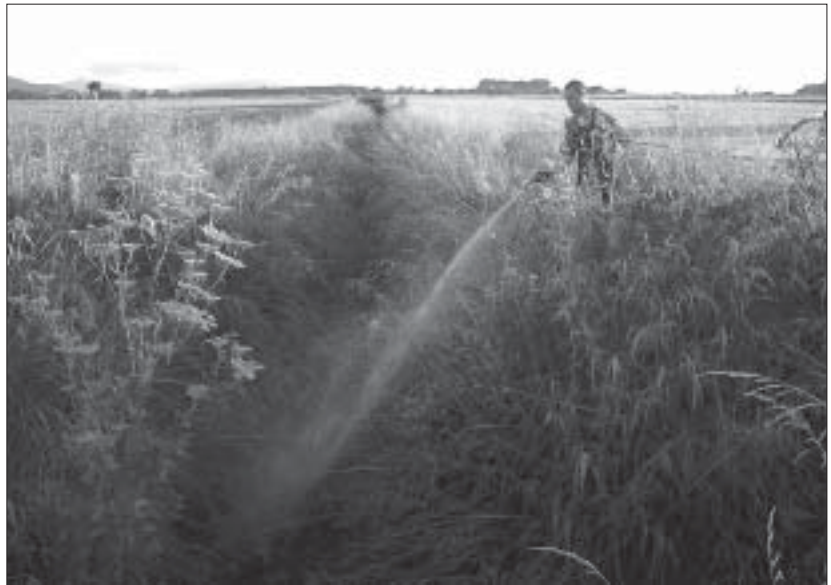
Figure 2. Application of diquat spray in Pa Drain.

In Pa Drain diquat spray was applied to the water surface and overhanging vegetation using a hand-held spray-gun connected to a motorised compressor on the back of a truck (Fig. 2), and achieved an estimated concentration of diquat in the water of 1.23 ppm (Bezar 2002). Mechanical clearing was carried out using a mechanical digger with a wide bucket that allowed water to drain out through holes (Fig. 3). The digger moved along the drain bank progressively scooping out the bottom of the drain, thus removing a layer of sediment (5–30 cm deep) and the associated macrophytes and fauna. Extracted material was placed in piles alongside the drain on the same side as the digger.

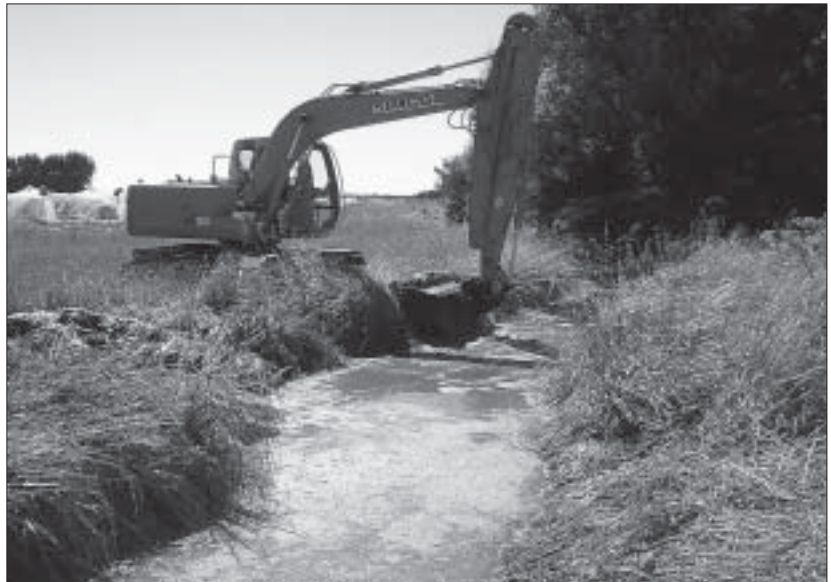
Figure 3. Mechanical clearance in Foothills Drain using an excavator.
