**Biological report on a proposed  
marine farm renewal (U950139A, Pe378)  
located east of Fish Bay,  
Kenepuru Sound**

**Research, Survey and Monitoring Report Number 498**

**August 2005**

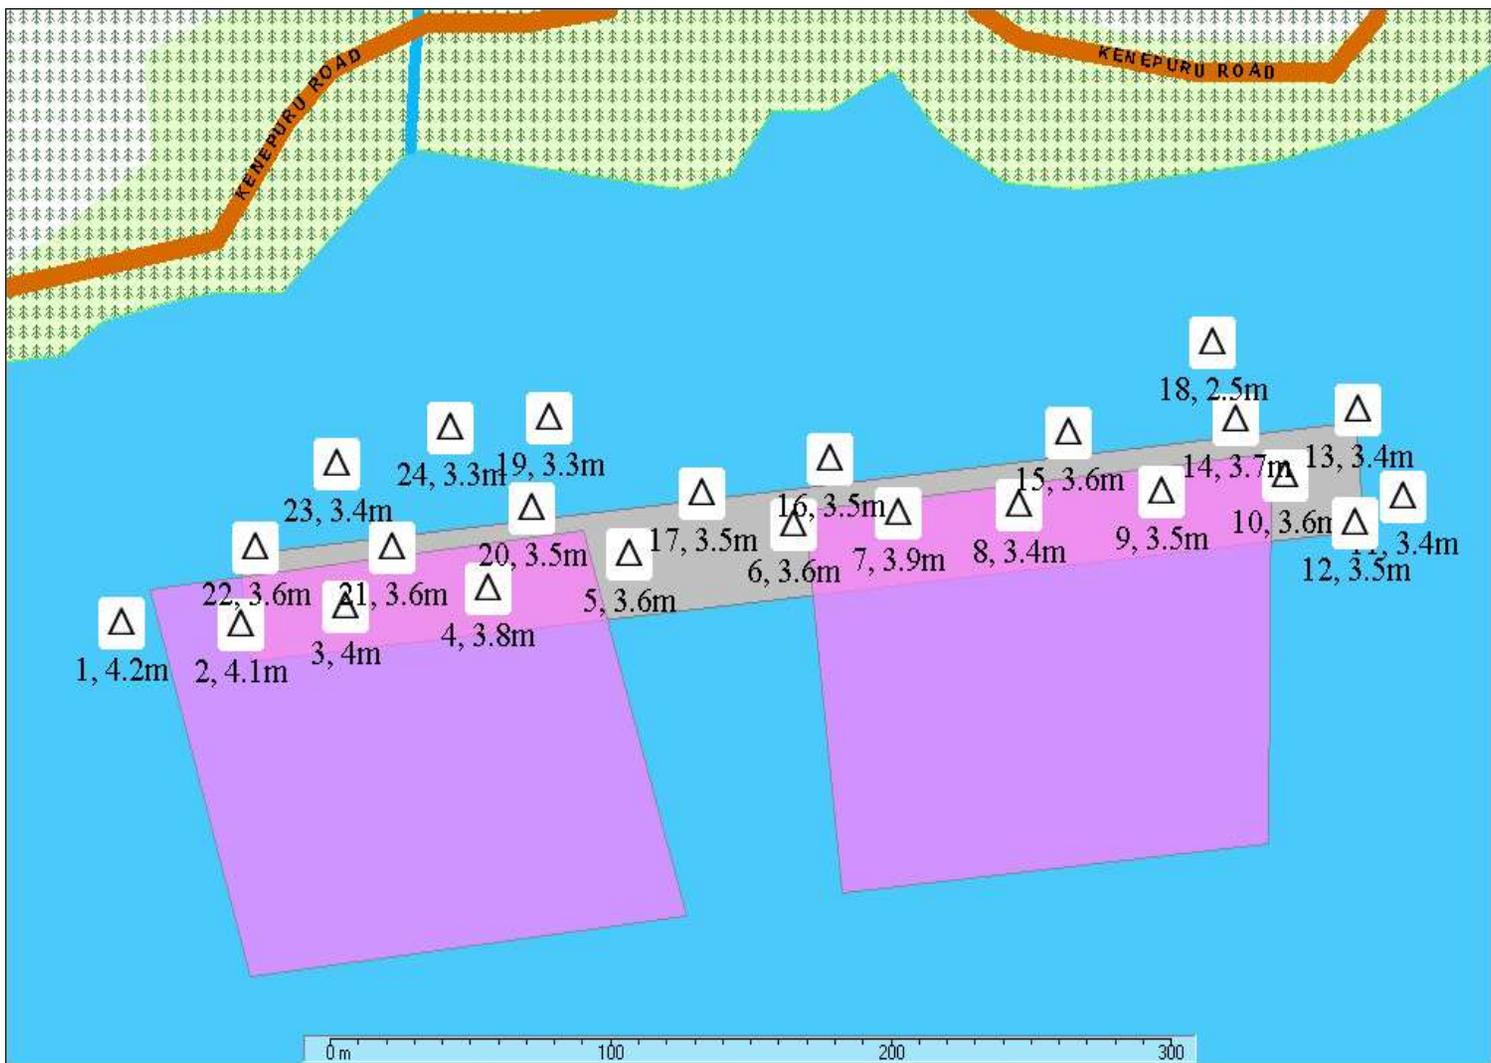
Figure 2. U950139A located east of Fish Bay in Kenepuru Sound, showing the marine farm consent area (light grey) and location of surface structures (pink). Triangles are locations of drop camera stations; numbers are the photo number and approximate water depth (m).

A total of 24 drop camera photographs were collected from the consent renewal area and adjacent areas (Figure 2). At each site, an IKELITE underwater splash camera fixed to a tripod was lowered to the benthos and an oblique still photograph was collected where the tripod landed on the benthos. The location of photograph stations were selected in an effort to obtain a representative range of habitats inshore, alongshore and offshore of the growing structures, and to detect the extent of spread of mussel shell debris on the benthos. Additional photographs were taken when features of particular interest (e.g. shell debris, reef structures, horse mussels) were observed on the remote monitor on-board the survey vessel. In particular instances, the boat was left to drift so that observations of the benthos could be made via the camera monitor. All photographs collected during the survey have been included in Appendix 1.

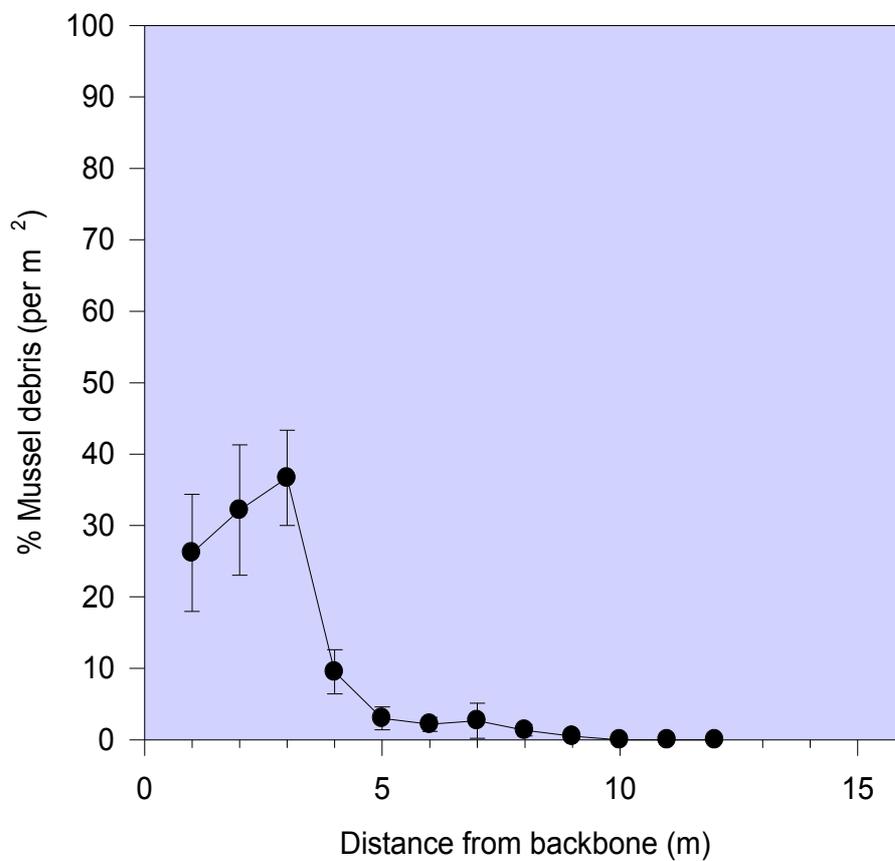
**Figure 3. Mean percentage cover of mussel shell debris collected from contiguous quadrats installed along transects at the inshore backbone. Error bars are +/- 1 s.e.**

The percentage cover estimates for mussel shell debris ranged from 10 to 65 % cover directly adjacent to the inshore backbone (Appendix 2). Mean mussel shell debris declined to < 5 % cover

by 5 m distance from the backbone and debris ended between 5 to 10 m distance (Figure 3). Due to relatively high sedimentation in Kenepuru Sound, much of the shell debris appeared to be in a process of smothering by silt and clay sediments.

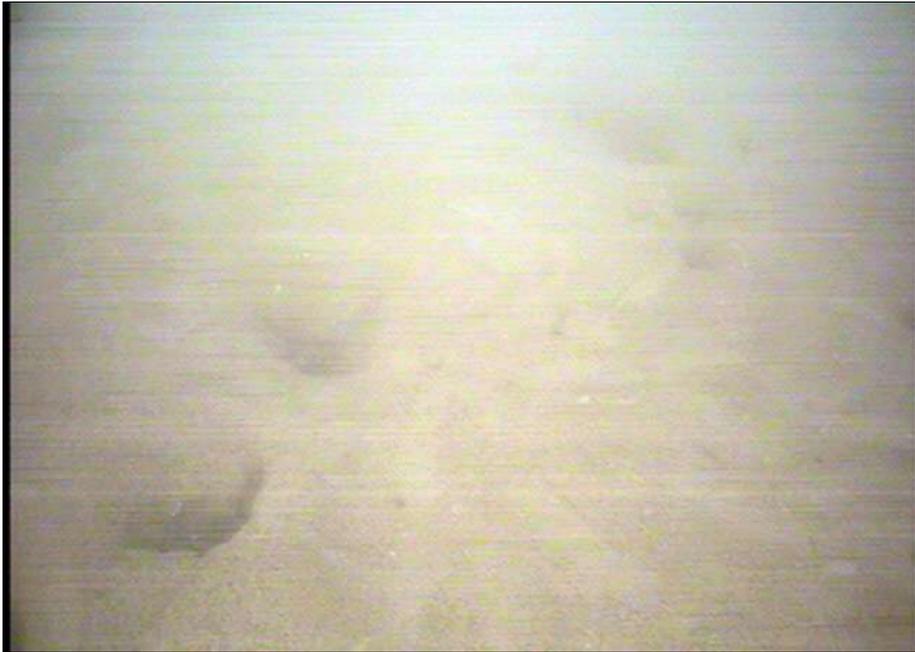
Photo site 1

No. & Depth (m)	Coordinates	Location	Substratum	Shell debris
1, 4.2m	41 10.73964,174 04.24765	outside consent	silt and clay	none
2, 4.1m	41 10.73963,174 04.27819	under structures	silt and clay	none
3, 4m	41 10.73635,174 04.30481	under structures	silt and clay	none
4, 3.8m	41 10.73310,174 04.34123	under structures	silt and clay	none
5, 3.6m	41 10.72671,174 04.37725	in consent	silt and clay	none
6, 3.6m	41 10.72141,174 04.41893	in consent	silt and clay	none
7, 3.9m	41 10.71921,174 04.44564	under structures	silt and clay	none
8, 3.4m	41 10.71741,174 04.47636	under structures	silt and clay	low
9, 3.5m	41 10.71486,174 04.51265	under structures	silt and clay	moderate
10, 3.6m	41 10.71170,174 04.54407	in consent	silt and clay	none
11, 3.4m	41 10.71504,174 04.57431	outside consent	silt and clay	none
12, 3.5m	41 10.71975,174 04.56208	in consent	silt and clay	none
13, 3.4m	41 10.70051,174 04.56241	outside consent	silt and clay	none

Photographs taken from areas alongshore and inshore of the existing farm structures showed no mussel shell debris adjacent to farming structures or outside of the consent area (e.g. photos 1, 10, 14, 16, 21) (Table 2, Appendix 1).
