Biological report for an off-site marine farm (MFL 99, No. 8393) located in Hikapu Reach, Pelorus Sound

Research, Survey and Monitoring Report Number 535

Rob Davidson and Laura Richards

January 2007

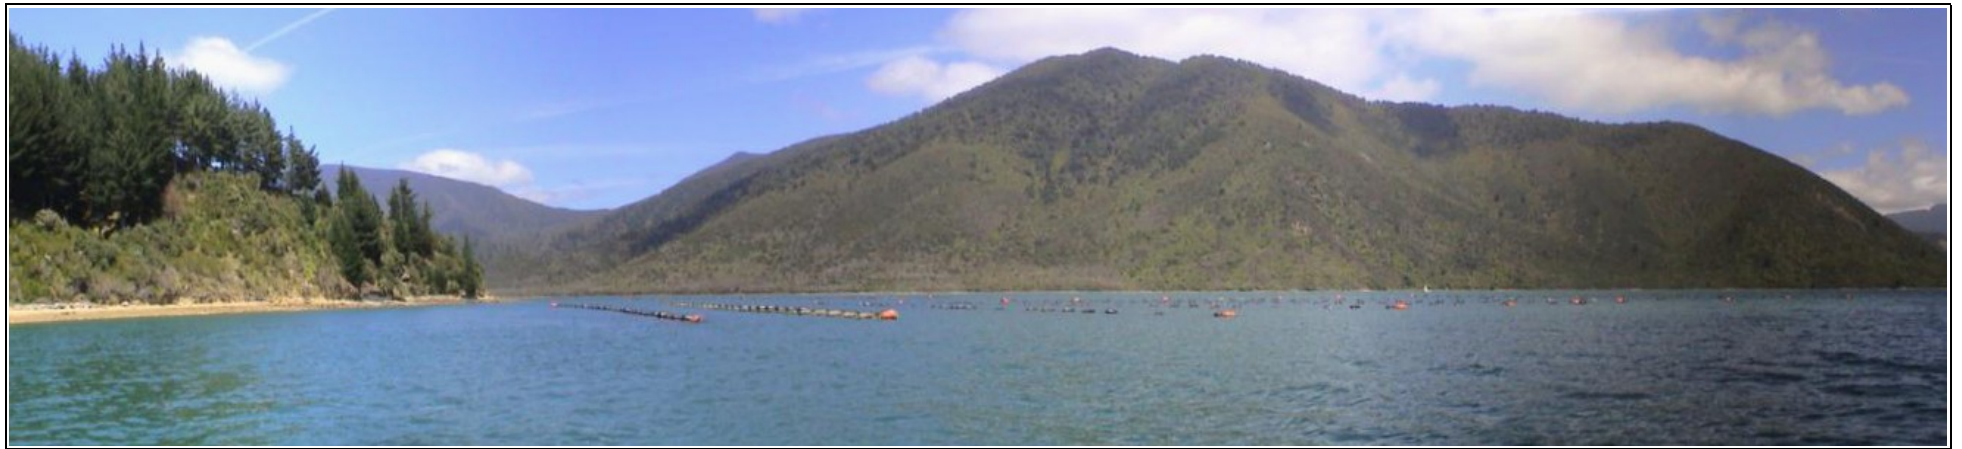
Plate 1. MFL 99, looking southward along the inshore lines.

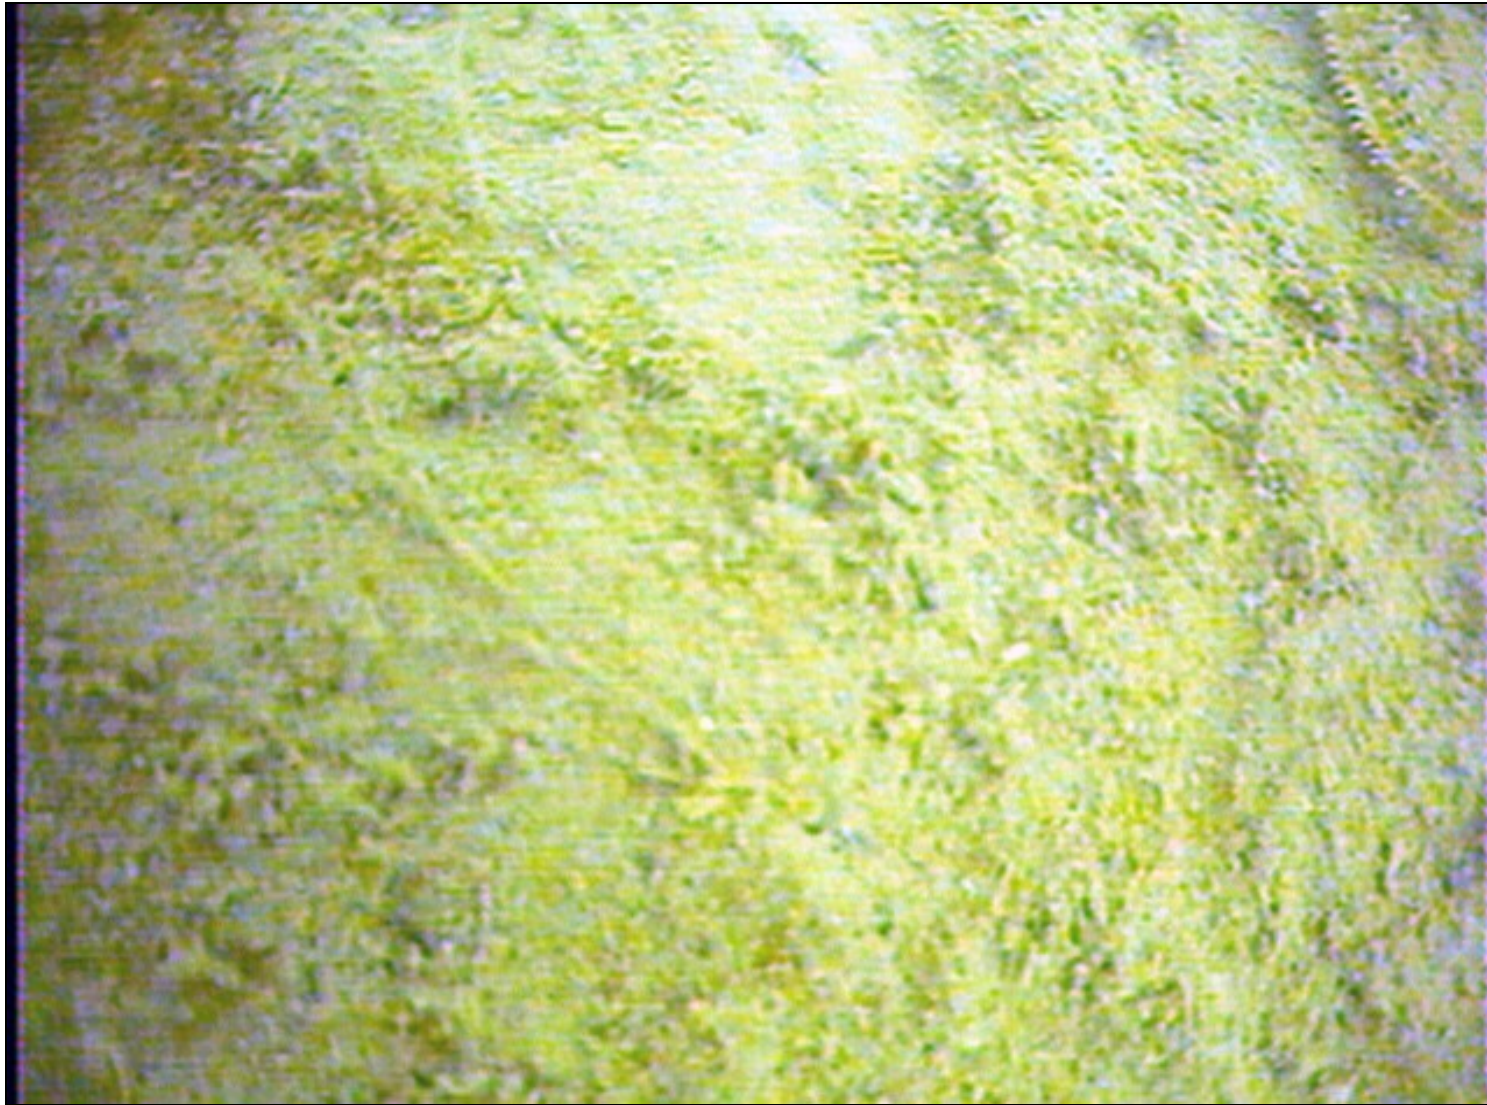
Photo 3

Substratum type is based on drop camera images (see photographs in Appendix 1). All areas photographed within the consent and offshore of the consent area were characterised by soft substratum (i.e. silt and clay). Mussel debris was observed from photographs collected directly inshore of the marine farm structures (photos 3 and 4, Table 2, Appendix 1).
