Engineering Report

Proposed Residential Dwelling

759 Kenepuru Road, Ohingaroa Bay, Mahau Sound

Project F06-1876

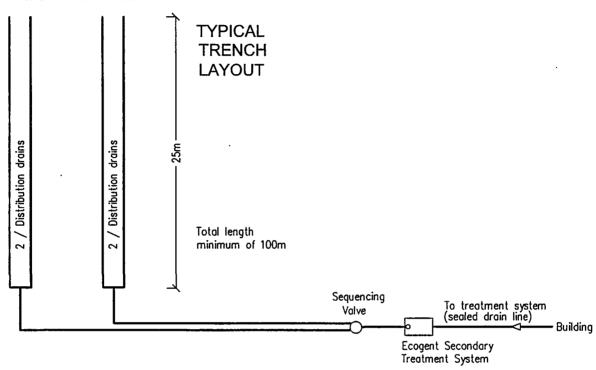
End cleanouts at ends of all distribution lines

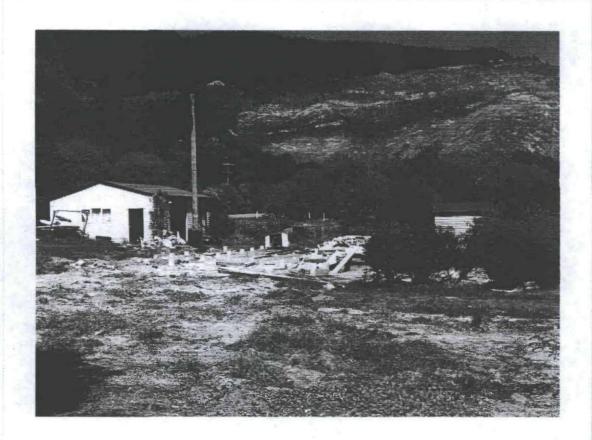
Photo 1: View looking to south towards existing garage and remaining building rubble.

The site was vegetated in lawn at the time of the investigation reported herein. The previously existing building at the site had been removed, although some building debris had yet to be cleared away, as can be observed in the site photographs appended to this report.

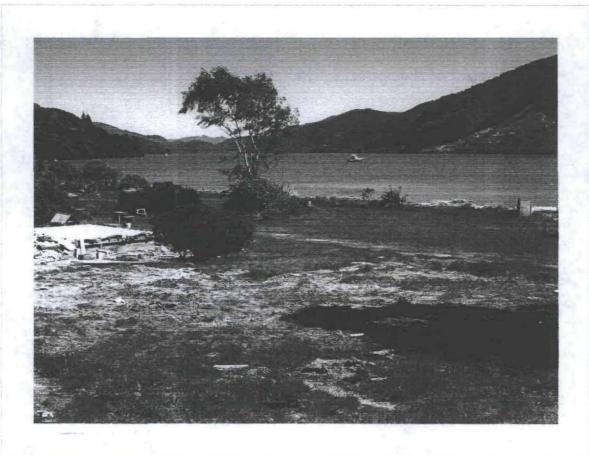
Photo 2: View looking to west towards Mahau Sound.

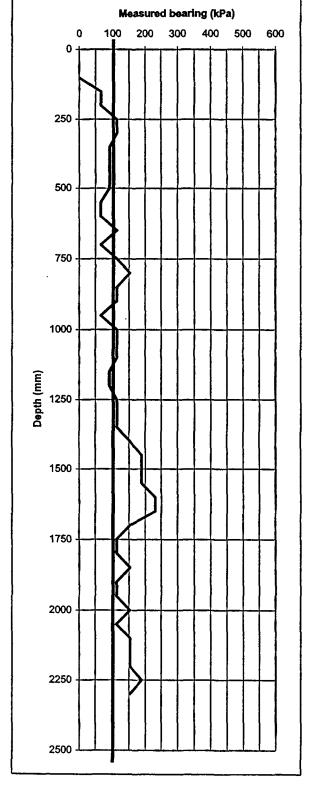
Test No P1

No. of	e (mm/blow)	Soil bearing	Depth (mm)
Blows		resistance	
		(kPa)	
	0	0	100
. 1	50	66	150
1	50	66	200
2	25	113	250
2	25	113	300
1.5	33	91	350
1.5	33	91	400
1.5	33	91	450
1.5	33	91	500
1	50	66	550
1 ,	50	66	600
2	25	113	650
1	50	66	700
2	25	113	750
3	17	153	800
2	25	113	850
2	25	113	900
1	50	66	950
2	25	113	1000
2	25	113	1050
2	25	113	1100
1.5	33	91	1150
1.5	33	91	1200
2	25	113	1250
2	25	113	1300
2	25	113	1350
3	17	153	1400
4	13	188	1450
4	13	188	1500
4	<u>.</u> 13	188	1550
5	10	231	1600
5	10	231	1650
3	17	153	1700
2	25	113	1750
2	25	113	1800
3	17	153	1850
2	25	113	1900
2	25	113	1950
3	17	153	2000
3 2 3	25	113	2050
3	17	153	2100
3	17	153	2150
3	17	153	2200
4	13	188	2250
3

On the basis of the recorded compactness, the soil bearing resistance (scala penetrometer) will generally exceed 100 kPa at depths exceeding approximately 0.5m, which should be suitable for the proposed residential development at the site and the construction of conventional shallow foundations constructed in accordance with NZS 3604:1999.

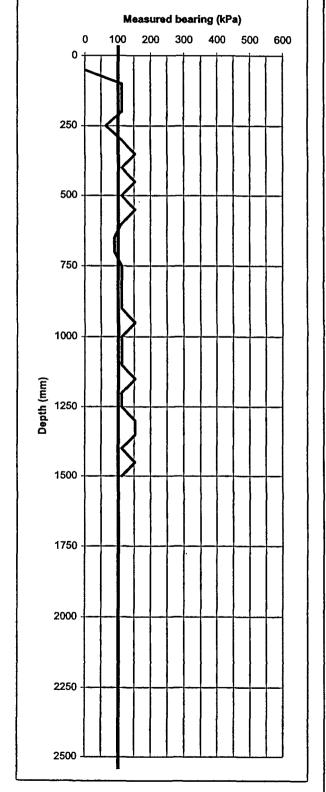
Test No P2

No. of Blows	e (mm/blow)	Soil bearing resistance	Depth (mm)
:		(kPa)	1
	0	0	50
2	25	113	100
2	25	113	150
2	25	113	200
1 2 3	50	66	250
2	25	113	300
3	17	153	350
2	25	113	400
3	17	153	450
2	25	113	500
3	17	153	550
2	25	113	600
1.5	33	91	650
1.5	33	91	700
2	25	113	750
2	25 25	113	800
2	25 05	113	850
2	25	113	900
3 2	17 25	153	950
2	25 25	113	1000
2	25 25	113 113	1050
3	17	153	1100 1150
2	25	113	1200
2	25 25	113	1250
2 3	17	153	1300
3	17	153	1350
2	25	113	1400
3	17	153	1450
2	25	113	1500
		•

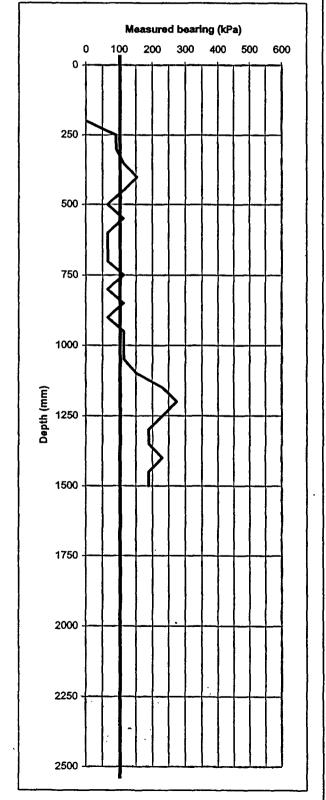
Test No P3

No. of Blows	e (mm/blow)	Soil bearing resistance (kPa)	Depth (mm)
	0	0	200
1.5	33	91	250
1.5	33	91	300
2	25	113	350
3	17	153	400
2	25	113	450
1	50	66	500
2	25	113	550
1	50	66	600
1	50	66	650
1	50	66	700
2	25	113	750
1	50	66	800
2	25	113	850
1	50	66	900
2	25	113	950
2	25	113	1000
2	25	113	1050
3	17	153	1100
5	10	231	1150
6	8	275	1200
5	10	231	1250
4	13	188	1300
4	13	188	1350
5	10	231	1400
4	13	188	1450
4	13	188	1500
-
