### **Residential Development**

- **Engineering Report**
- St Omer, Kenepuru Sound**

**09 July 2014**

Jeff and Trish Pearse  
 Site Development  
 St Omer, Kenepuru Sound

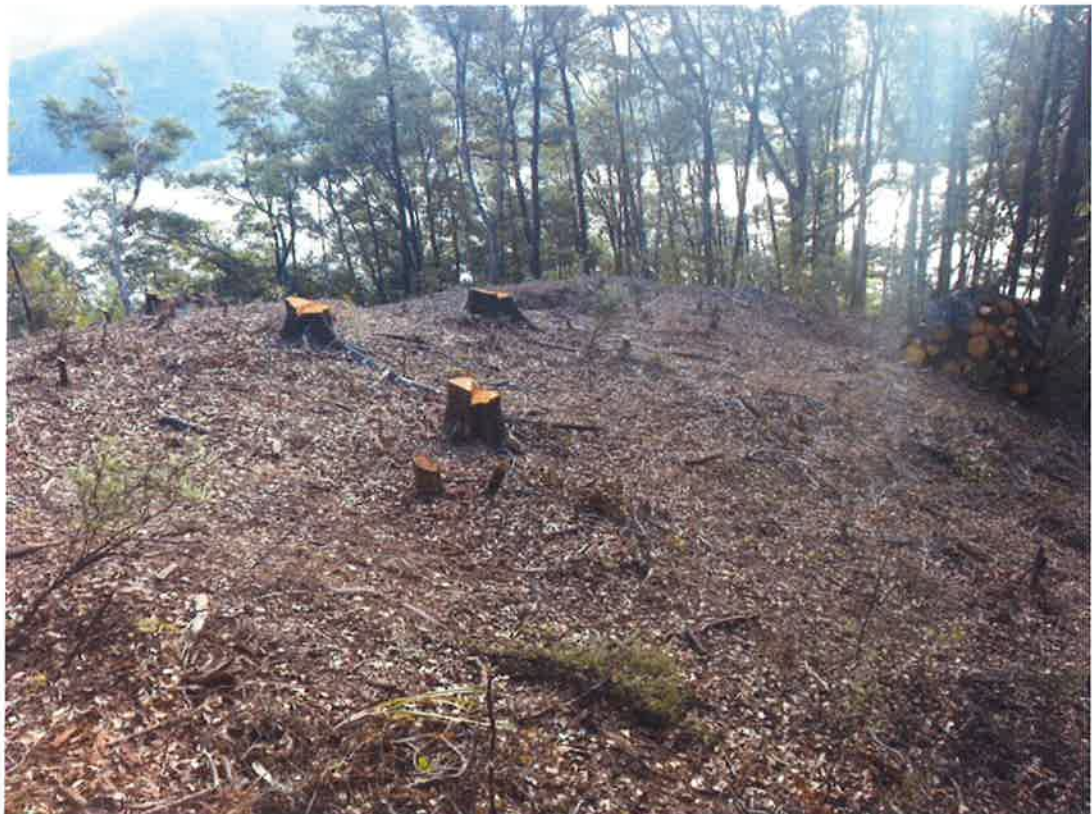
Building site looking north

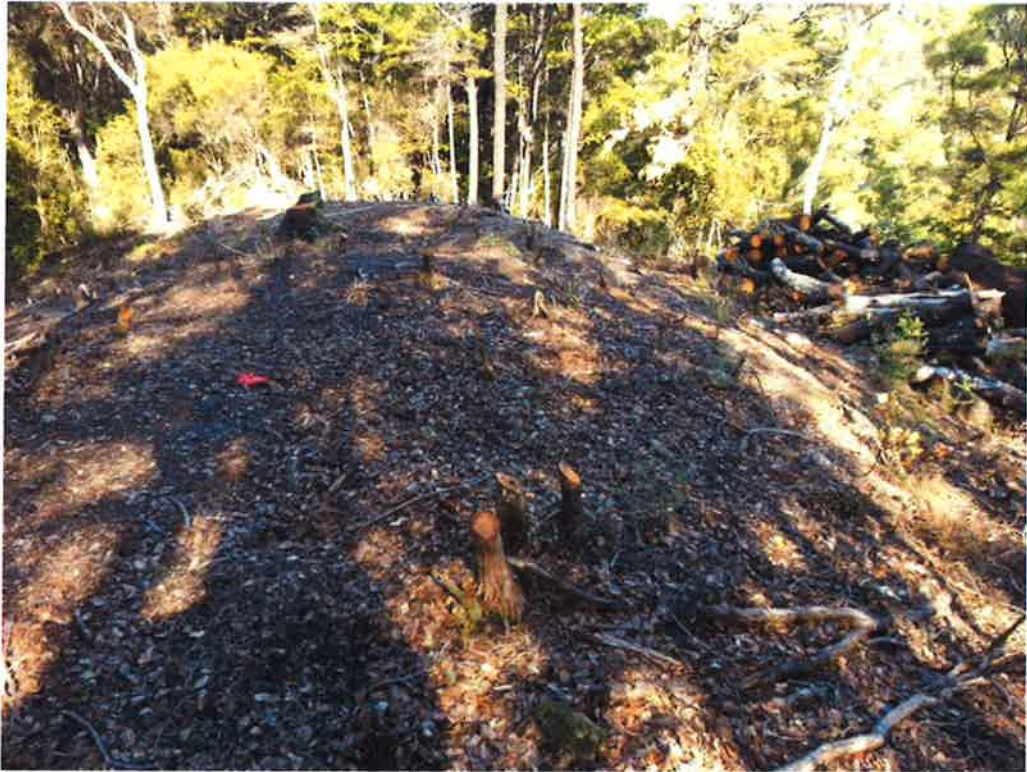
Building site looking south

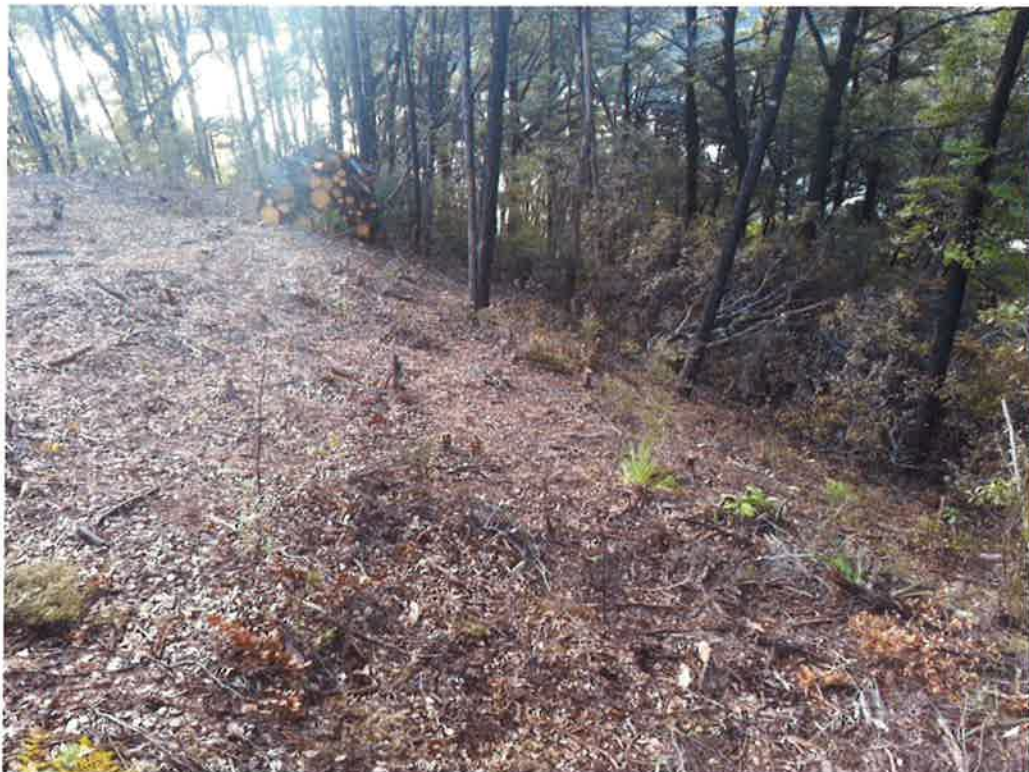
Main wastewater field location

The proposed land application area is to be split into two. One field to the northwest and the other to the north east (downhill) of the proposed building site on a moderate to steep northerly facing slopes, exposed to both sun and wind. The slopes are covered in dense regenerating native bush and beech trees.

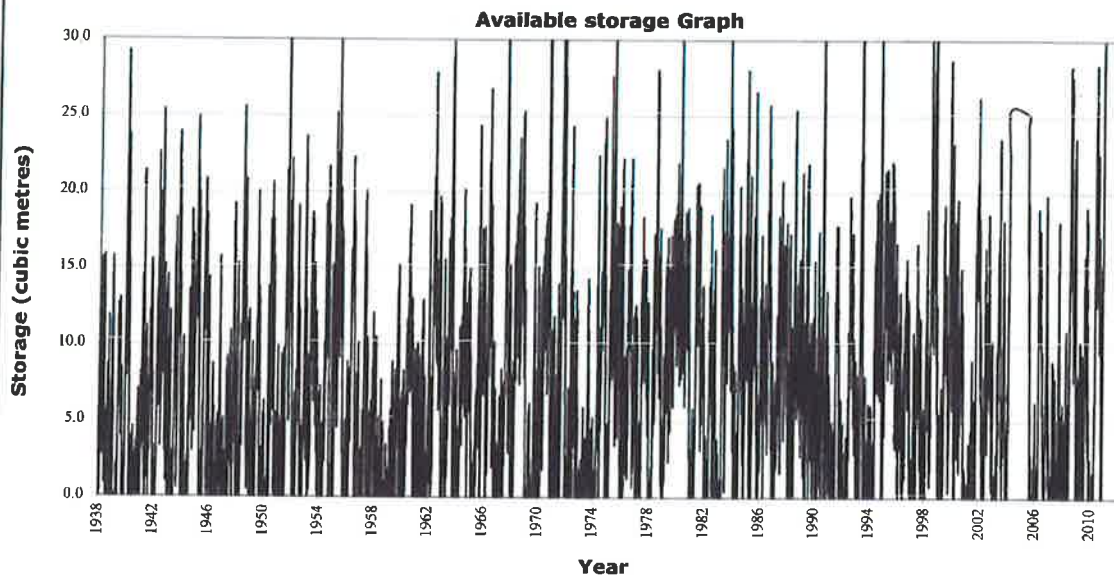
<b>Average empty days per year</b>	<b>70</b>
<b>Average days per year tanks full</b>	<b>1</b>
<b>Average days per year water short useage</b>	<b>326</b>
<b>Maximum days usage without recharge</b>	<b>45</b>

**Note: Deisgn based on water shortage use at water shortage trigger volume**

**This spreadsheet is based on the water supply spreadsheet supplied by the Marlborough District Council. Rainfall figures have been supplied by the Marlborough District Council from 1938-2010.**

It is recommended that tank/s giving a total minimum storage capacity for domestic use of 30,000 litres be installed for any proposed dwelling of this size (around 120m<sup>2</sup>).
