GEOTECHNICAL REPORT

BLACKWOOD BAY LTD
BLACKWOOD BAY

**GEOTECHNICAL REPORT
BLACKWOOD BAY LTD
BLACKWOOD BAY**

LOCATION DETAILS: Blackwood Bay

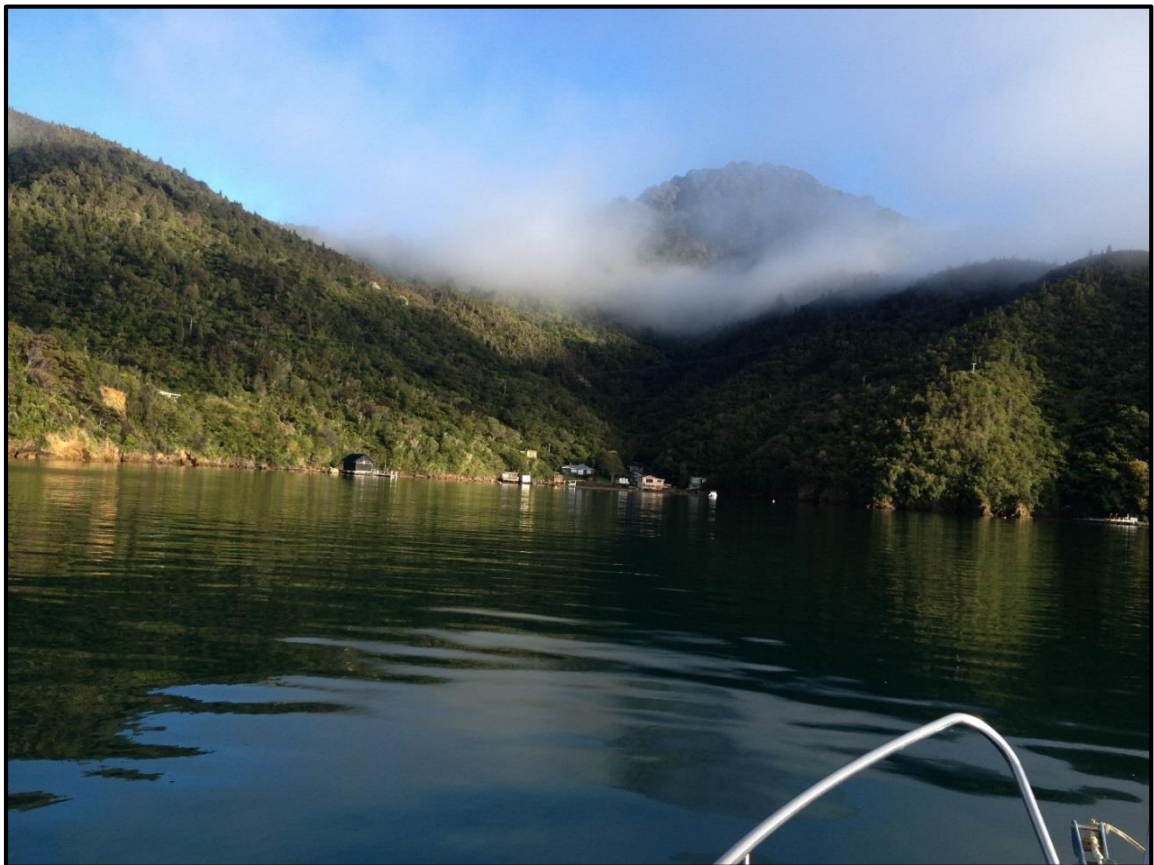
The property (Pt Lot 2 DP 1045) is located on the western side of Blackwood Bay and consists of south, east and west facing, moderate to steep slopes which are well vegetated with regenerating natives.

A water course bisects the property and is piped through the low lying, flat area where most of the dwellings are located, before discharging at the beach.

View from the South

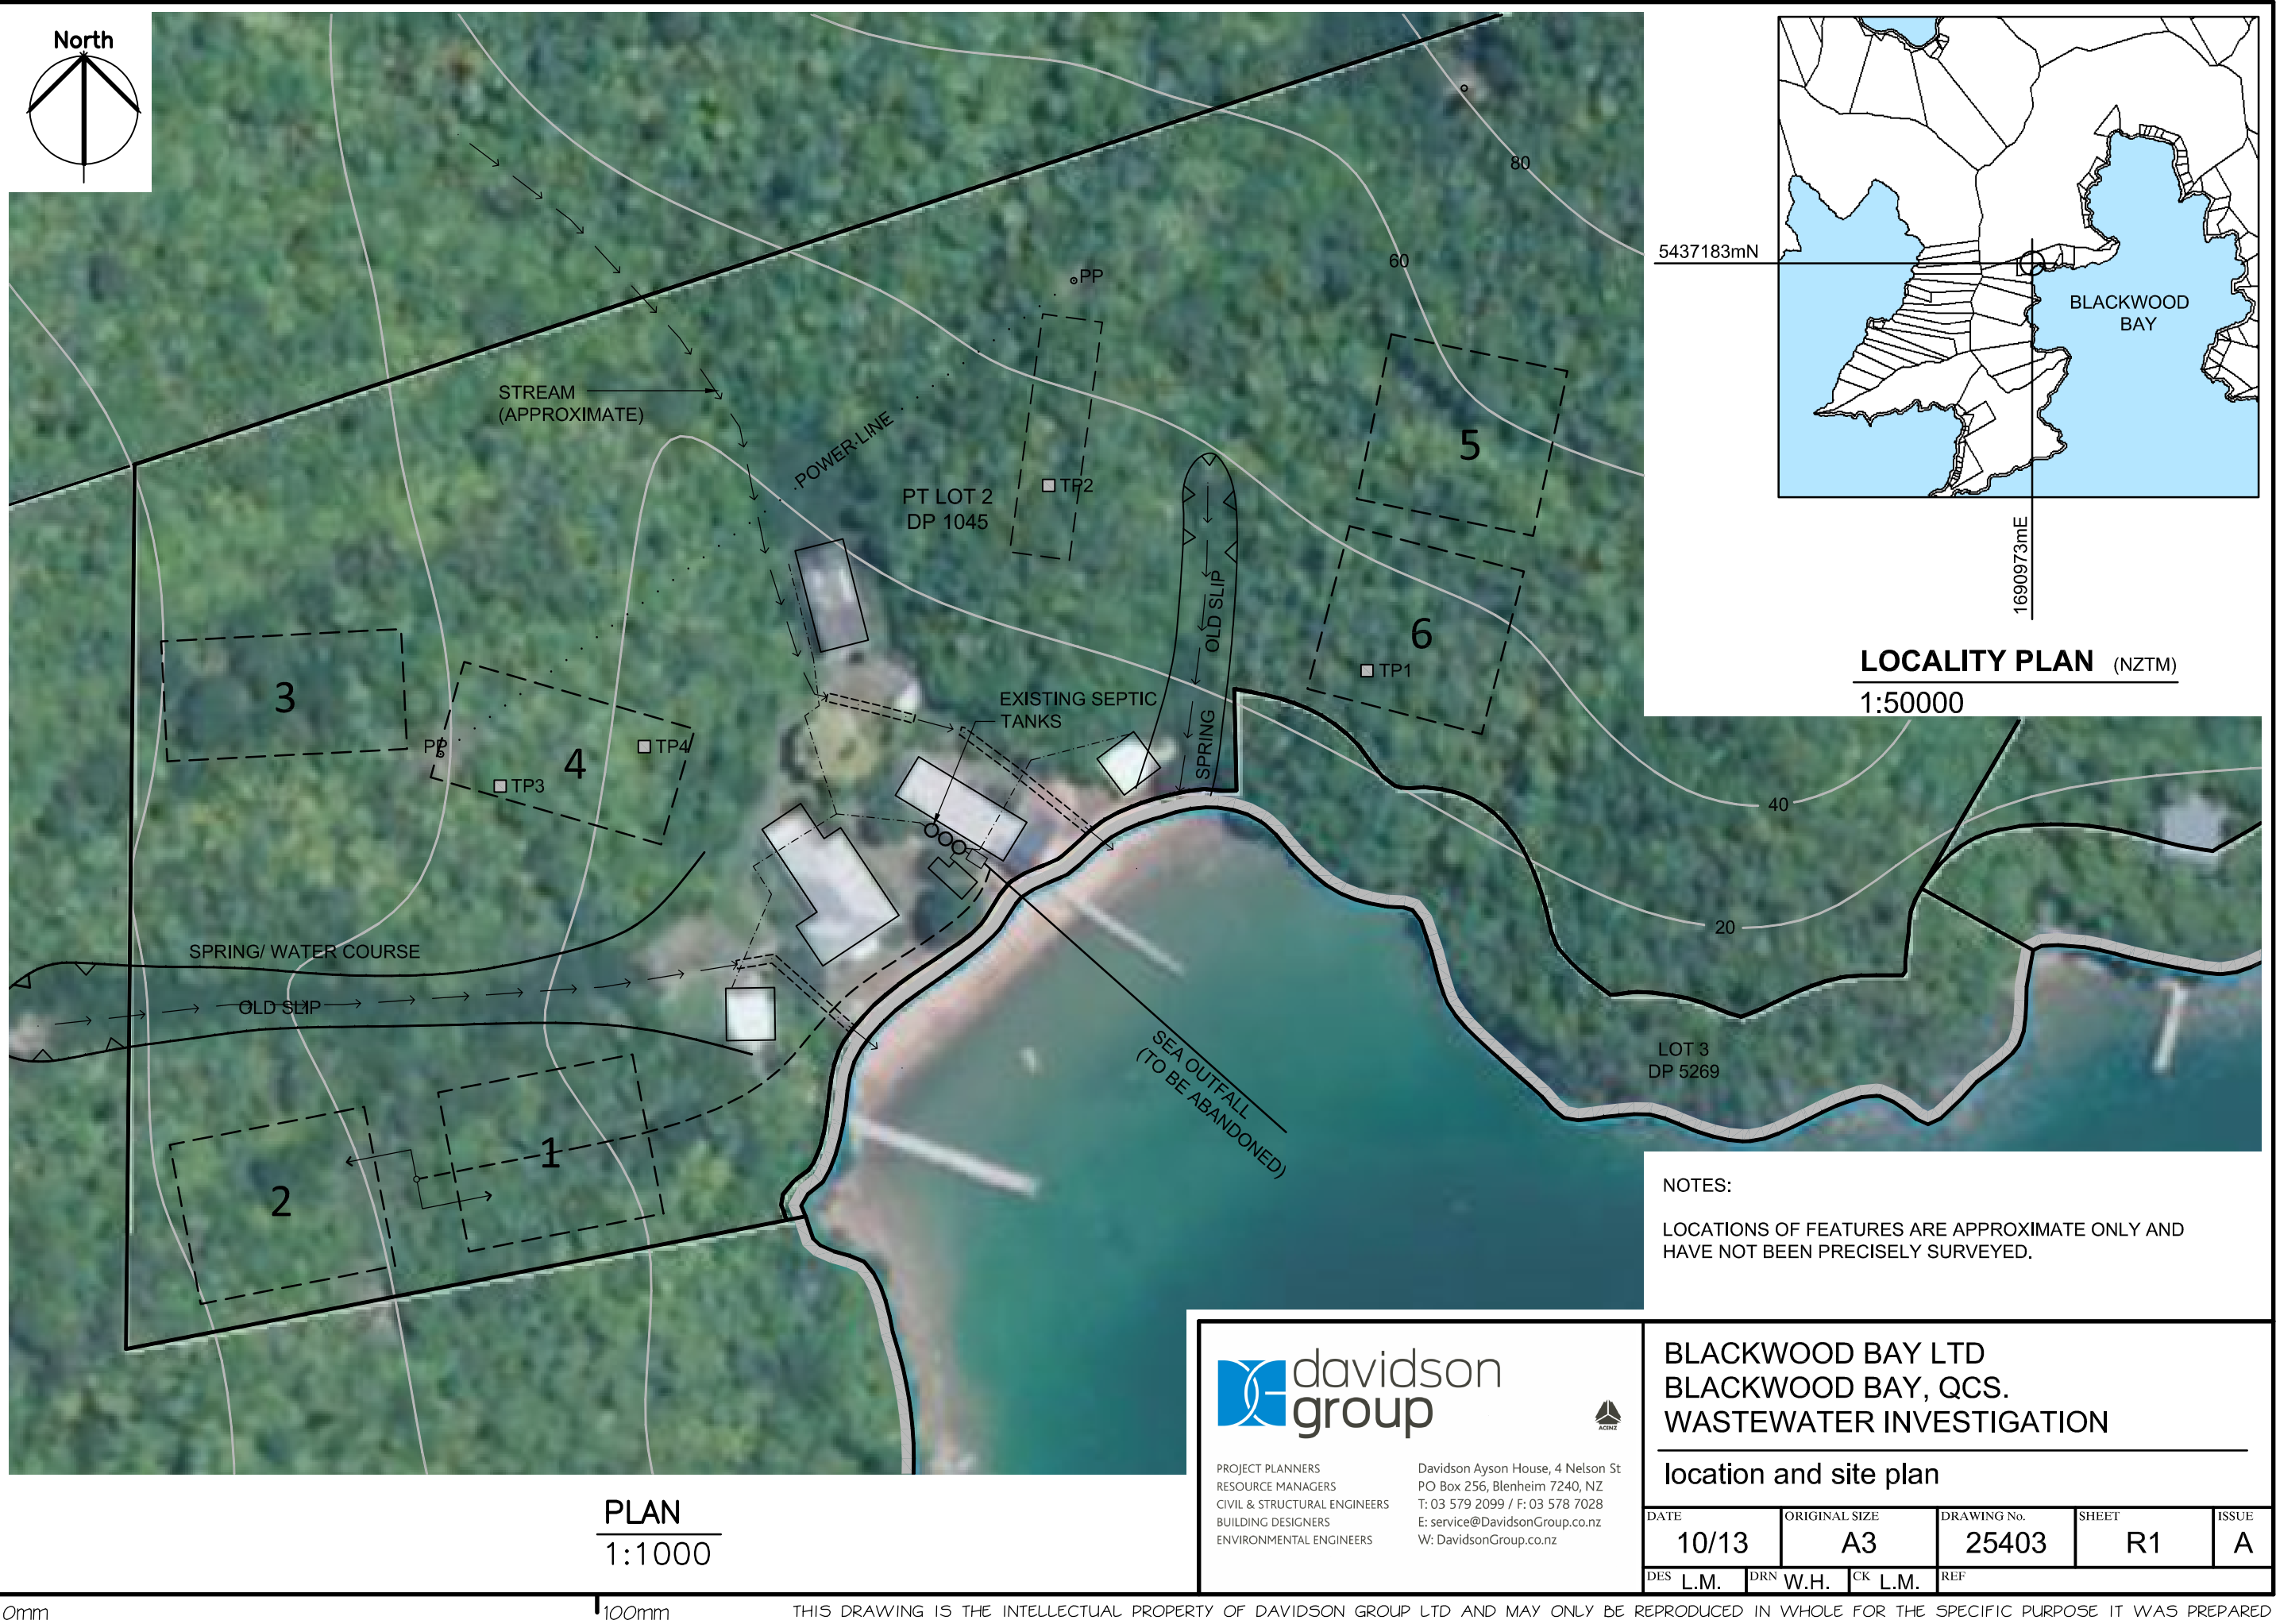
location and site plan

A geomorphological walkover survey was undertaken over the proposed disposal areas. Rock fragments were present on the surface and some slopes were over 30°. A recent slip (probably within the last decade) was noted west of the cottages in the form of a long, narrow slide in a gully, as shown on the drawing attached.

The rock debris on the slopes indicate past movement, but apart from one recent slip in a gully, there was no recent or active instability on the slopes inspected.

Nevertheless, gullies should be avoided and ridges and side faces should be used for LAA's, preferably areas 1 - 4 on the western side.

- a) the areas identified as 1 - 4 on drawing number 25403 / R1 be used as land application areas only, and
- b) the land application be restricted to irrigation methods only at a maximum application rate of 2.0 mm/day with the lines spaced at 1.5 m centres around even contours.

The areas identified as suitable for LAA's are considered to have a low to moderate risk of instability and the use of these areas for wastewater application is expected to have a negligible increase in the instability risk if the land application method is restricted to drip irrigation at less than 2 mm/day.
