## **Preliminary Geotechnical Assessment of Proposed Winery Building, Ara Winery, Waihopai Valley**

Wine Growers of Ara  
Ara Winery – Proposed Winery Building

T&T Ref: 42866  
19 December 2012  
MARLBOROUGH  
DISTRICT COUNCIL

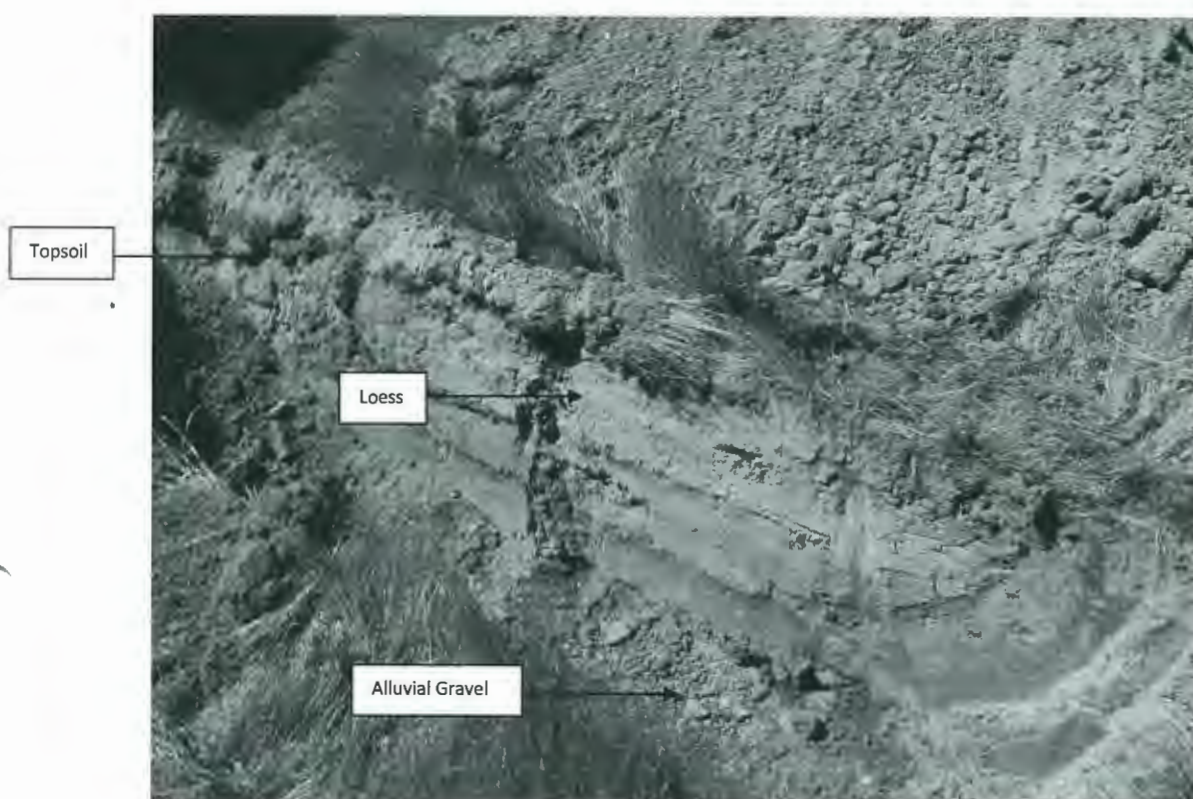
Where the ground profile is slightly elevated, more silt is present (i.e. TP3). Where the ground profile is lower, much of the silt is removed. The lower lying ground is likely to represent the location of stream channels that previously ran across the terrace surface. These channels would have stripped the silt mantle.

Photograph 2 Soil profile at the proposed site (TP3)

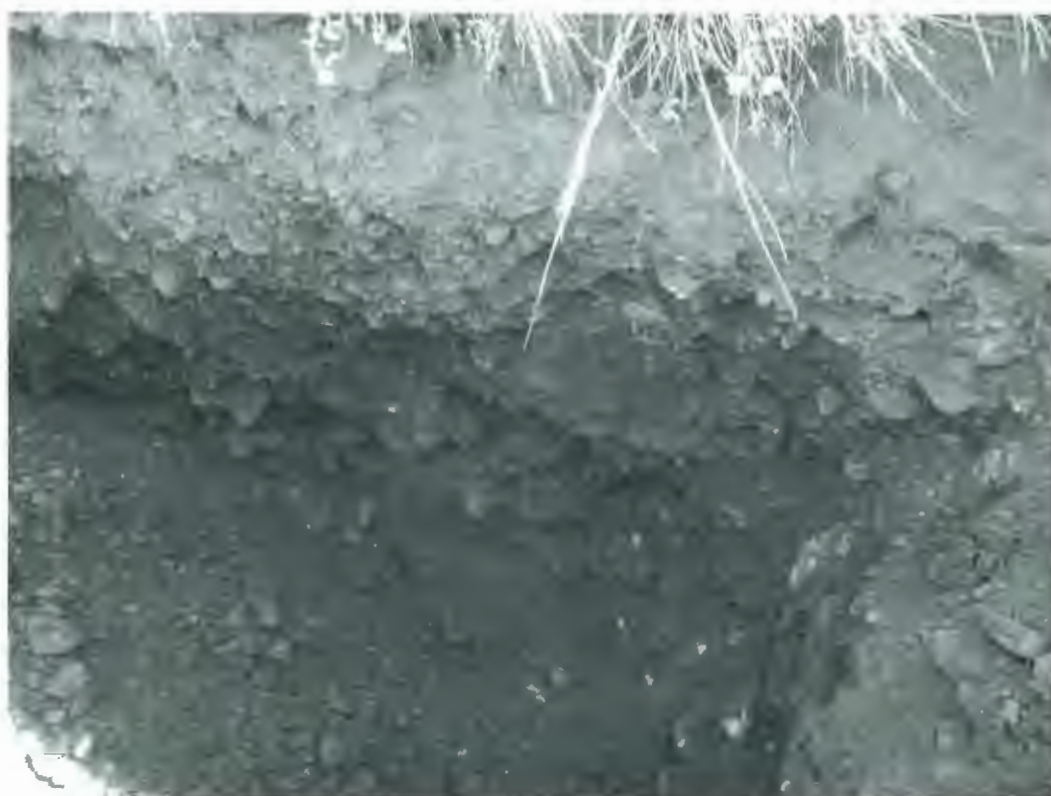
Photograph 3 Typical appearance of alluvial gravels (TP1)

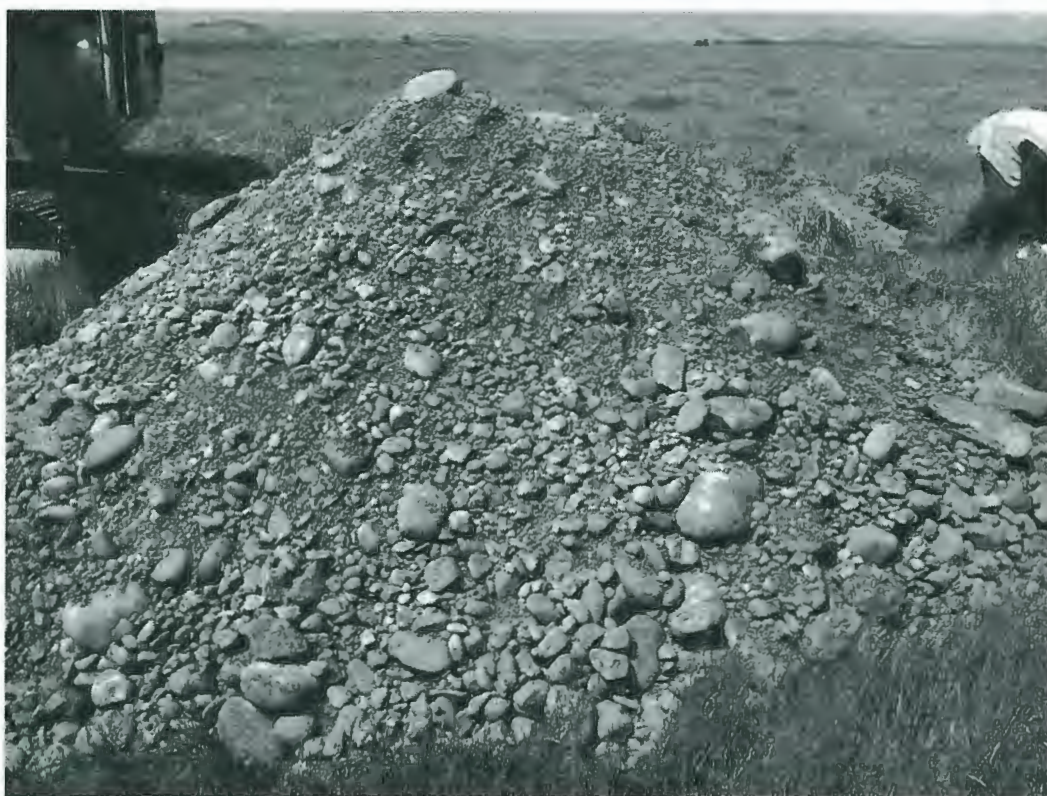
Photograph 4 Typical alluvial gravels (TP4)

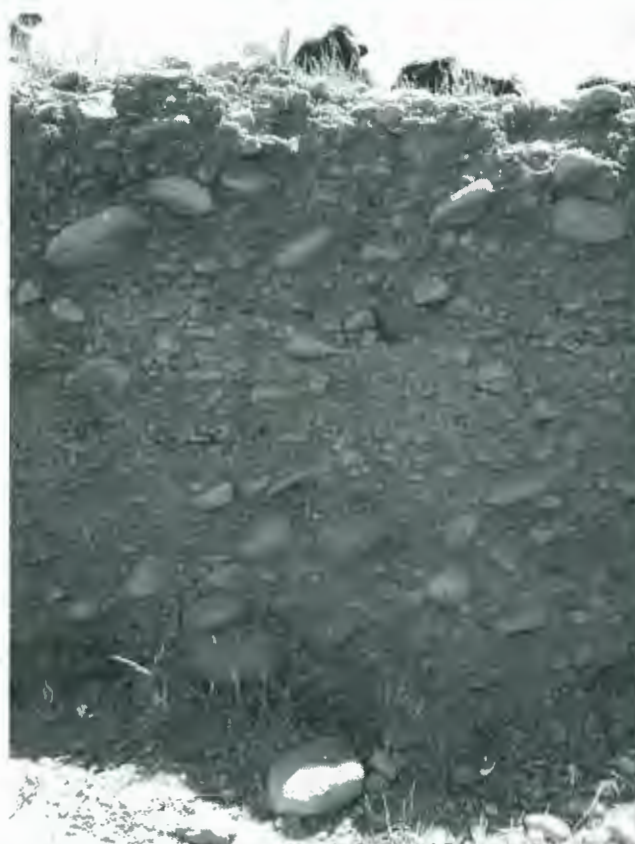
As part of this investigation we also inspected the exposures on the terrace riser. The geology was observed in discontinuous exposures on the slope face and down an access track. The exposed geology was consistent with what was observed in the test pits. There was no evidence of any loose sand or silt layers within the gravels.

Photograph 5 Example alluvial gravel exposure on terrace riser face

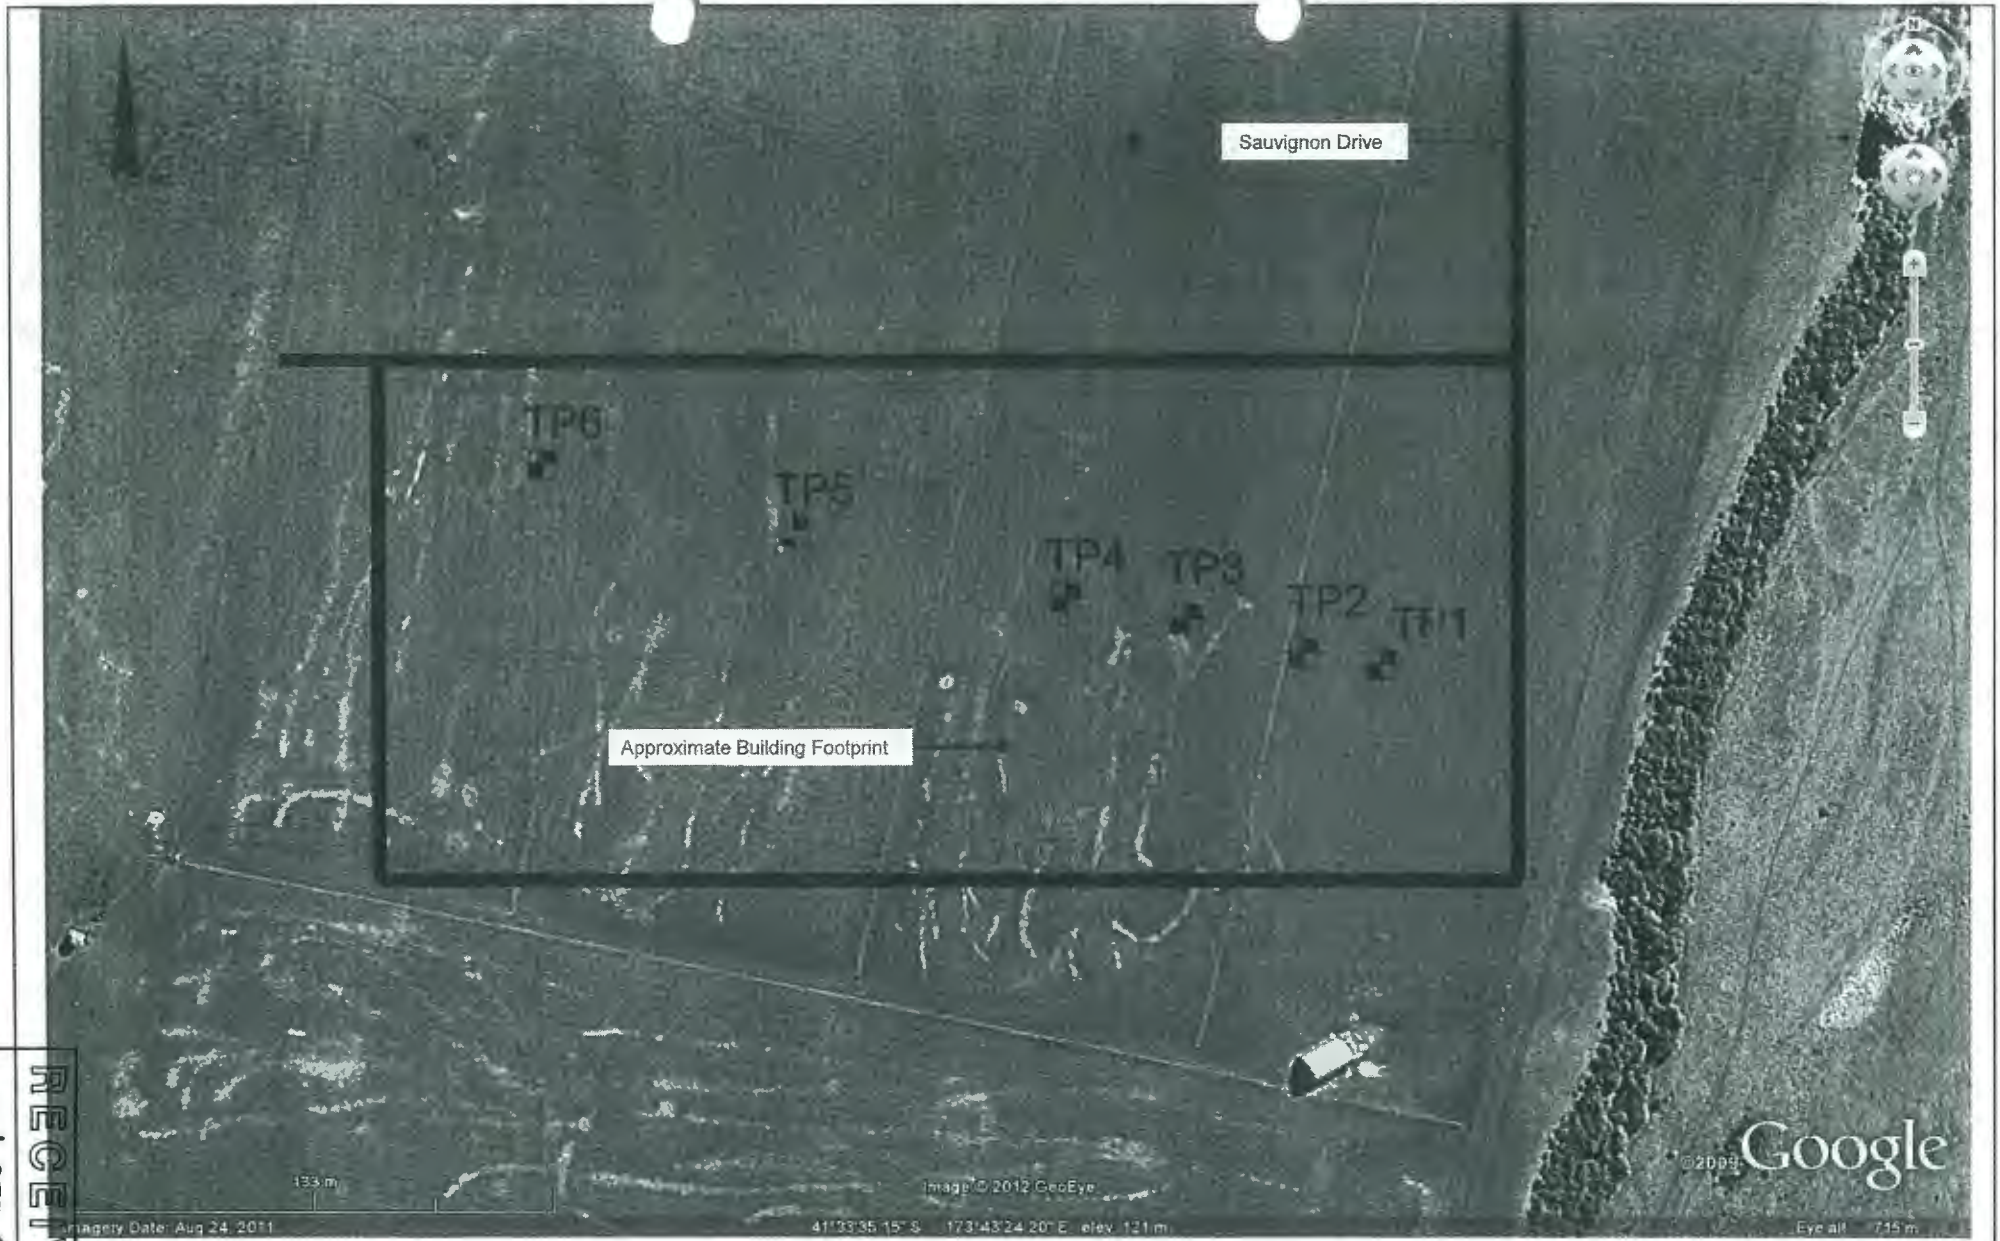
Figure 3 Test Pit Investigation Plan

We completed 6 test pits at the site on 8 November 2012. The test pit locations are shown in Figure 3 attached. The test pit logs are also attached. Based on our observations and the 6 No test pits, the typical soil profile at the site is summarised in Table 1.

Test Pit locations are approximate only  
 Aerial Image taken from Google Earth  
 Scale as shown
