**REPORT ON AN EXISTING
WASTEWATER SYSTEM FOR
SERENDIP RETREAT LTD**

**Our Ref: 26783
Date: May 2019**

REPORT ON AN EXISTING WASTEWATER SYSTEM FOR SERENDIP RETREAT LTD

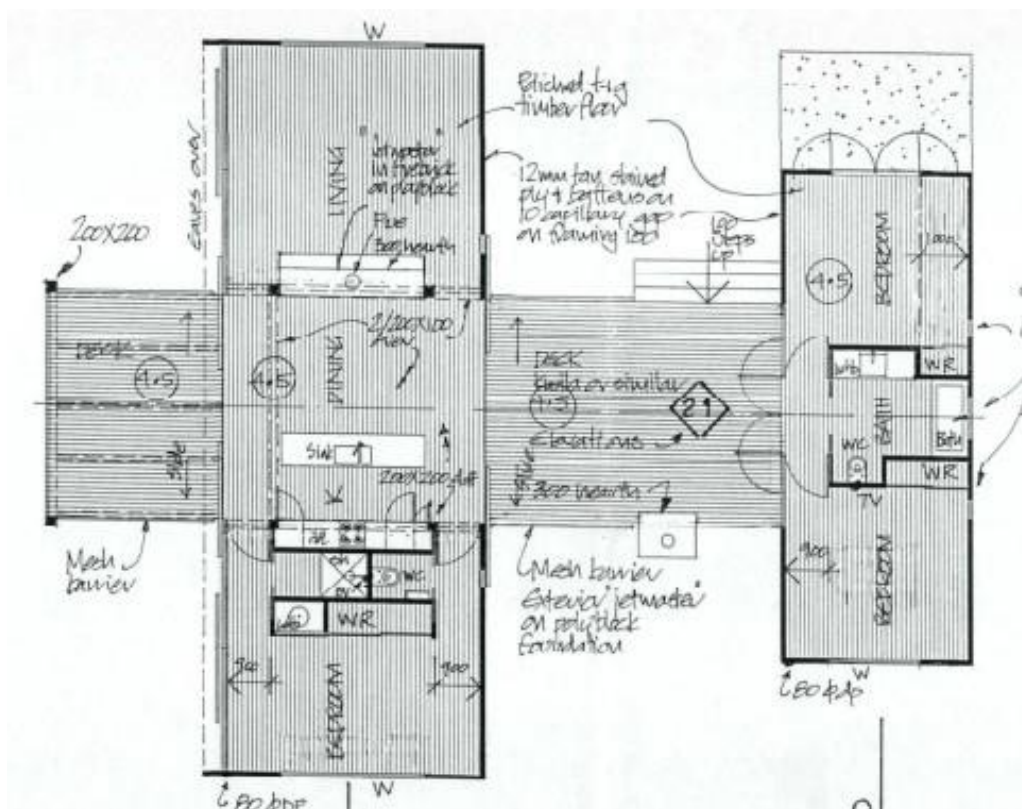
Floor Plan

The house has 3 bedrooms and there are no other office or rumpus rooms which could be considered as potential bedrooms.
