## KAKARA RESERVOIR DAM DESIGN REPORT

**Report prepared for:** Kakara Estate Ltd

**Report prepared by:** Titus Smith, Civil Engineer, CPEng

**Report Reference:** 08822-E

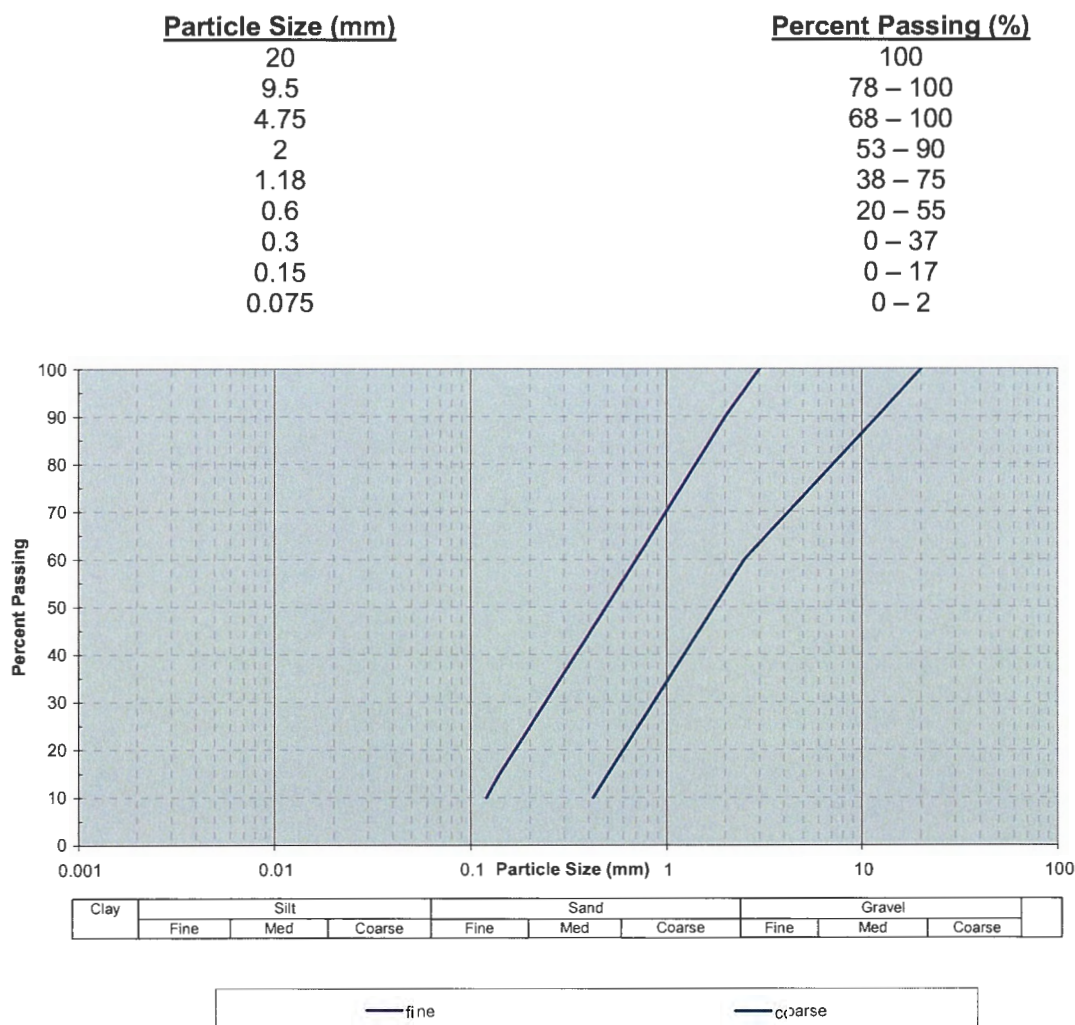
Figure 4.3: Plot of filter drainage envelopes

The dam fill material is a silty gravel or type 3 to 4A material (i.e. up to 35% fines after re-grading). The silt lenses in the dam foundation are a Type 2A material (i.e. up to 85% fines) and require a relatively fine filter ( $D_{15}$  of less than 0.7 mm). A suitable drainage material compatible with both the gravel and the silt lenses is selected as shown below and in Figure 4.3.

Filter compatibility had been checked for the interface between the drainage material for the cut-off and toe drains, the gravel earthfill, and the silt lenses found in the dam foundations. Filter/drainage material grading has been determined as per the USDA-SCS (1994) method modified by Fell et al (Ref 3). This method incorporates limitations to the design filter/drainage gradings to ensure adequate:

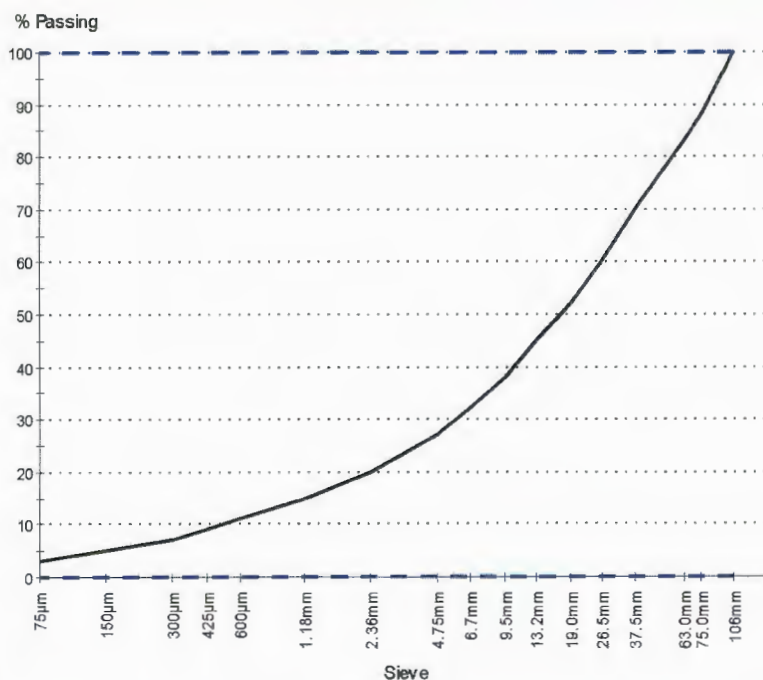
### Particle Size Distribution

**Method:** NZS 4407:1991 Test 3.8.1  
**Drying by:** Oven

**Note:** Percentage passing the finest sieve was obtained by difference.
