Engineering Geology Ltd
CONSULTING GEOTECHNICAL, GEOLOGICAL AND EARTHQUAKE ENGINEERS

Ref: 6266

**KEIRON MCKEE
CABLE STATION ROAD, SEDDON
WATER STORAGE DAM
RESOURCE CONSENT APPLICATION
Technical Report**

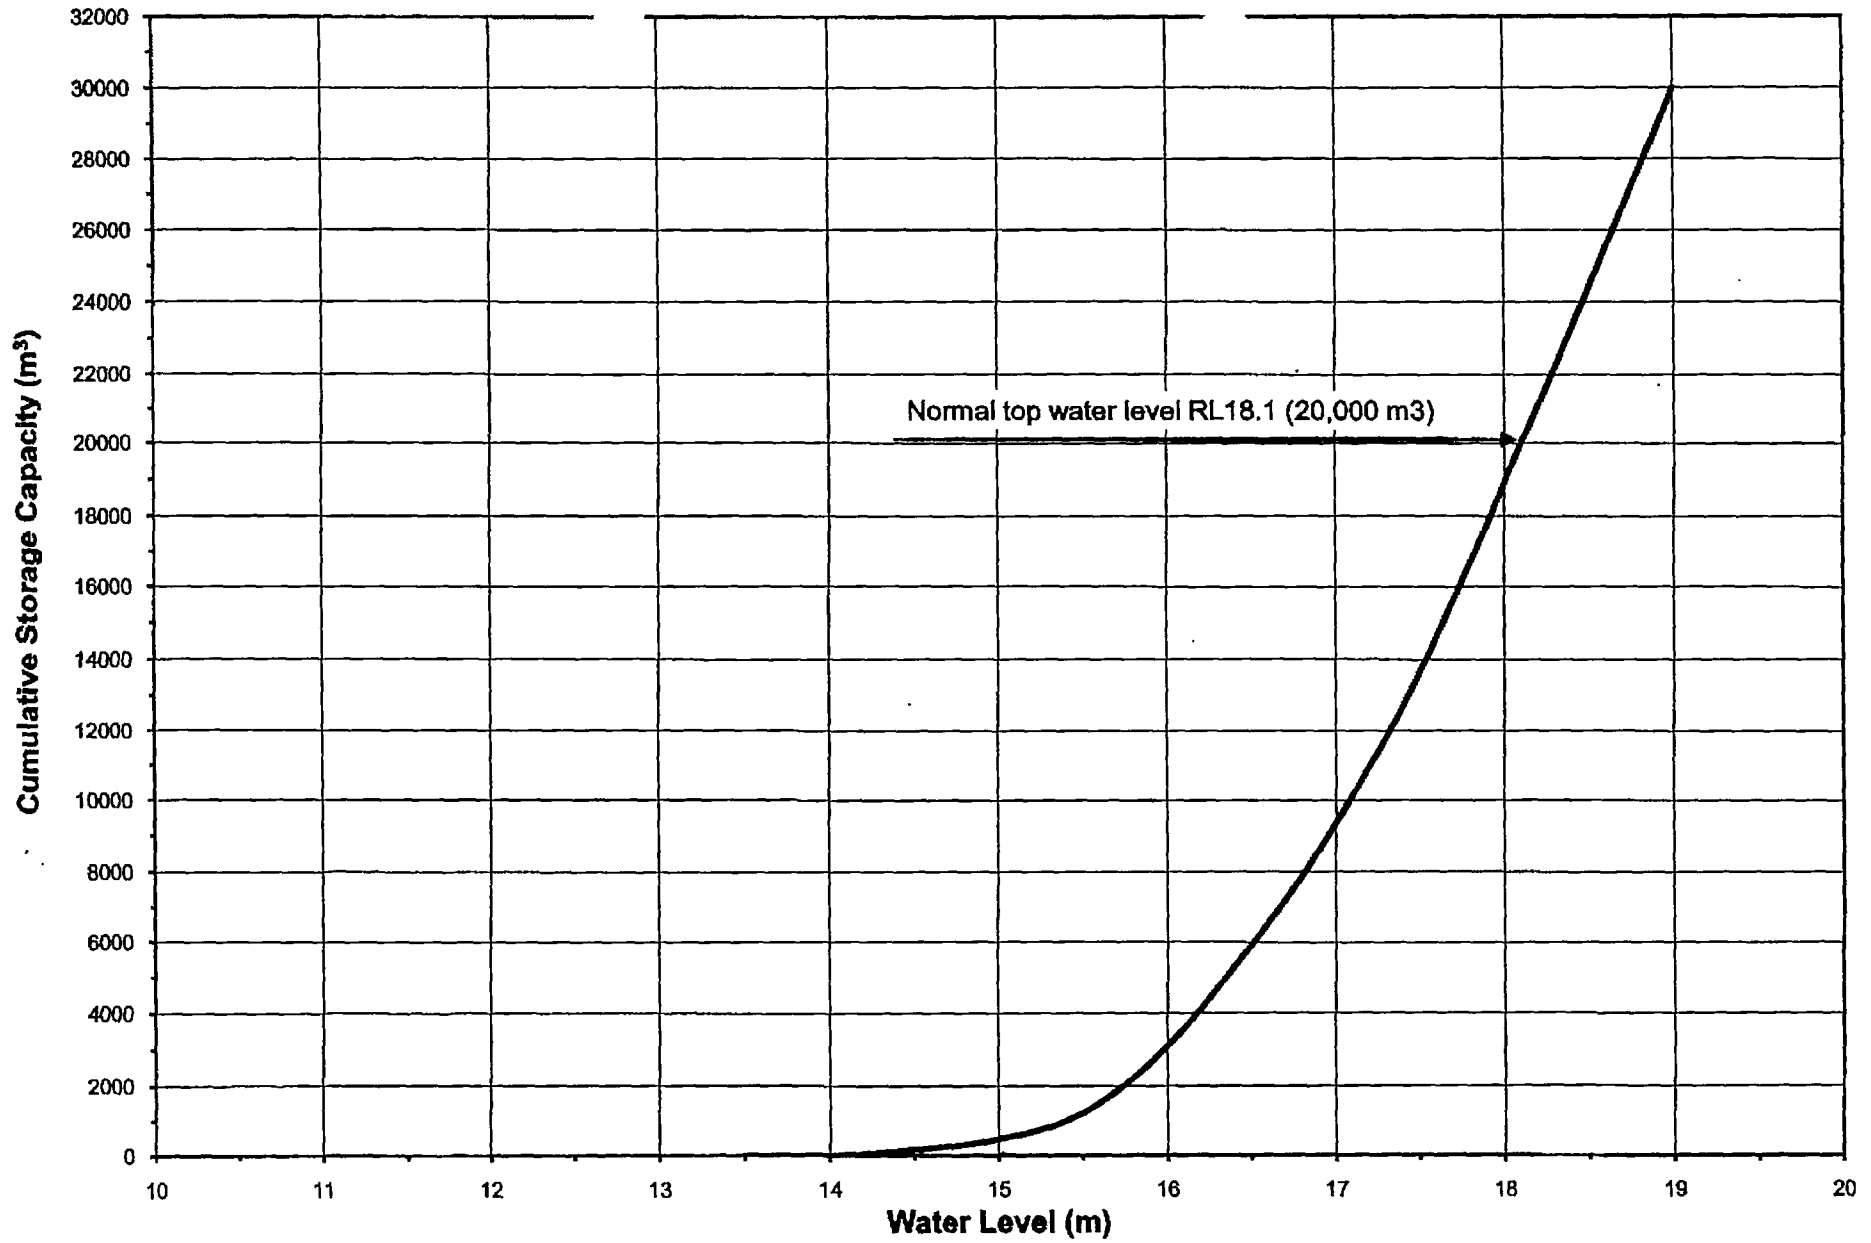
Figure 5

Height Storage Curve for K McKee Dam

The dam will form a reservoir to provide a storage capacity of up to 20,000m³. Approximately 7,000m³ of this storage is obtained by excavation of material from within the reservoir footprint to construct the dam. The height-storage curve for the reservoir is shown on Figure 5.
