Constellation Brands NZ Ltd

Hillersden Reservoir

**Technical Report in Support of Resource
Consent Application**

October 2016

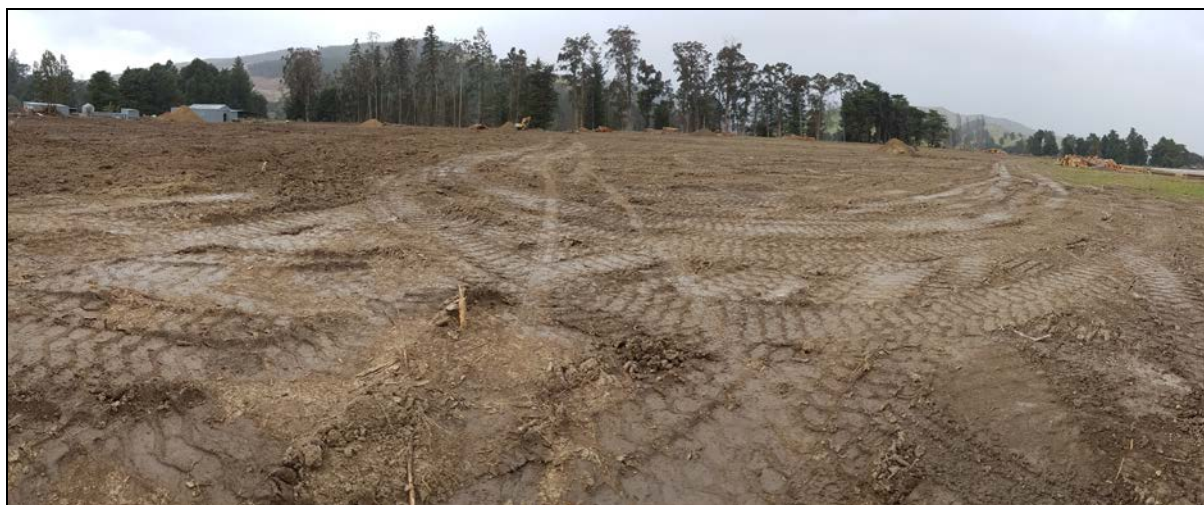
Panorama photo looking south towards the proposed reservoir (note test pit locations).

Field investigations were carried out on 7 September 2016 with the help of a 20 tonne excavator and five test pits were dug around the site, with depths ranging from 4.8 to 5.6m. Refer to the concept reservoir plan, attached in Appendix A, which shows the location of the test pits (Test Pit A to Test Pit E).

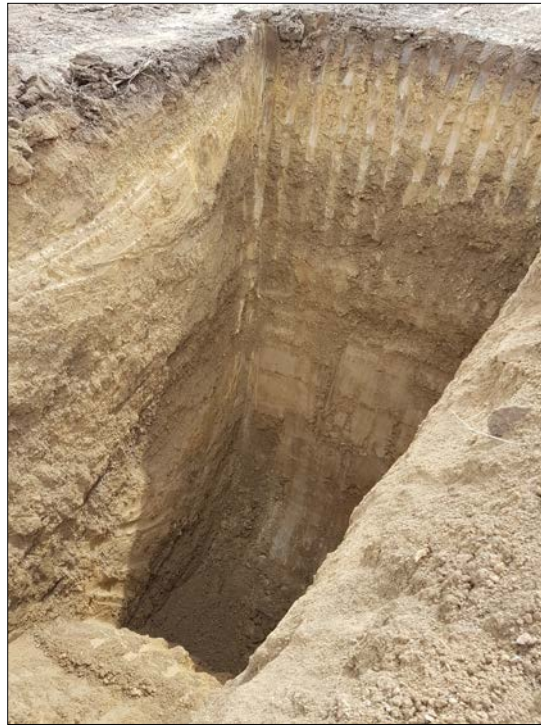
Photo of Test Pit A showing typical soil layers.

Test pits A, C and E all show similar soil profiles, being:

- a 0.25m thick layer of dry, dark brown, silty topsoil with roots, over;
- a 0.35 to 2.15m thick layer of dry, yellow/brown, silty clay with minor fine gravel intrusions, over;
- a 1.1 to 2.3m thick layer of dry, yellow/grey sandy gravels ranging from 0 – 100mm with lenses of finer, open gravels ranging from 0-100mm. In Test Pit A the moisture in this sandy gravel increased with depth and a minor amount of water seeped out of the bottom of this layer. In Test Pits C and E this layer was dry.

- a 1.1 to 1.8m thick layer of moist, yellow/brown, silty clay, over;
- yellow/grey sandy gravels ranging from 0 – 100mm with lenses of finer, open gravels ranging from 0-100mm. In Test Pit A minor free water seeped out of this layer. In Test Pits C and E this layer was dry.

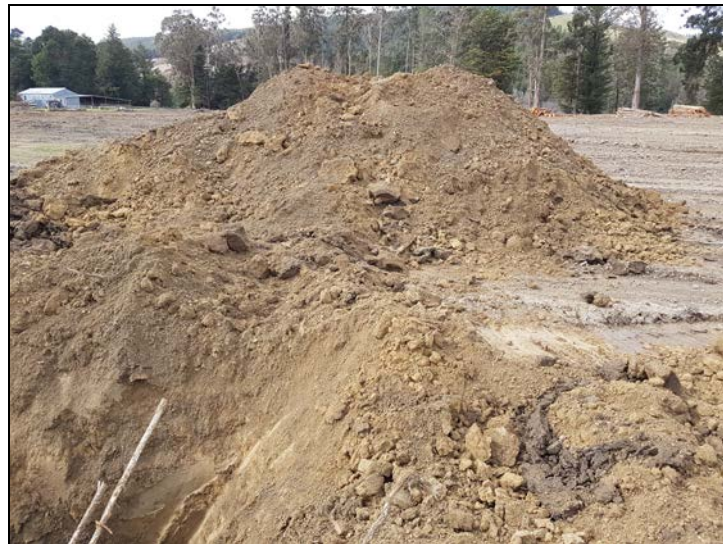
Photo showing material excavated from Test Pit A.

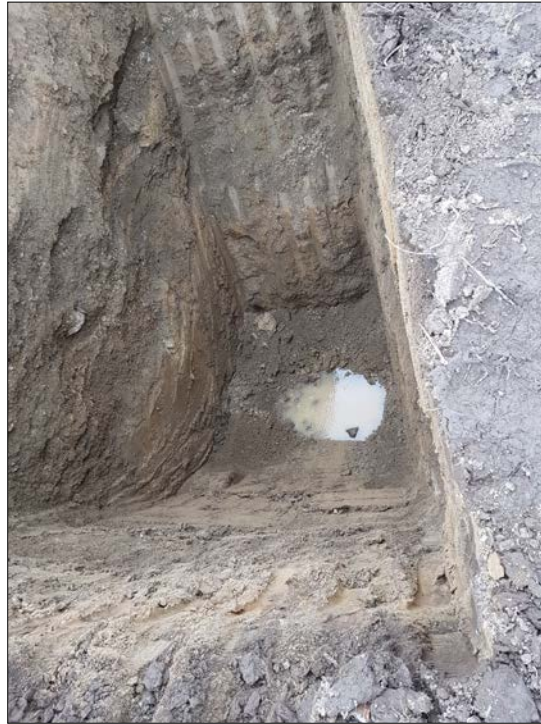
Photo showing water collected in Test Pit A after 1.5 hours.

Even Test Pit A did not intercept much groundwater and after 1.5 hours only some 100mm of water had collected in the bottom of Test Pit A, as can be seen from the photo below.

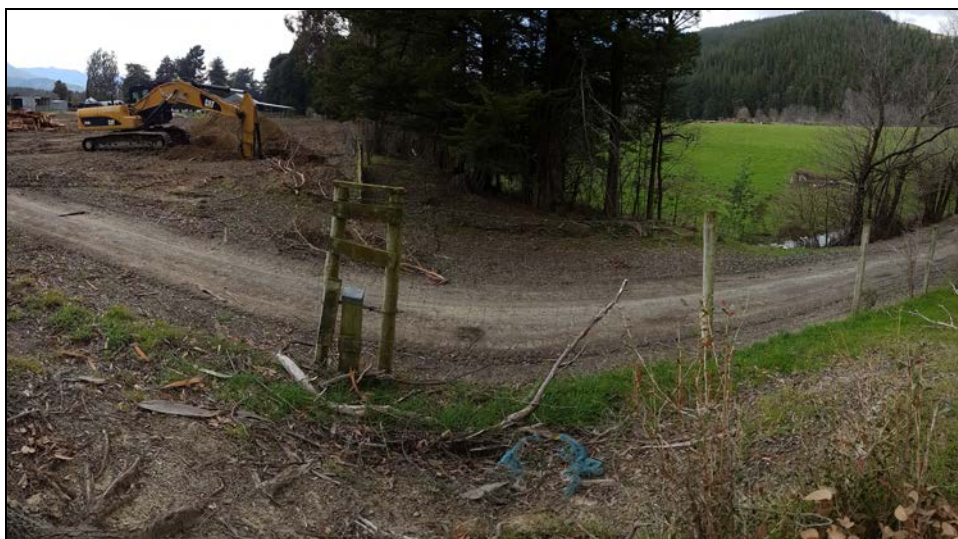
Photo looking west showing Test Pit E being excavated close to the Wairau Fault terrace bank (note fault follows the grassed hollow to the right of the photo)

The proposed reservoir site is close to the active Wairau Fault which runs some 50m to the south of the proposed reservoir site and has resulted in a 8m high terrace bank. Test Pit E was excavated as close to this bank as possible (without damaging the trees that were retained along the bank) to see whether any trace of the faultline could be found which would have a direct effect on the reservoir.

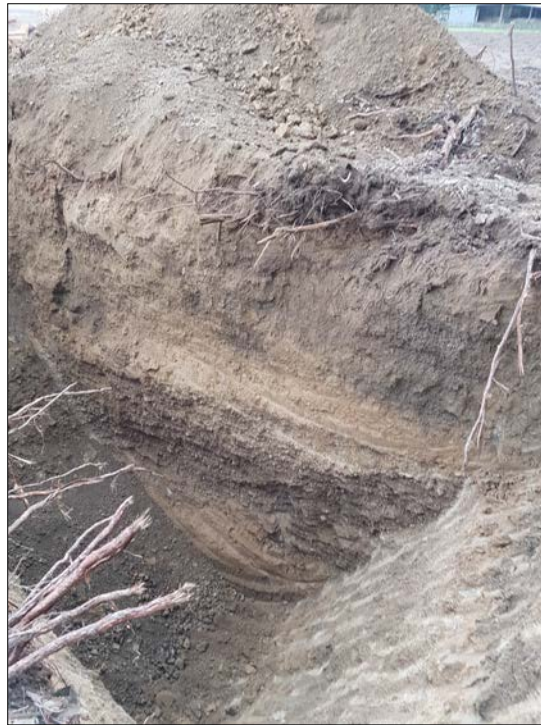
Photo of Test Pit E showing uninterrupted horizontal deposition of soil layers

The soil profile in Test Pit E was found to consist of dry, uninterrupted horizontally deposited soil layers similar to the other four test pits excavated around the reservoir.

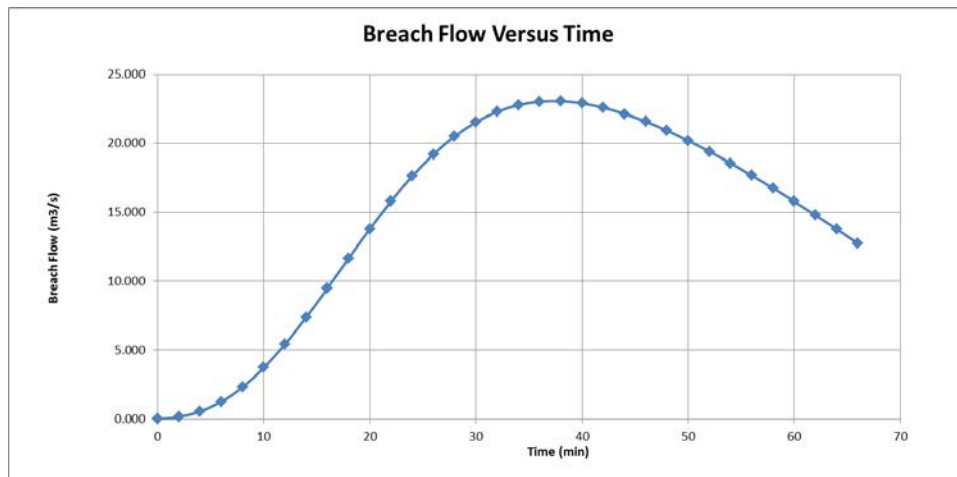
Breach Flow Versus Time Curve

The dam break assessment has resulted in a peak outflow of 23m³/s as shown in the graph on below.

This flow steadily increases from nothing to the estimated peak of 23m³/s over some 38 minutes, after which it reduces back down over a slightly longer period.
