Claydon Investment Trust

Claydon Reservoir

Technical Report in Support of Resource Consent Application

March 2019

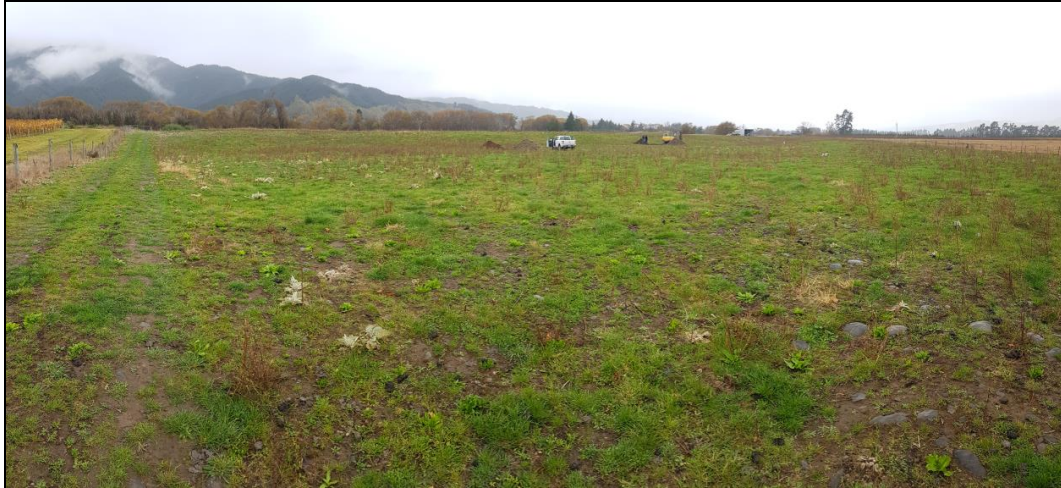
Photo looking north-east towards the site for the proposed reservoir.

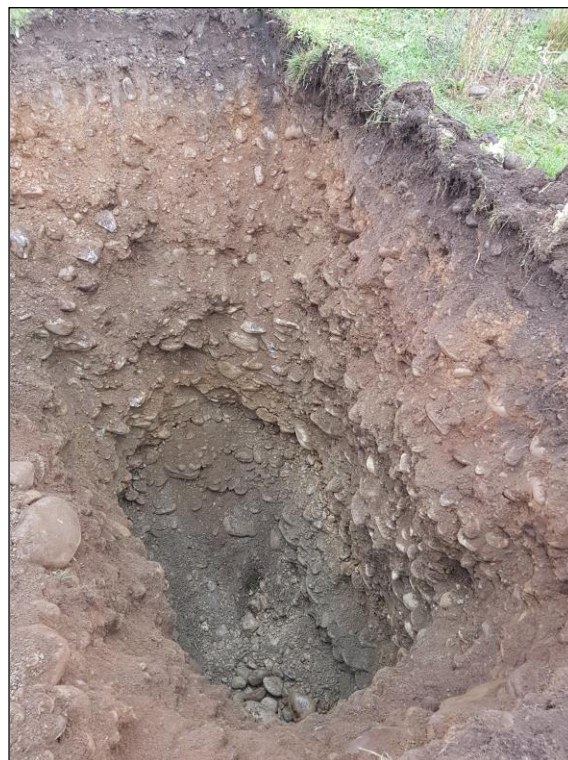
- a 0.25m thick layer of dry, brown, silty gravel (0 to 150mm) topsoil with roots, over;
- a 2.5m thick layer of dry, light brown, sandy gravel (ranging from 0 to 300mm), over;
- dry, grey-brown sandy gravel (ranging from 0 – 300mm).

Photo of Test Pit A showing soil layers.

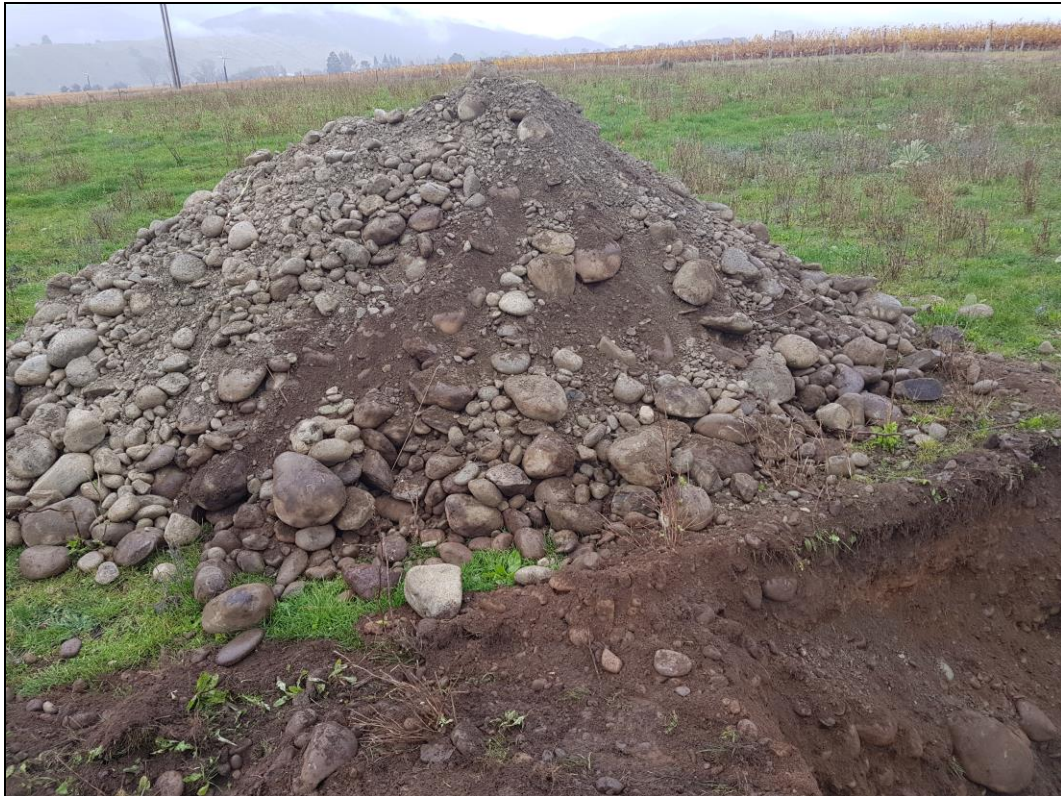
Photo showing material excavated from Test Pit A.

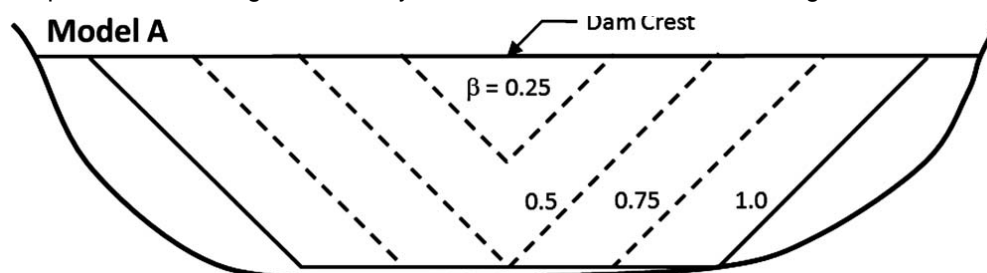
The reservoir was assumed to be full at the time of the breach, with the breach occurring as a rapidly growing, triangular failure till it reaches the level of the downstream surrounding ground, after which it widens at the same rate till the breach has been completed and the reservoir has emptied. This is diagrammatically shown on the Model A failure diagram below.

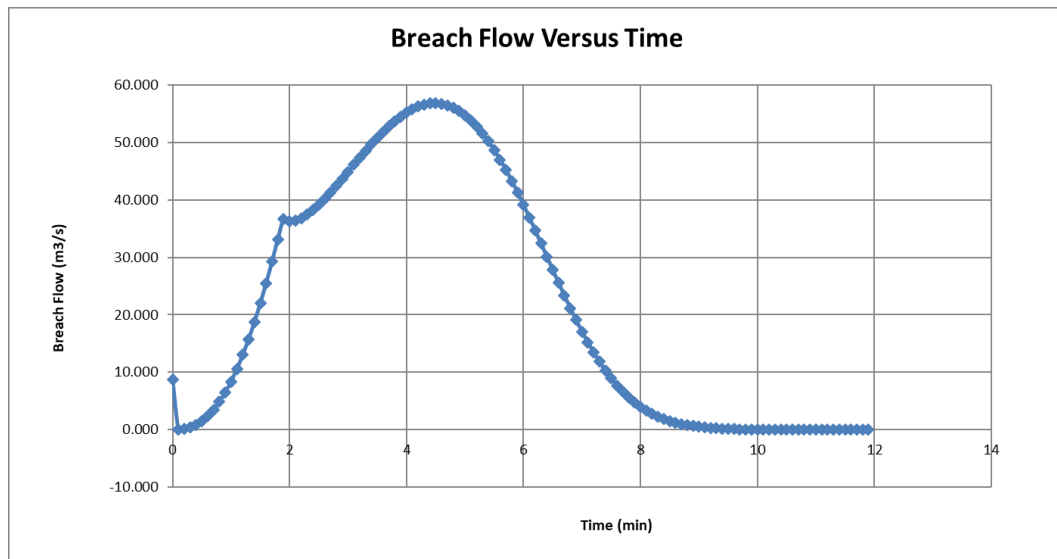
This breach has been modelled on this basis and the estimated breach flow versus time, matching the calculated values using the Froehlich equations, is shown in the graph below.

Breach Flow Versus Time Curve

This graph shows how the breach flow steadily increases from nothing to the estimated peak of 56.5m³/s over some 5 minutes, after which it reduces back down over a slightly shorter period, with a total breach being completed in 9 minutes.

- a Breach Formation Time, being the time from the beginning of rapid growth of a breach to the time when significant lateral erosion of the embankment has stopped, of 11 minutes, and:
- a Peak Breach Outflow of 56.5m³/s.
